THE PROPERTIES OF BEEHIVE KILN FIRED BRICKS USED IN A NINETEETH CENTURY BUILDING

SUMMARY

The McNeill Drugstore is located in Tenaha Texas and was constructed around about 1870. The building has a lime mortar with a salmon-reddish brick. This paper presents a summary of the investigation this Texas drugstore, which is typical of the period and presents the experimental results on testing of a sample of bricks from the building. The bricks were manufactured in a beehive kiln.

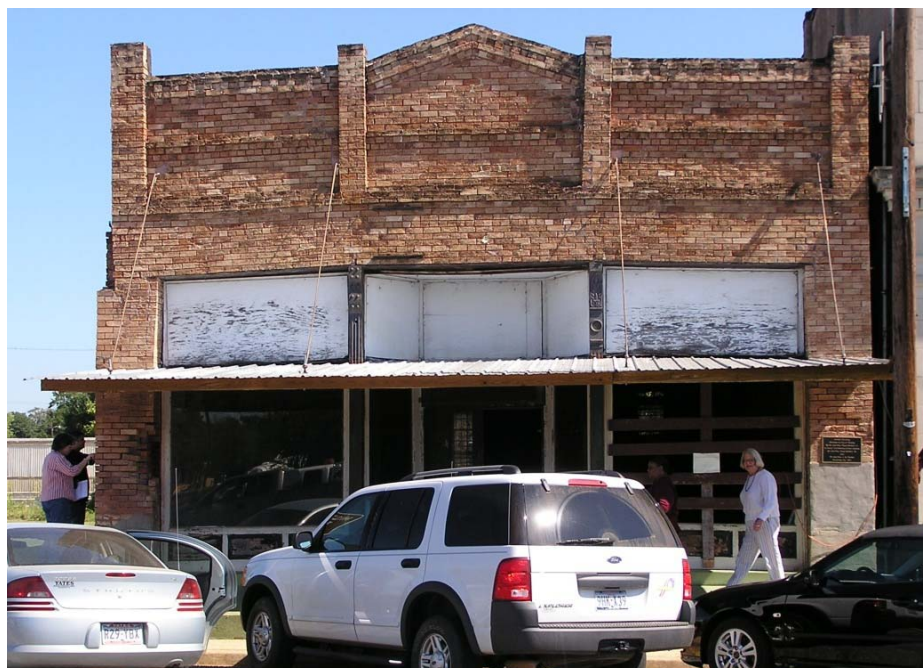
The McNeill Drugstore represents the quintessential American Drugstore of the late 19th and early 20th centuries, and like most such drugstores, chain stores have displaced these familiar sites from the old town squares of America. The McNeill Drugstore has not been occupied from some years and has fallen into a state of disrepair (Figure 3)

Figure 3. McNeill Drugstore – Street Elevation.

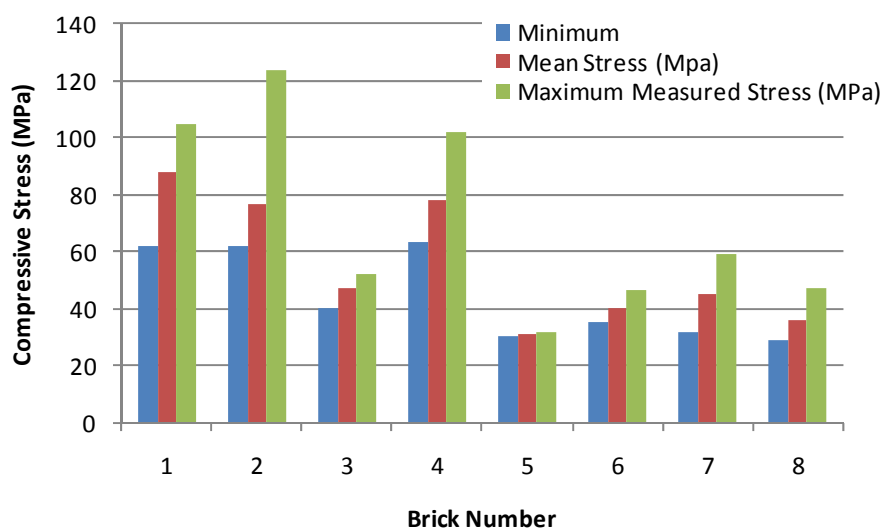
Figure 5 shows the plotted results from the data presented in Table 1. Brick results typically have a coefficient of variation of 25% (Page, 1973) and the data shown in Figure 5 would be considered typical for the later part of the nineteenth century. The difficulty in manufacturing bricks in a beehive kiln is quality control, and minimizing the variations in quality of the bricks. Baker provides a summary of the different grades of bricks produced in a single firing in a beehive kiln. Although Baker does not explicitly state that results 4 to 8 for bricks from Massachusetts brick kilns, but this appears a reasonable assumption based on the town names.

The distinct difference in the results for Sample 4 and 7 highlight the issue of temperature control in the firing of bricks in beehive kilns.

Figure 5. Louisiana Purchase Exposition – Brick Compressive Stress Results

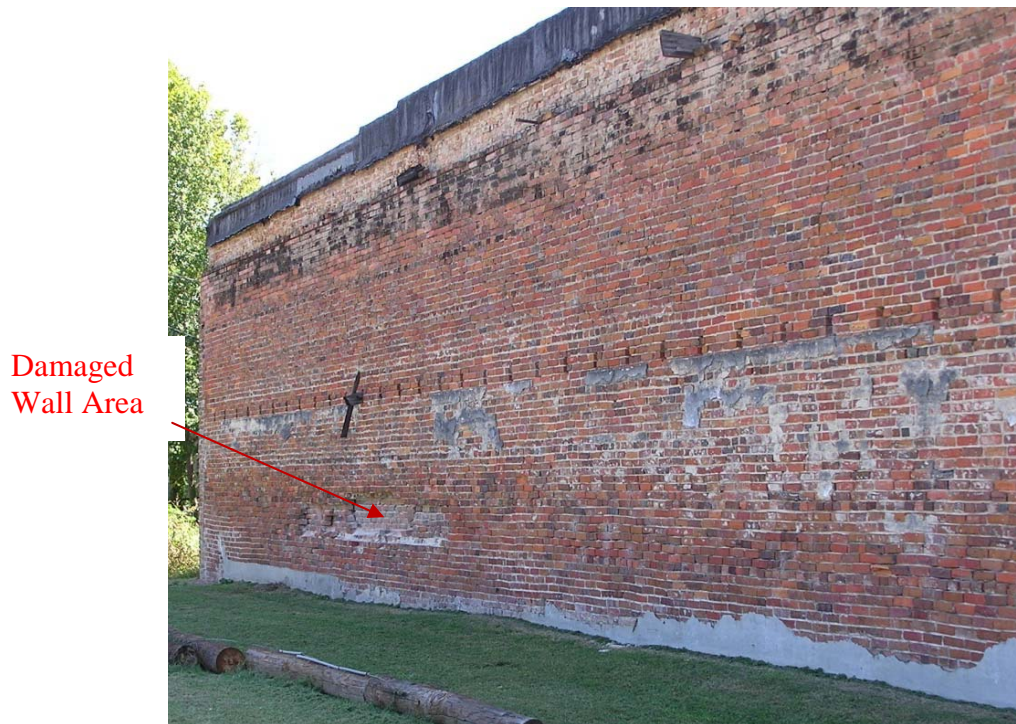
The drugstore is not currently in use, nor is the building habitable without a significant reconstruction effort to bring the building up to acceptable occupation standards. A picture of the northern wall is shown in Figure 6. This picture clearly shows evidence of the building located in the grassy space visible in front of the wall. There is an area of heavily damaged bricks in the lower left hand quadrant of the wall.

Figure 6. McNeill Drugstore – Northern Elevation.

The building requires a significant effort to return the structure to a habitable standard. The key findings were to improve the drainage beneath the floor area, rebuild the street frontage using the available original bricks and columns, re-point the mortar, and rebuild the damaged areas of external bricks. The southern or rear wall requires significant work to repair cracked lintels and to remove the ivy on the walls. The design of the overall structure will require careful consideration to achieve an acceptable level of safety for a wind or earthquake load. Shelby County is located away from the Texas coastal strip, which reduces the design wind velocity and is far enough away from the major fault located north of Dallas, Texas so that a normal intraplate design standard for earthquake would be appropriate (American Society of Civil Engineers and Structural Engineering Institute, 2003). The interior design will be dependent on the proposed use of the structure.

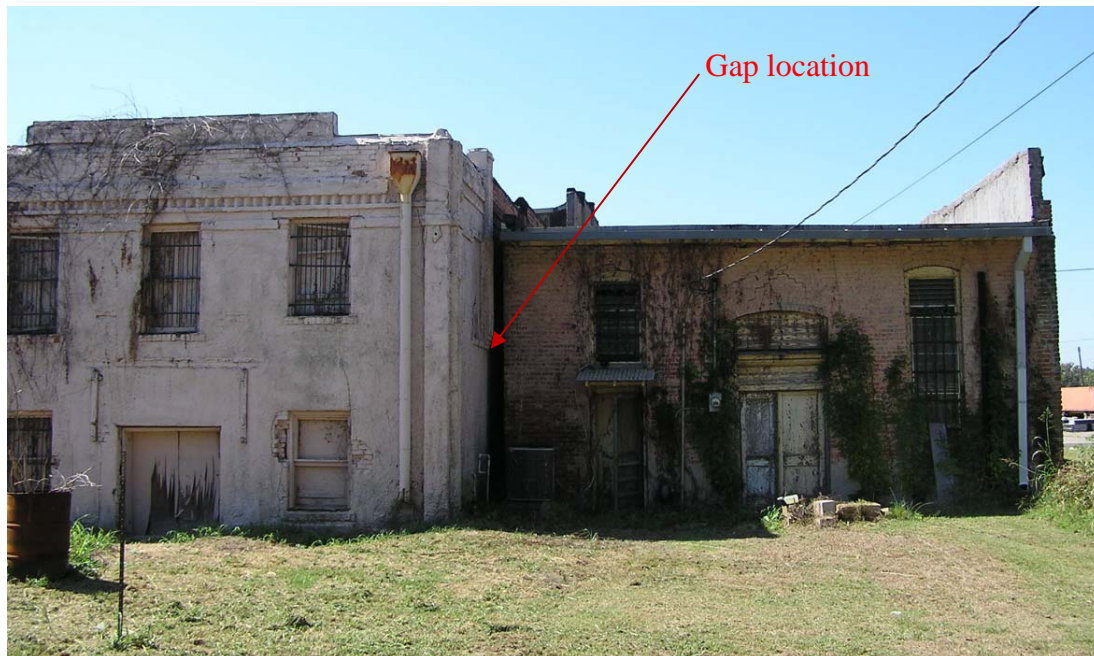
Figure 7. McNeill Drugstore – Western Elevation.

The western wall provides access onto the rear laneway. The initial concern for the building was centered on the gap between the two external walls for the Old Bank Building on the left-hand side of Figure 7 and the McNeill Drugstore on the right-hand side of the picture. This arrangement was for the safety of the bank building to prevent unauthorized access through the drugstore walls, reminiscent of “The Red-Headed League”(Doyle, 1892). This wall needs

to be re-pointed and checked for plumb, but there would appear to be no viable method to eliminate the space that did not place further significant strains on the two buildings. A close up view of the gap between the buildings is shown in Figure 8. Building orientation is maintained in this photograph.

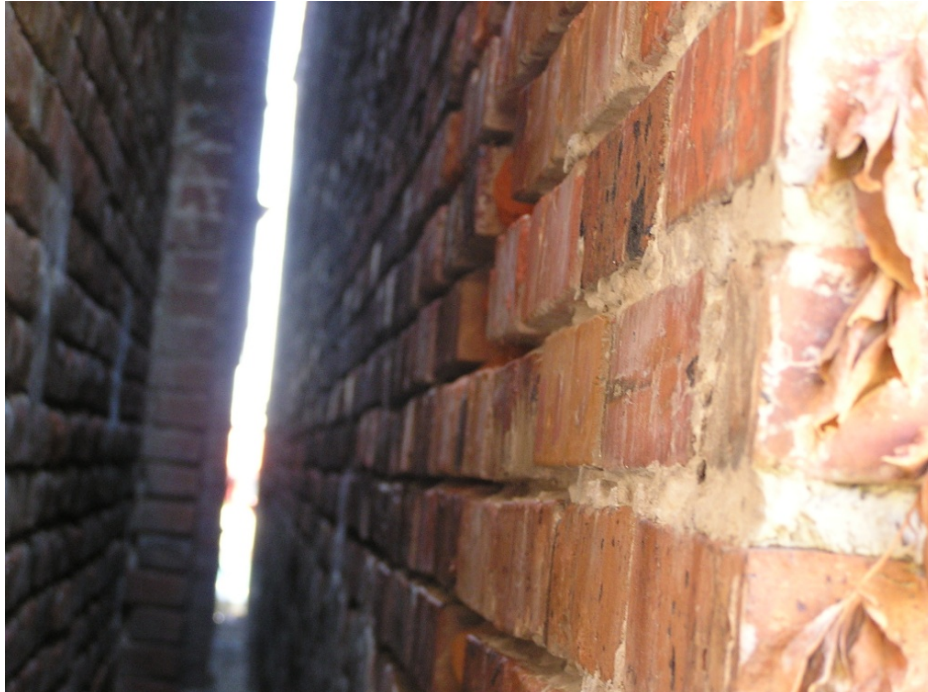
Figure 8. McNeill Drugstore – Southern Elevation, showing the gap to the Old Bank Building.

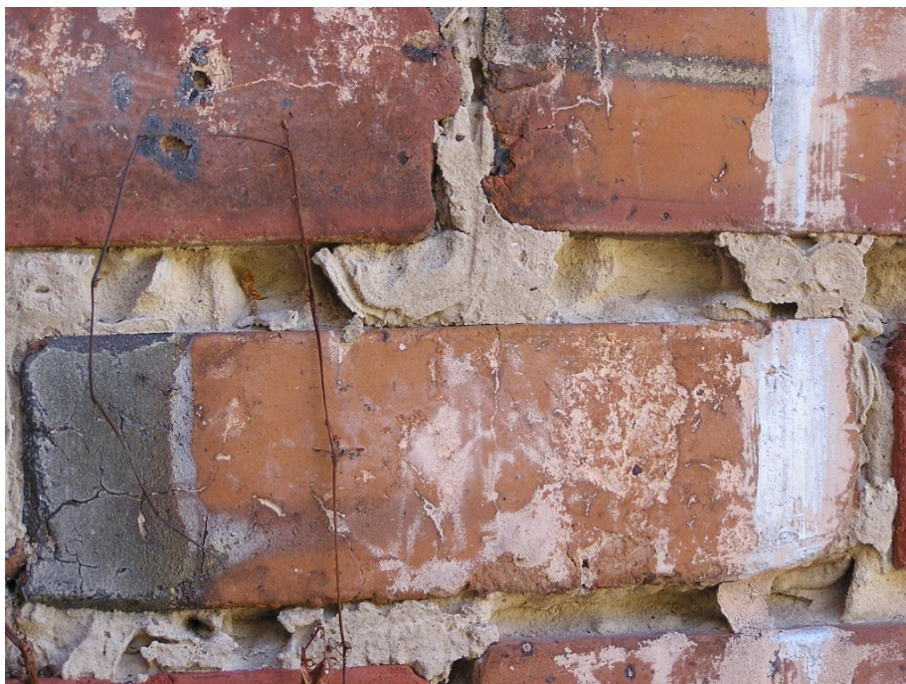
A picture showing the typical brick detail is shown in Figure 9.

Figure 9. McNeill Drugstore – Southern Elevation - Close up of joints

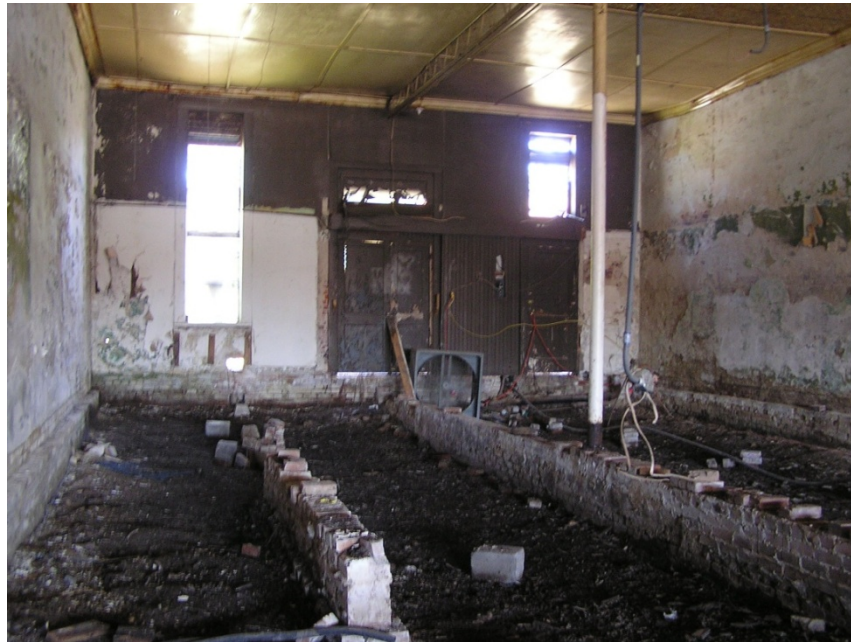
Figure 10. McNeill Drugstore – Interior

Figure 10 shows the interior of the building.

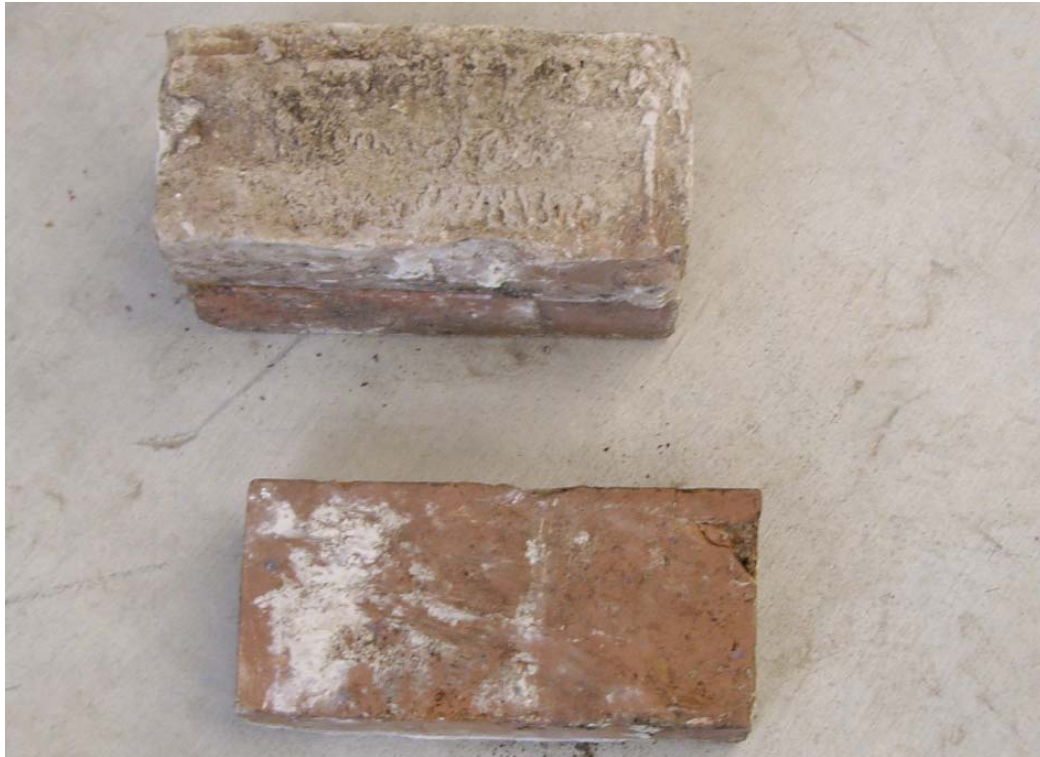
Four bricks were obtained from the structure's interior. Figure 11 shows three of the four bricks tested in the experiments. The bricks were tested for compression strength (AS 3700-2001/Amdt 2-2003, 2001) using an Instron 600DX (Instron Corporation, 2005). The testing protocol used endwise tests, with plywood capping, as for all other tests by the first author.

Figure 11. McNeill Drugstore – Brick Samples

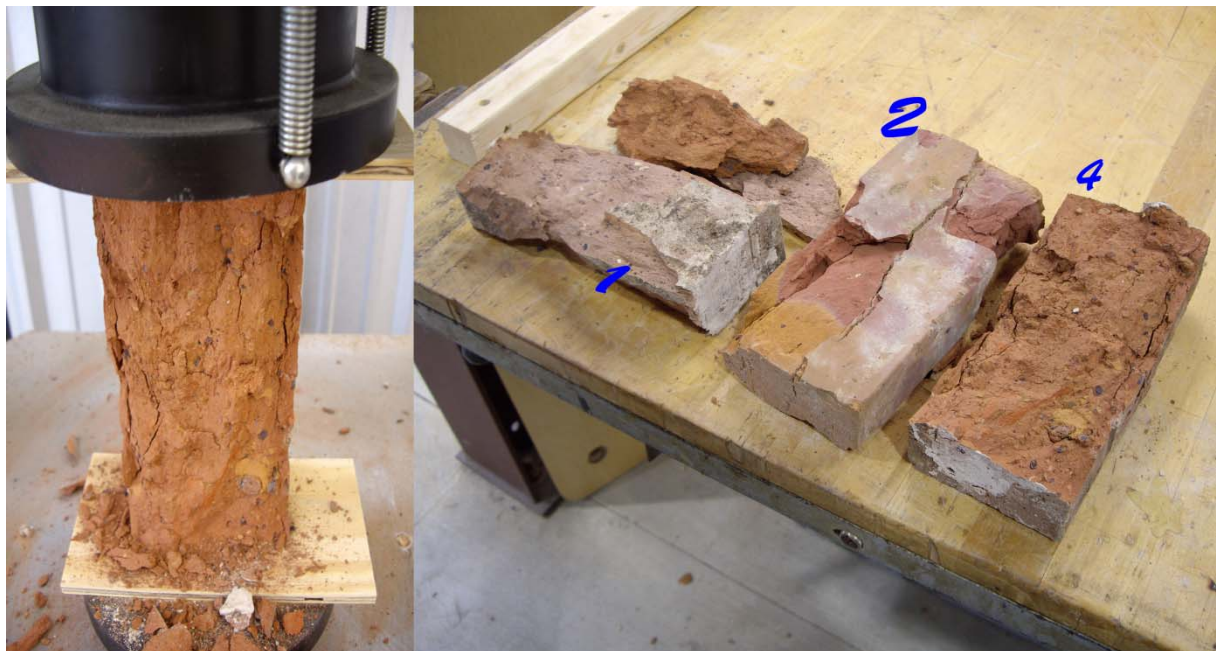
The brick failure patterns showed a brittle failure mode, with significant color variation indicating the normal problems of firing in a beehive kiln. The kiln fuel source is unknown at this stage in the research. Figure 12 shows four of the sample specimens after testing.

Figure 12. Specimens after testing, Specimen 4 in the Test Rig.

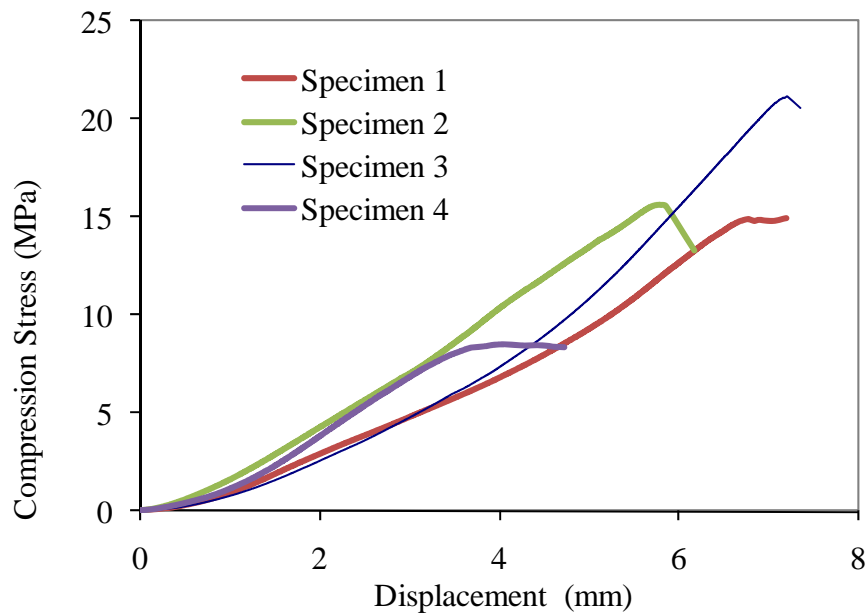
Figure 13 shows the plot of stress against displacement for the four bricks. The Young's modulus cannot be determined from the tests because of the use of plywood capping. Further testing using Linear Velocity Displacement Transducers would be required to determine Young's modulus and Poisson's ratio (Totoev and Nichols, 1998).

Figure 13. Brick Experimental Compression Test Results
