THE INFLUENCE OF EARTHQUAKES ON NEW ZEALAND MASONRY CONSTRUCTION PRACTICE

J. M. INGHAM

SUMMARY

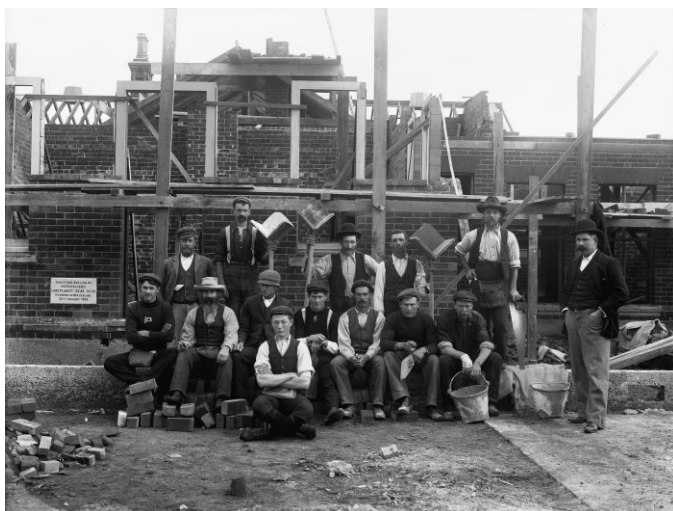
Figure 8. Group photograph of the construction workers, including bricklayers, that built the Stratford Public Hospital during 1906-1907 [Alexander Turnbull Library].

The lack of durable local building stone meant that the great majority of city buildings were constructed of clay brick with a stucco finish. Figure 8 and Figure 9 illustrate typical construction scenes (although dated from a slightly later period). In other parts of New Zealand there was a more plentiful supply of natural stone, with New Zealand's earliest masonry building having been constructed of stone in 1833 (see Figure 10). Figure 11 shows an example of early rural construction in parts of New Zealand where timber was scarce and natural stone was the primary construction material.

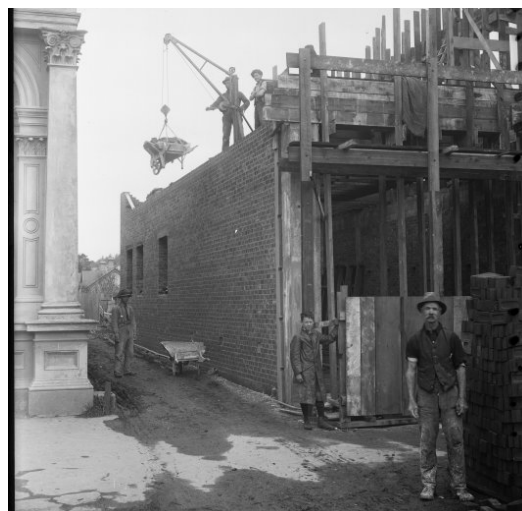
Figure 9. Brick building under construction, ca 1920 [Alexander Turnbull Library].

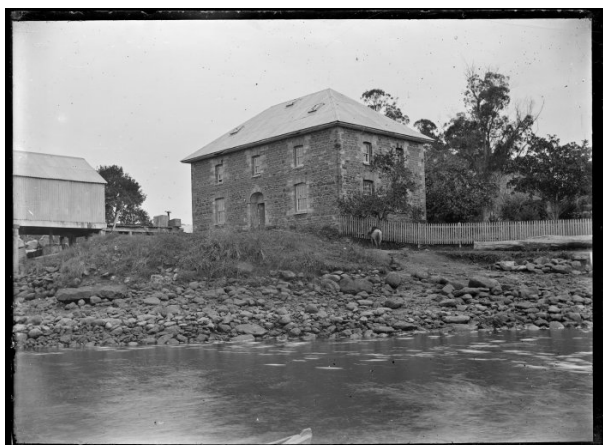
Figure 10. The 1833 Stone Store at Kerikeri was built by the Church Missionary Society. Stone was used to provide greater strength against possible attack [A P Godber Collection, Alexander Turnbull Library].

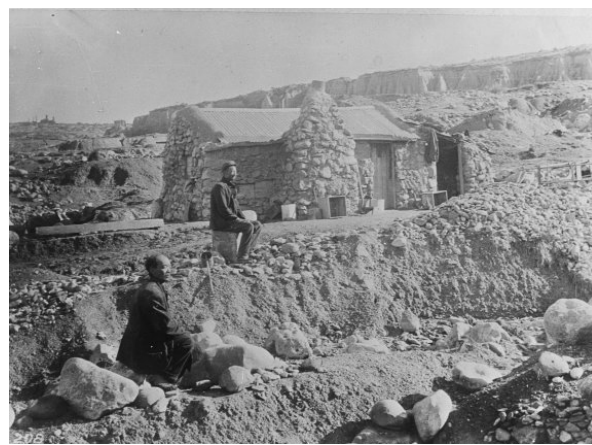
Figure 11. Two Chinese miners in front of a stone cottage in central Otago, ca 1860 [Alexander Turnbull Library].

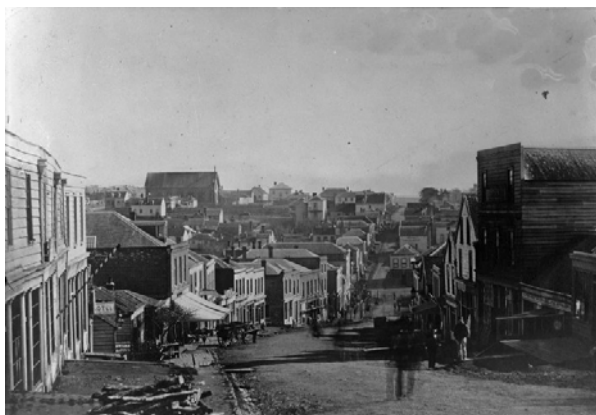
Figure 12. Looking down Shortland Crescent, Auckland, circa 1865. Construction is a mix of timber, brick masonry and stone masonry [Alexander Turnbull Library].

Figure 12 shows Auckland at a time where the majority of buildings were of timber, but a number of masonry buildings were becoming prominent. However Figure 13 shows that not all masonry buildings were well constructed. Hodgson (1992) reports that inferior materials and uncertain ground conditions were not uncommon in building projects of this period. Hodgson also reports that the city went through a transformation during the 1870s when almost all timber buildings were replaced by masonry structures, and Figure 14 and Figure 15 show that by 1910 the central city was composed almost entirely of unreinforced masonry buildings. Stacpoole and Beaven (1972) have similarly reported that Auckland's early wooden buildings dating from the 1840s were badly in need of replacement by the 1860s.

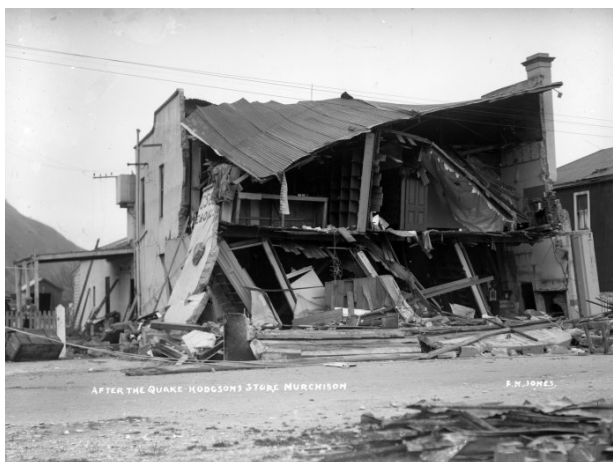
Figure 16. General store damaged by the 1929 Murchison earthquake [Alexander Turnbull Library].

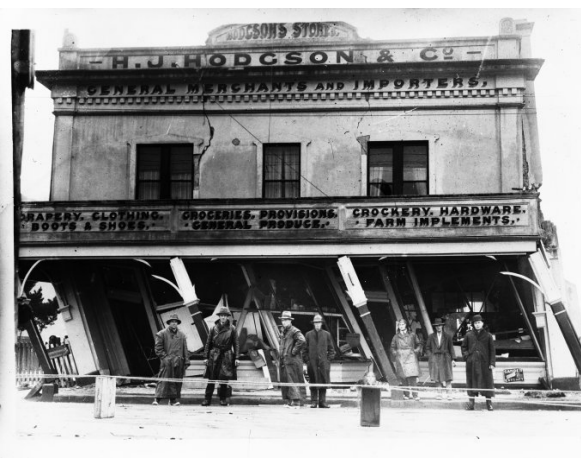
Figure 17. Damaged business premises after the earthquake of 17 June 1929 [Alexander Turnbull Library].

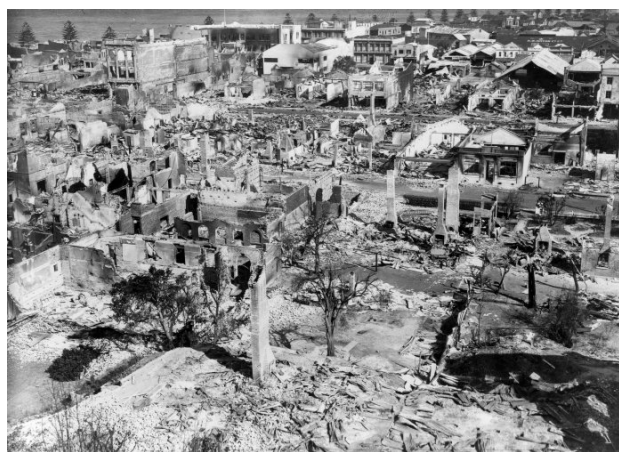
Figure 19. Looking over Napier at the buildings ruined by the 1931 earthquake and the fires [Alexander Turnbull Library].

slow to adopt masonry construction. This caution proved to be well justified. On the morning of 3 February 1931 the Hawke's Bay region of the eastern North Island was struck by an M7.8 earthquake that completely destroyed the city of Napier (see Figure 18 to Figure 21). Fires swept through the wreckage, destroying much of what was left. Eight nurses died when the reinforced concrete Napier nurses home collapsed, and perhaps the largest brick masonry building to collapse was the Napier Anglican Cathedral (see Figure 22 and Figure 23). The shaking resulted in damage from Taupo to Wellington, and left 30,000 people homeless (see Figure 24 and Figure 25). The official death toll was 256, and the event remains the worst disaster of any type to occur on New Zealand soil (Dowrick 1998; Dalley and McLean 2005).

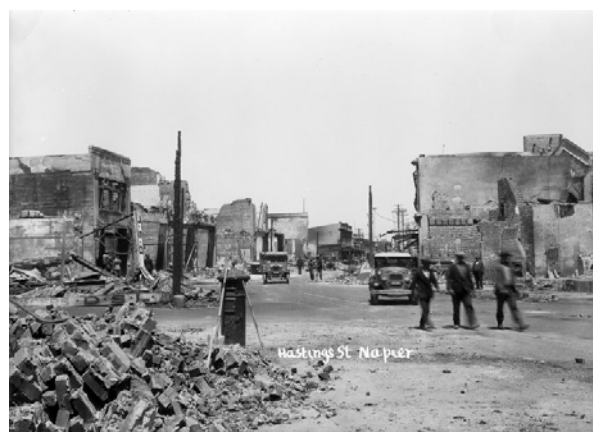
Figure 21. View down Hastings Street, Napier after the earthquake 1931 [Alexander Turnbull Library].

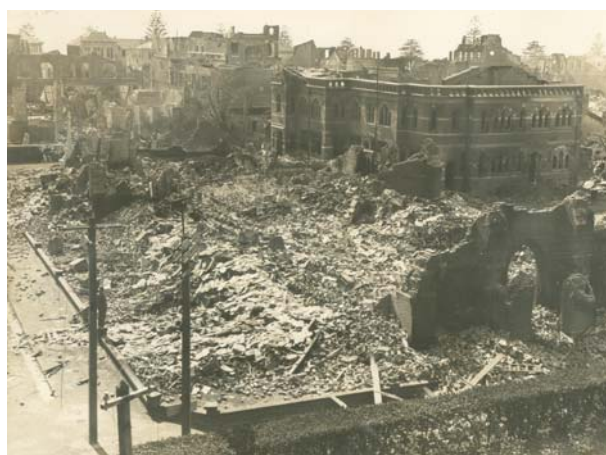
Figure 23. Ruins of the Napier Anglican Cathedral after the 1931 Napier Earthquake [Alexander Turnbull Library].

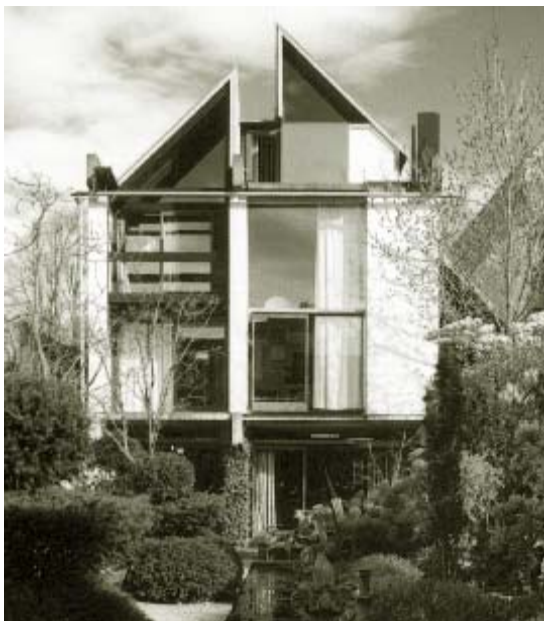
Figure 26. The Warren concrete masonry townhouse constructed in 1965 (Gjerde 2006).

Stacpoole and Beaven (1972) report that in the post war period until the mid 1960s, most New Zealand buildings were simple concrete earthquake frames with clay brick infill panels. Gjerde (2006) reports that an eminent New Zealand architect Sir Miles Warren was formative in the promotion of architectural concrete masonry in the 1960s, with a highlight of the period being a townhouse that he designed for himself in 1965 (see Figure 26 and Figure 27). Texture and scale were pursued as beneficial architectural properties of concrete masonry.

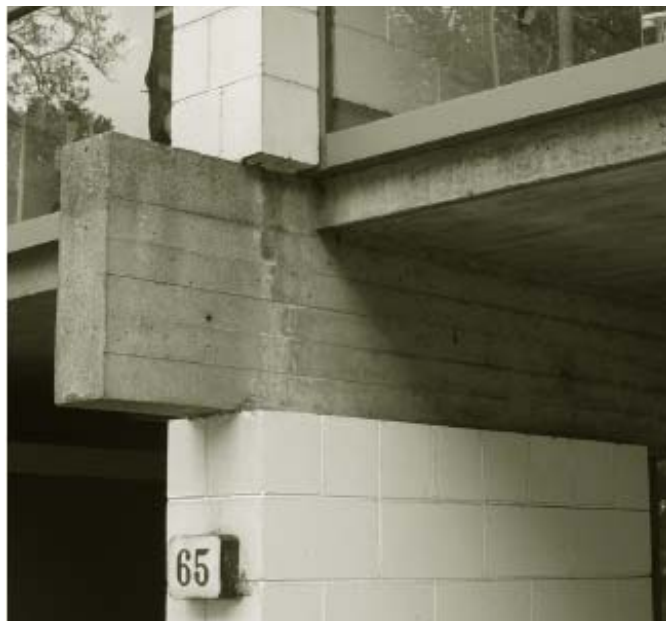
Figure 27. Texture and scale were important architectural properties of concrete masonry construction that Warren deployed (Gjerde 2006).

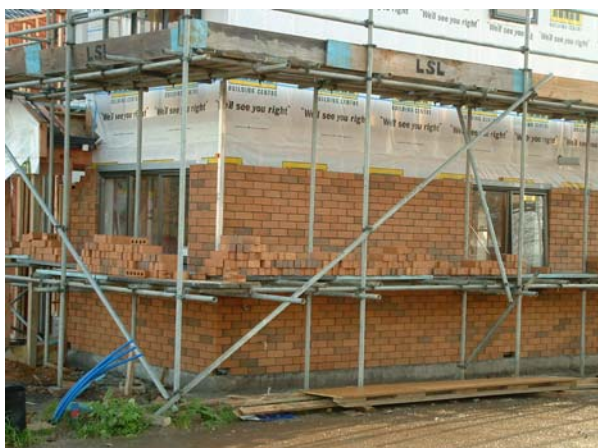
Figure 30. Unreinforced clay brick masonry veneer being applied to a light timber framed home.

Recognising that all structural masonry in New Zealand is required to be reinforced in order to resist lateral earthquake loads, it follows that masonry units must be cellular in order to accommodate reinforcement. Over time this has led to the practice where solid clay brick masonry is almost exclusively used as a single leaf veneer mounted to a light timber frame using veneer ties, with the masonry being deployed for its weather tightness and pleasing appearance (see Figure 30 and Figure 31). Oliver (2006) reports that 55% of new dwellings

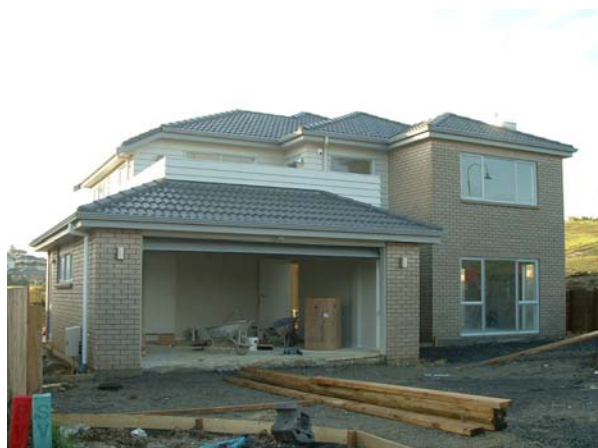
Figure 31. Light timber framed home with clay brick masonry veneer, nearing completion of construction.

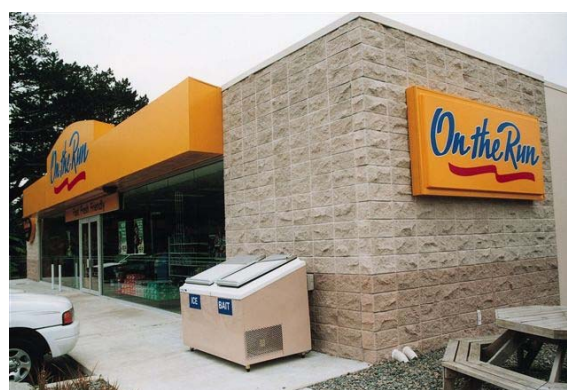
Figure 33. Textured and coloured concrete masonry wall.

Within the New Zealand construction market, reinforced concrete masonry construction now competes with both precast and cast in-situ concrete. Consequently, reinforced concrete masonry continues to hold appeal because of its attractive patterns, textures, colour and scale, its precast modular nature, and its ability to be formed into a curved surface (see Figure 32 and Figure 33). These characteristics obviously replicate international trends, with the speed and quality of construction also influenced by the availability and the skill of the project mason.

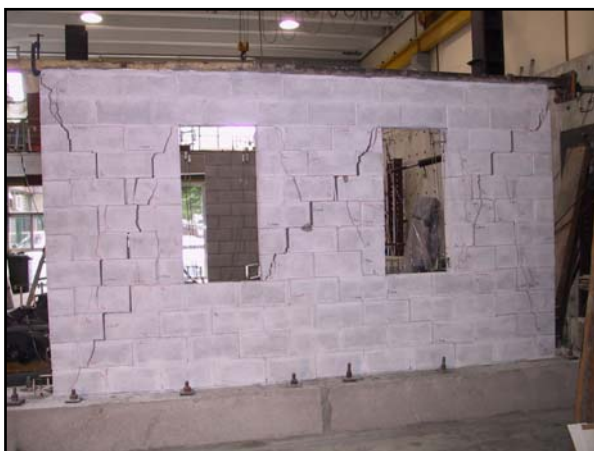
Figure 39. Condition of nominally reinforced partially grouted filled concrete masonry wall after being subjected to cyclic loading.

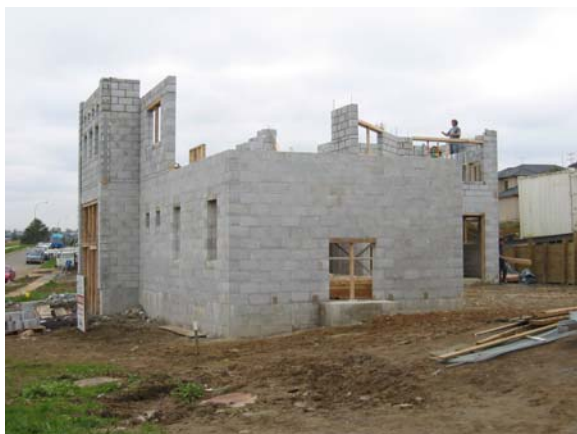
Figure 41. A two-storey concrete masonry house during construction.

In the mid-1990s the New Zealand concrete masonry industry undertook several initiatives with the purpose of facilitating greater use of structural concrete masonry. The first of these initiatives was the production of NZS 4229:1999 (SNZ 1999), which is a non-specific material design standard for concrete masonry buildings that enables a limited scope of reinforced concrete masonry buildings to be seismically designed without requiring a consulting structural engineer, thereby reducing the overhead costs associated with construction using concrete masonry (Ingham 2000). A further innovation of the standard was that the advocated building system employed 140 mm thick concrete masonry units with deformed 12 mm grade 300 MPa vertical reinforcement spaced at 800 mm centres, with blockfill grout only being provided in the cells that contained reinforcement. The contents of the standard are based on rigorous experimental validation (see Figure 39 and Ingham et al. 2001) and a companion user guide was prepared (see Figure 40; Ingham and Gjerde 1999; Gjerde et al. 2001) that was disseminated at a series of seminars held nationwide. The standard and user guide are regularly combined to design concrete masonry homes such as those shown in Figure 41 and Figure 42.

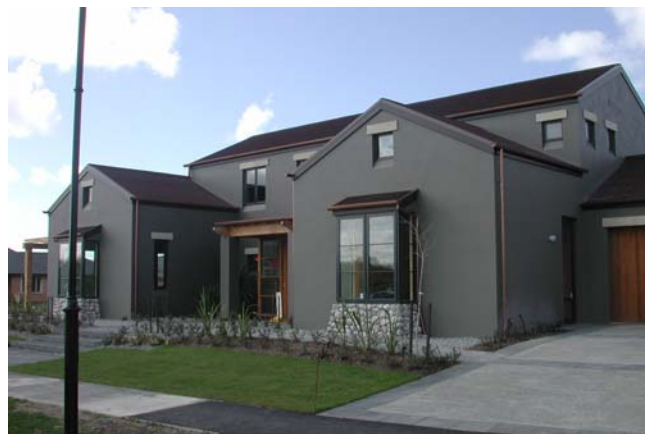
Figure 42. A completed concrete masonry house that has a plastered surface treatment.

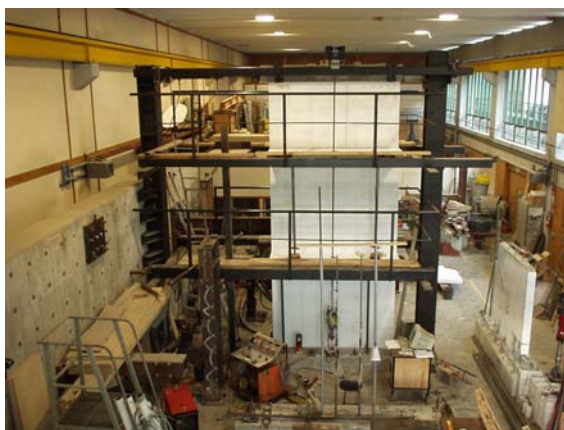
Figure 43. Pseudo static cyclic testing of a multi-storey concrete masonry wall.

A second initiative was to promote the use of unbonded post-tensioned concrete masonry construction. Two doctoral studies were conducted by Laursen and by Wight, who investigated creep and shrinkage properties (Laursen et al. 2006), pseudo-static cyclic response (Laursen and Ingham 2001, 2004a,b), shake table testing (Wight et al. 2006, 2007c), and displacement-based design procedures (Wight et al. 2007b), culminating in the design of an innovative concrete masonry building that utilised both unbonded post-tensioning and mortarless construction (Wight et al. 2007a). Figure 43 and Figure 44 show laboratory experimentation and Figure 45 and Figure 46 show construction of an unbonded post-tensioned concrete masonry house that was built in conjunction with the not-for-profit organisation Habitat for Humanity. Confirmation of the seismic response of masonry shrinkage control joints was also investigated (Ingham et al. 2007).

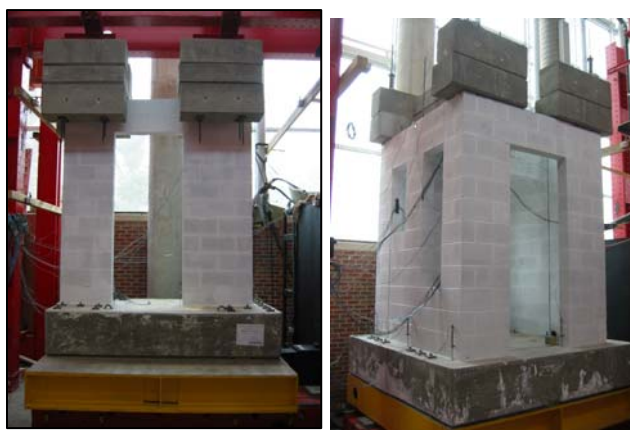
Figure 44. Shake table testing of (1) wall with opening and (2) small structure.

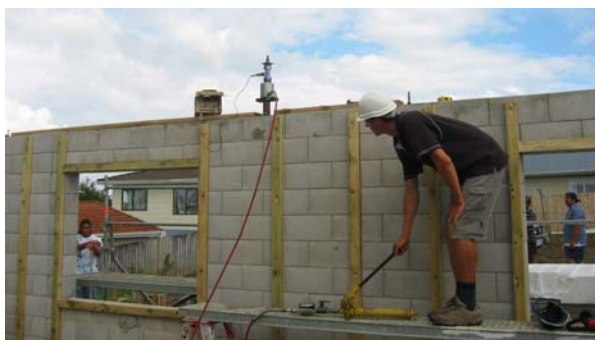
Figure 45. Applying post-tensioning.

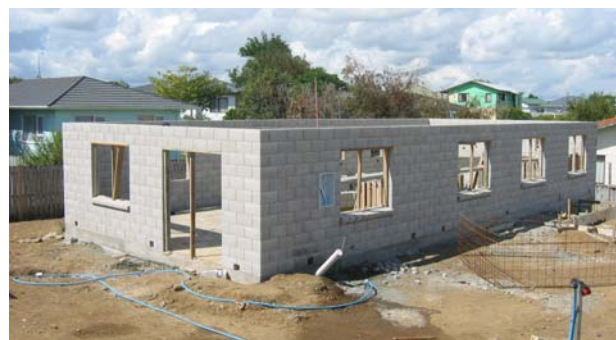
Figure 46. Completed masonry structure.

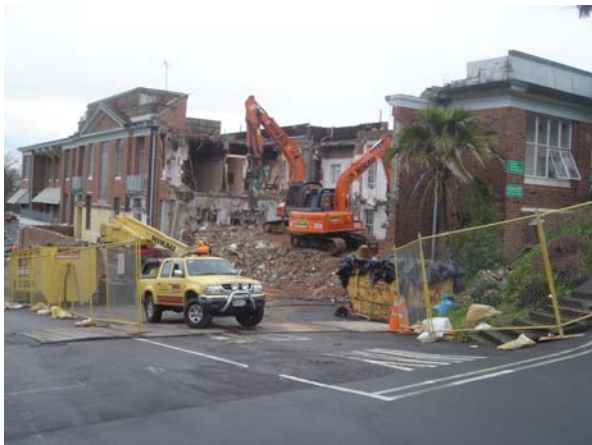
Figure 47. Demolition of an unreinforced masonry building.

- Component and system-level simulated seismic loading (Russell and Ingham 2007b). This involves both laboratory studies and field testing of existing URM building components. Field studies are being conducted in co-operation with several Auckland demolition companies (see Figure 47 and Figure 48).

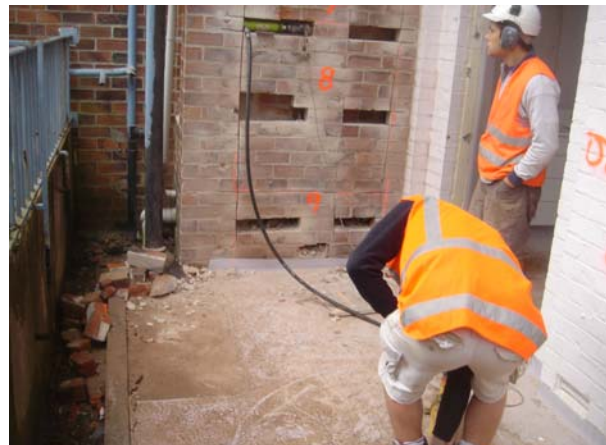
Figure 48. Site determination of masonry material properties.
