Behaviour of multi-leaf stone masonry walls strengthened by different intervention techniques

M. R. Valluzzi, F. da Porto and C. Modena

University of Padua, Department of Structural and Transportation Engineering, Padua, Italy

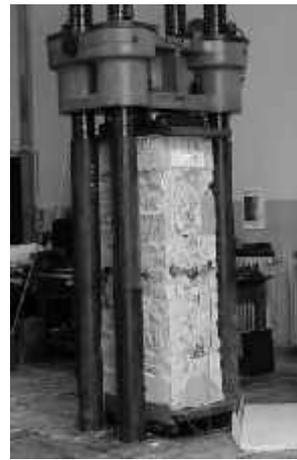
Figure 3 : Experimental set-up.

The compressive tests were performed under load control, with vertical increments of a rate about of 0,25 kN/s. Six displacement transducers were used to measure the deformations under loading: two vertical W20 (20 mm of maximum deformation) and two horizontal W10 (10 mm of maximum deformation) on each main façade of the walls, and two horizontal W10 on each transversal section (see Figs. 2 and 3).

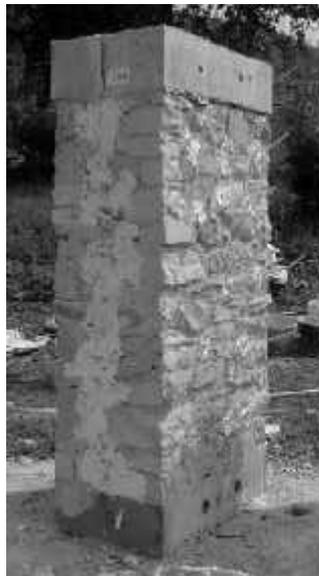
Figure 4: View of a wall before injection

Before grouting, a series of injection holes have been drilled on one side of the walls, spaced of about 25-30 cm one to the other, following approximately a scheme of equilateral triangles. A number of 11-12 holes per m² were used. Such holes distribution was arranged to assure the complete injection of the voids and to check the diffusion of the grout during the intervention. Actually, about the 70% in average of the holes were really injected. To the same purpose, some checking holes were drilled also on the other surfaces, that is on the two lateral sections and on the not injected façade. Subsequently, plastic tubes (9 mm internal diameter, 12 mm external) have been introduced and sealed into each hole. The lateral sections have been roughly sealed with plaster to avoid excessive leakages of grout, but allowing some small outflows. In Fig. 4 a wall ready to be injected can be seen.
