Examples of strengthening of main walls in old buildings

P. Berkowski and G. Dmochowski

Wroclaw University of Technology, Department of Civil Engineering, Building Engineering Institute, Wroclaw, Poland

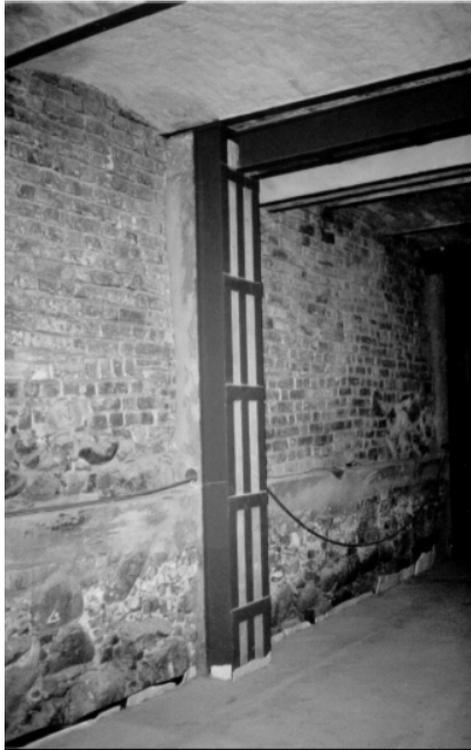
Figure 3 : View of a reinforcement - cellar.

Columns of steel frames were placed along building walls every 6 m and based on concrete boards, common for both columns of the same frame. Steel binders with I260 were placed on pillars, along the building wall. The floor on steel beams was made on binders. Beams were condensed above the columns. On the overhanging floor beams, laid above the columns of the lower storey, there were placed columns of the higher storey, pushing them as close as possible to the brick walls. The whole structural arrangement of the building was repeated up to the 3rd floor, above which the floor was based on the building walls. Additionally, on every storey, on which the strengthening was applied, the walls were braced to the floors with inserted anchors of HILTI type. The reinforcement itself, after applying it in the building, is shown in Figs. 3-4.

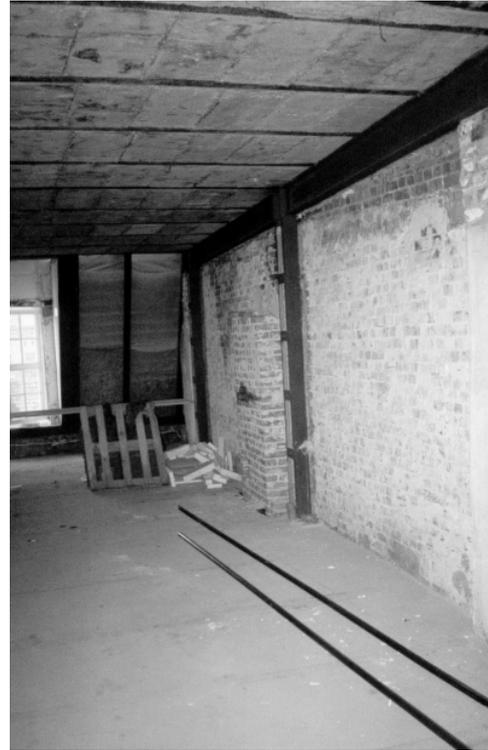
Figure 4 : View of a reinforcement - ground floor.
