Reconstruction of Jupiter's temple baptistery of St. John in Split, Croatia

Egon Lokošek,
University of Zagreb, Faculty of Architecture, Zagreb, Croatia

ABSTRACT: Jupiter's Temple in Diocletian's Palace in Split is neglected, in an inappropriate and rather bad condition today, especially its semblance. This is mostly related to its west gable and horizontal cornices of the longitudinal walls. It never had a roof, so it was always exposed to the bad environmental influences that forced its deterioration. Significant damages of ashlar, visible as shiftings and fractures at particular portions, as well as the corrosion and braking of the iron ties, demand an adequate reconstruction, and its preservation can be accomplished by final covering.

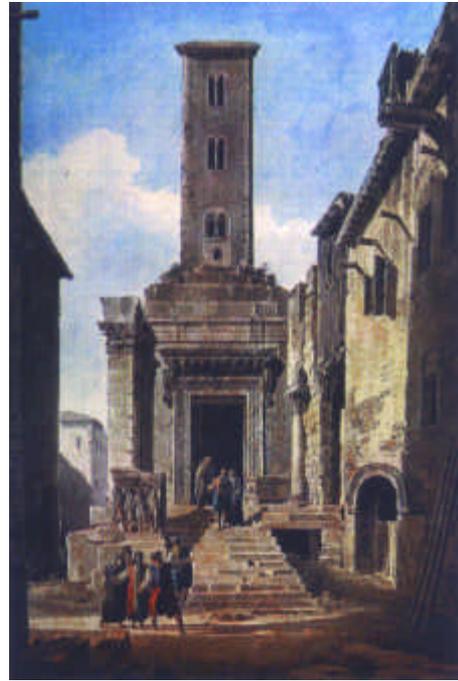
Figure 3: Reconstruction of eastern tower

At the eastern side of the vault that never had a roof, an early Romanesque tower had been built in 11th century. It was removed in the year 1840. At the beginning of 20th century a few houses at the eastern and western sides were removed, and Jupiter's Temple is free from interpolations, except one house that is still leaning to its north-western quoin.

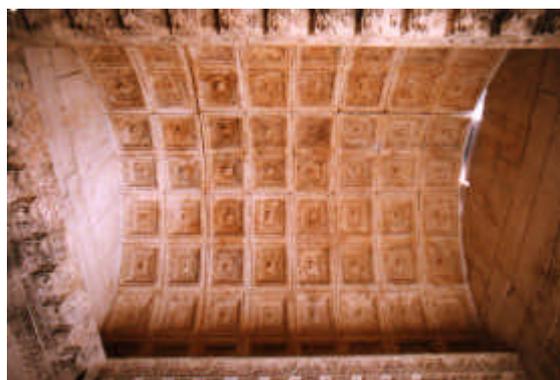
Figure 6 : Soffit of the vault

The baptistery vault is built of forty ashlar, placed in eight rows lengthways, with five ashlar each, across the longitudinal axis.

On the outer side the ashlar were hewn round shaped with quite a lot of rough areas, but they were profiled very richly on the internal side.

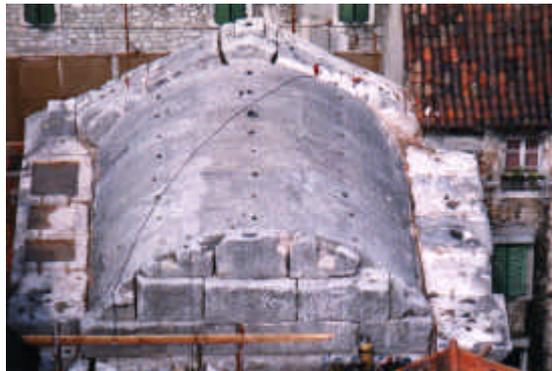
Figure 8 : Vault and cornices - the exterior

The cornices of the longitudinal walls, both the ones at the top on the outer side and those cornices the vault leans on inside, must be mentioned in the context of the bearing system. The outer top cornices are made of ashlar of about 150 cm ground cross dimension, that, considering the method of joining them together with metal ties and the distance between cross walls of the baptistery of about 7,00 m, gives the cornice potential ability of taking and transmitting the horizontal pressing of the vault. The cornice below the beginnings of the vault is probably also able to take such pressing.

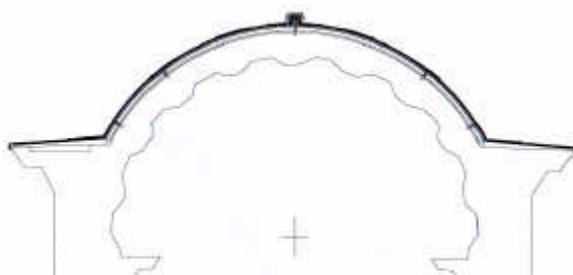
Figure 18 : Part of the cross section plan with the new lead covering

Together with reconstruction of the bearing construction parts, the temple has to be finally protected from rainfall and other bad environmental impacts. A lead covering on the bearing under-construction of steel “T” profiles is planned for protection. The board shuttering and a layer of hydro-insulation are laid over the profiles as a support for lead covering. The covering is set in a way that allows ventilation space between lead covering and stone vault to prevent any kind of inconvenient physical condition.
