The Convent of Santa Maria Madalena – Alagoas – in project of preventive conservation

ABSTRACT: The project proposes conservative measures in the Franciscan Convent Marechal Deodoro State of Alagoas – Brazil, built between 1689 and 1793, contiguous to the aisle of the Santa Maria Madalena church. The historical relevance and the peculiarity of the baroque composition of the religious set of buildings has been put under federal government trust in 1964 by the National Institute for the Historical and Artistical Patrimony – IPHAN, and in 1983 it was adapted to become the Museum of sacred arts. Today it is still a museum although very vulnerable to geo-physical aggression especially those caused by humidity. Aiming at safeguarding both the building and the museum collection, the project is structured in a way which makes it possible to register the causes of the aggressions which are generating the processes taking place at the moment, to afterwards propose corrective and preventive measurements adequate to the functioning of the museum.

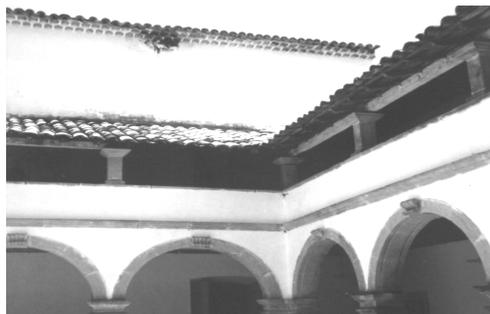
Caused by the separation and cracks on the roof tiles, on rufos and roof ridges; as well as the lack of well done cleaning process on the roof emptying drips and gutter pipes and eaves. (Photo 2)

Figure 2 : Roof tiles cracks/ obstruction of drips causing infiltration.

Continuous absorption of humidity by the roof support structure (truss, clap-board, and roof timber) as well as that of the ceiling (spars, pegs and frameworks of arches and vaults) all made in wood. Lixiviation of the pictorial layer of the ceilings due to leaking of rainwater. Proliferation of superior plants specially on the drips and entablatures, which contributes to a bigger separation among the roof tiles and a dilatation of the drips due to the expanding force of the roots.

Making a general revision on the roofing of the building, substituting all the broken tiles and fastening the ones, which may be loose.

Clear and recover all the drips, gutter pipes and eaves to avoid the retention and leaking of rainwater.

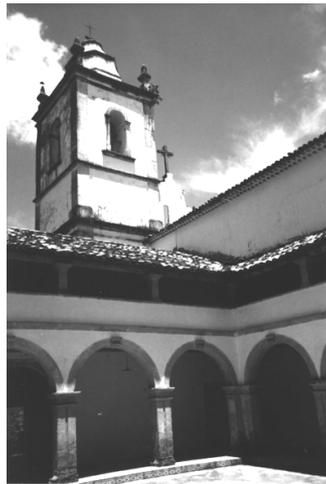
Figure 3: Patio – pillars and pavement.

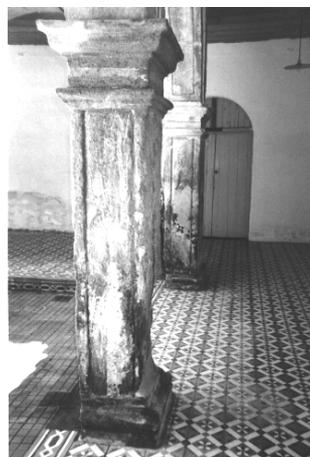
Due to the permeability of soil, sensitive to the variations of the seasonality of the tides which cause floods in the limits of the vegetable garden and the orchard of the convent, and to the migration of salts from the rain water which sprinkles, specially on the open air patio of the convent, which is completely paved, intensely devastating the base and pole of the limestone columns (Photo 3) as well as in other places where the lack of a grate or drip to collect the volume of water from the eaves, allow a saturation on the inferior base of the walls.

Jeopardizing of the stability of the plasterwork of the masonry walls (internal and external) with partial losses and ascendancy to the uprising of “leprosy” as well as the accentuated abrasion of the base and inferior part of the limestone pillars of the patio. (Photo 4)

Figure 4: Migration of salts and abrasion of pillars.

Remove the existing amount of saline efflorescence by using a soft brush or vacuum cleaner, maintaining the action while others appear along the drying process. Each part must be monitored to accompany the proportions and absorption of salt for the planning of possible renovations and the creation of a control process.

The use of sacrifice plasterwork (reboco de sacrificio) equally having as a base the use of lime (as a temporary revetment) as an option for removing the salinity of the walls stimulating a process of evaporation. The plaster must be made of lime and grain of sand of (0,500mm to 1.000mm) and the proportion of ingredients of concrete of 1-4. The inclusion of materials such as bricks and crushed shells is indicated and this procedure has been tested and approved by the TERRACAL / IPHAN program, having its application been recommended to minimize the effects of the salinity, where it's impossible to eliminate the ascending humidity. It's recommended the definition of a mapping for the gradual implementation of the plaster.

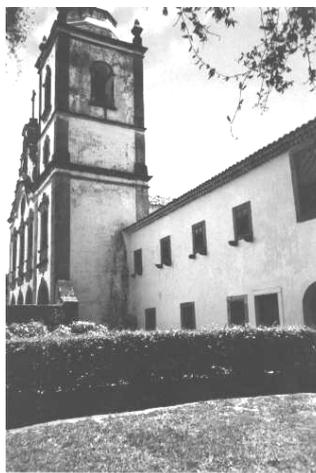
In several parts of the façade, especially in those under some type of shade, it was identified dark stains, caused by the lack of direct solar incidence and by the elevated air humidity which resulted in the retention of superficial particles having in some cases already formed dark crust. These stains also reach higher and more extreme points like the pinnacle and the cornice. (Photo5)

Figure 5: Impregnation of humidity on the external plasterwork.

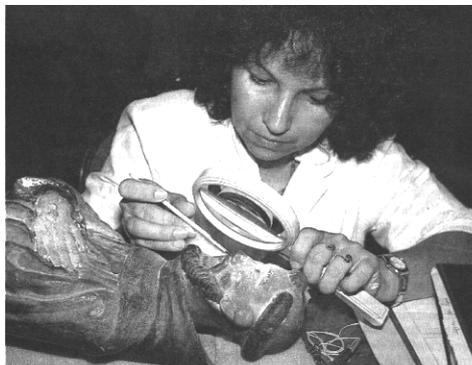
Figure 6: Recurrence of restoration on pieces degraded by the action of humidity.
