Strengthening of monuments under the effect of static loads, soil settlements and seismic actions – Examples

Giorgio Croci

University of Rome, Department of Civil Engineering, Rome, Italy

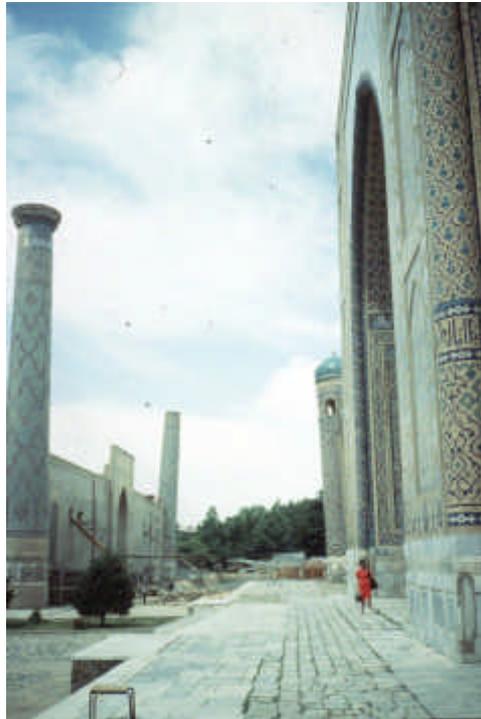
Figure 2

Minarets, towers and bell towers are structures particularly sensitive to soil settlements. Leaning effects may occur very easily because a very small original inclination it is sufficient to increase the pressures “downstream” and therefore to allow the phenomenon to develop. Significant cases can be seen in Samarkand where most of the minarets are leaning dangerously (Fig. 2).

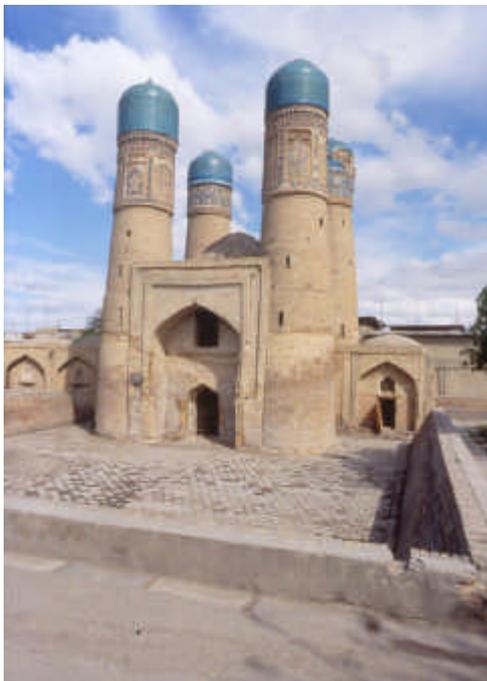
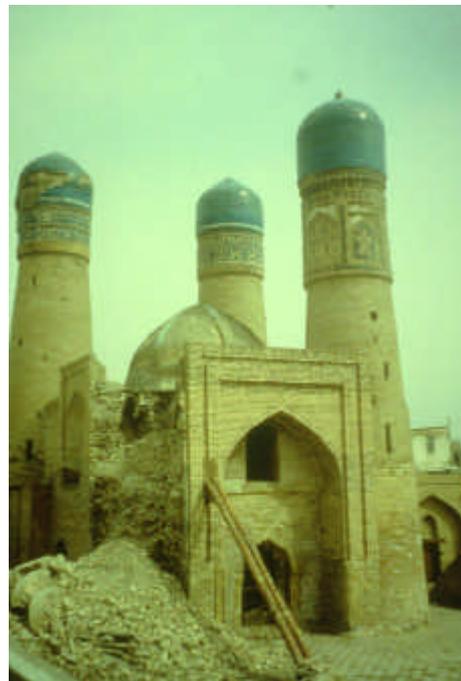
Figure 3

It is possible that this was the true cause of unexplained collapses, such as the bell tower of St Marco in Venice at the beginning of the 20th century; it is also possible that these changes in foundation pressures, which are totally invisible and occur before any vertical cracks are produced in the masonry were, combined with the decay of the masonry, the underlying cause of the collapse of the Chor Minar in Bukara (Figures 3 and 4).

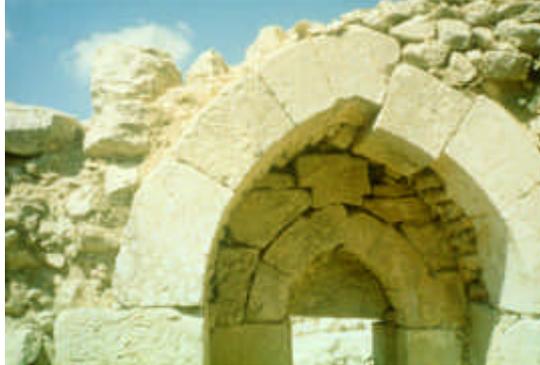
Figure 6

In dry block arches it is the shear strength between the joints that can easily be exceeded, leading finally to loss of equilibrium and geometry (Fig. 6). In corbelled arches outward rotations of the base (Fig. 7) can create situations so severe that collapse often ensues. Inward rotations increase the thrust till sliding between the blocks occurs but the consequences are not usually so severe and new equilibrium conditions can usually be achieved.

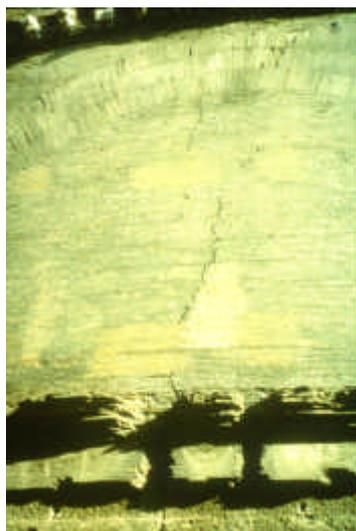
Figure 9

In the Pantheon, whose dome is directly supported by the walls of the “Rotunda”, ancient soil settlements induced tensile horizontal stresses in the walls and the lower zone of the dome,

creating cracks in the dome itself and in the structures below (Fig. 9); the need to strengthen some of the architraves was the result of this phenomenon.

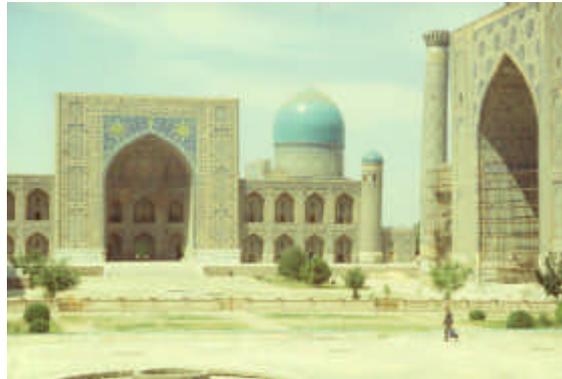
Figure 12

In some cases what is really necessary is not to substantially change the global load, but to increase and reduce the loads, and then the pressures, in different areas of the soil in order to reduce the differential settlements. A current technique is the use of a hydraulic jack acting against piles or new foundations providing an upward reaction. To stop the increasing settlements at the Tilla Kari Mosque in Samarkand, where deformations have also created large cracks in the structures (Fig. 12) it is proposed to combine the effects of jacks on the side of the major settlements with an enlargement of the foundations (Fig. 13). In addition to eliminate the high stresses produced in the connections between the heavy central dome and the two lateral wings, as clearly shown by a mathematical model (Fig. 14), two joints are proposed to separate these zones (Fig. 15).

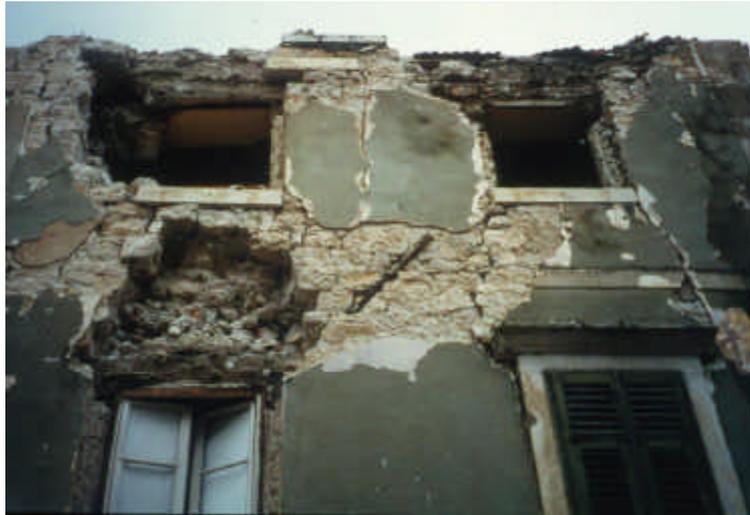
Figure 18

- the “flexural” behaviour of the walls is characterised by cracks mainly concentrated under and over the windows (Fig 18); the wall behaviour can be improved by ensuring good horizontal connections at floor level. This can be done by using “kerbs” formed with steel or synthetic bars injected in the masonry. Concrete “kerbs” can be structurally useful but often incompatible with the historical appearance and can be difficult to insert in the building; their use must therefore be limited to situations where it is not possible to ensure safety levels in more acceptable ways; it is always better, anyway, to lose the kerbs in the thickness of the masonry. Small x-frame steel braces can be inserted in the zones under the windows, which are often weak. Vertical bars or cables, often prestressed, may be placed through drilled holes ideally near the corners of the masonry to eliminate vertical tensile stresses produced in the walls by high seismic actions.

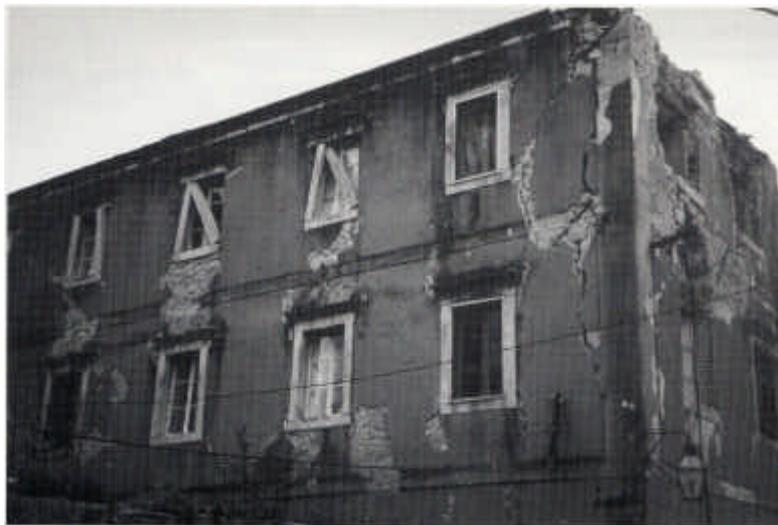
Figure 19

- the “shear” behaviour of the walls is characterised by cracks mainly concentrated between the windows (Fig. 19); it is more favourable than the “flexural” behaviour and usually only occurs where the floor level connections have been reinforced.

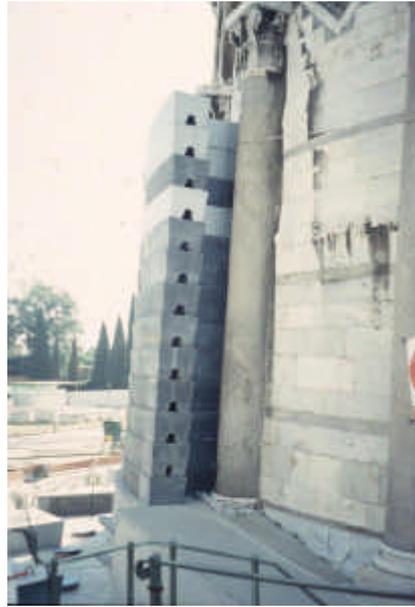
Figure 21

In 1993, anyway, about 600 tons of lead blocks (afterwards increased till about 900 t) were applied on a provisional reinforced concrete ring realized over the foundation (Fig. 21), creating a first even if small recover of the tilting.

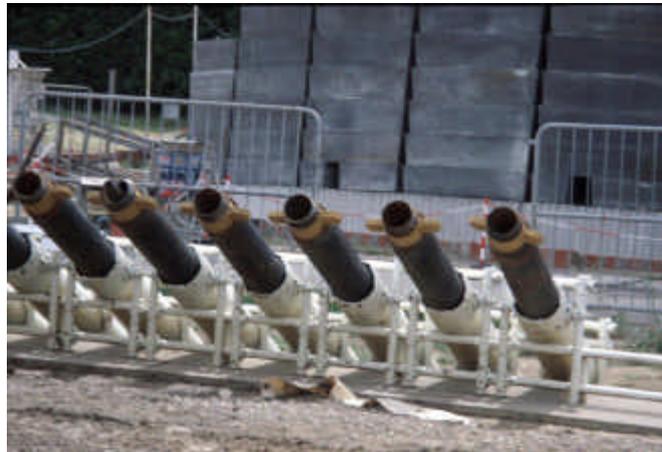
Figure 23

This technique consists on pulling out, about 5 meters under the upstream border of the foundation, little bits of soils, through a series of casings drilled into the soil (Fig. 23). This operation causes little cavities which progressively close due to the pressure, producing then little artificial settlements and a tilt on the opposite side respect the present one.

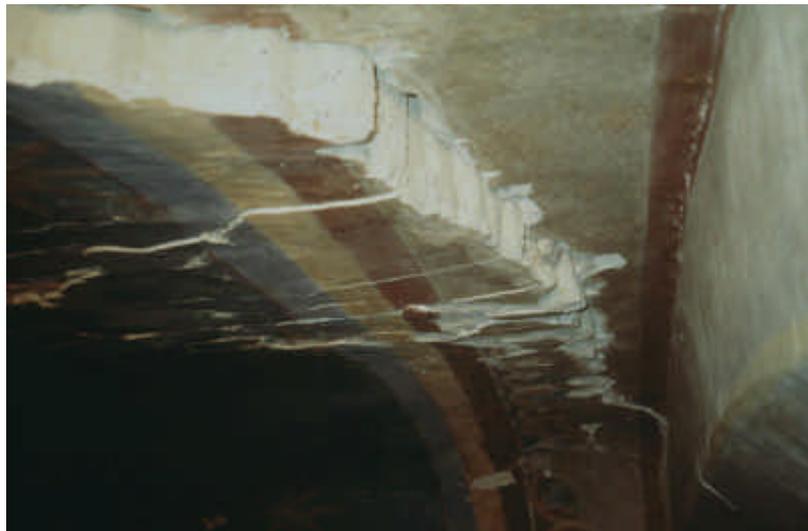
Figure 30

Urgent measures were required immediately after the earthquake to prevent the global collapse of the tympanum and of the vaults. The survived vaults were all affected by large cracks distributed both on the intrados and the extrados (Fig. 30); curvature, as already said, was lost in several zones.

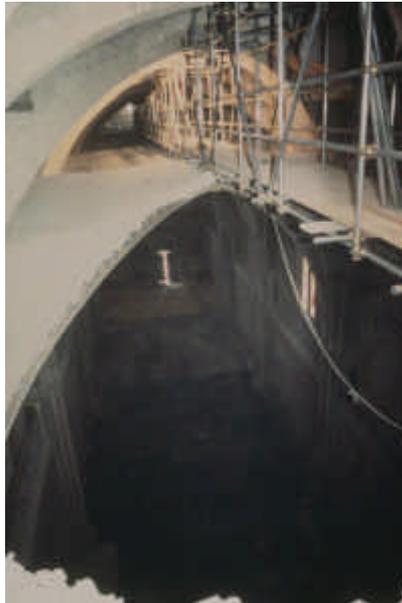
Figure 31

The danger that the standing vaults might collapse, and the consequent risk to the human life, precluded the possibility of supporting the vaults from the ground level. Instead, a platform was suspended from the roof above the vaults with the double function of inspection and of providing a base for working over the vaults (Fig. 31).

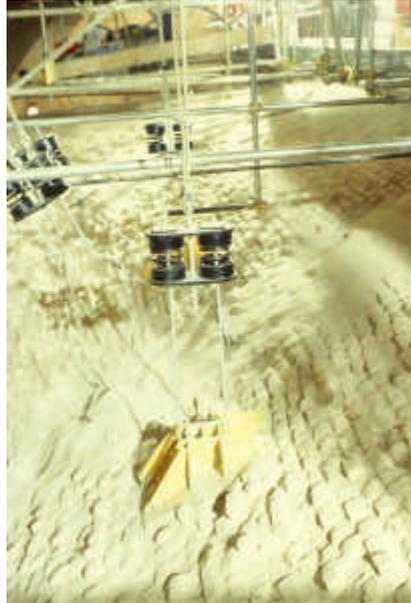
Figure 32

- suspending the vaults from the roof with a system of tie bars, having first inserted two springs to maintain the force at the design value, independent of thermal effects and minor vibrations (Fig. 32)

The cracked ribs were suspended from the roof as well with a system similar to the previous one after having placed underneath a kind of steel cradle filled with soft rubber in order not to damage the frescoes.

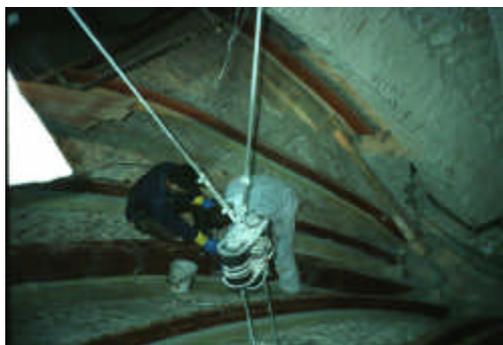
Figure 33

value of the original vaults structure. Finally the choice has been to realize on the extrados a series of little ribs, following a pattern typical of Gothic structures (Fig. 33), letting clearly visible the original structure.

These ribs are made up of a composite material with aramidic fibers bedded in epoxy resins and a central timber nucleus; this material is light, very strong (the tensile strength of the aramidic fiber is 30.000 Kg/cm² and that of the fiber with resins is about 14.000 Kg/cm²) and less stiff of the steel (the elasticity modulus is respectively 1.200.000 Kg/cm² and 600.000 Kg/cm²).
