## Damage characterization in stone columns by dynamic test. Application to the Cloister of Girona Cathedral, Spain

**ABSTRACT:** This contribution provides an overview of the use of a method based on dynamic identification for the detection and characterization of damage in 24 stone columns located in the XI-century cloister of Girona Cathedral in Spain. An attempt to estimate the work axial load applied on the columns from the measured natural frequencies, is also presented. In order to calibrate the method, a full-scale model of the columns was subjected to increasing load in laboratory to observe the evolution of modal parameters under axial load. The column was dynamically evaluated 14 times for different load levels. 48 dynamic tests (2 per column) were also developed *in-situ* to monitor the columns.

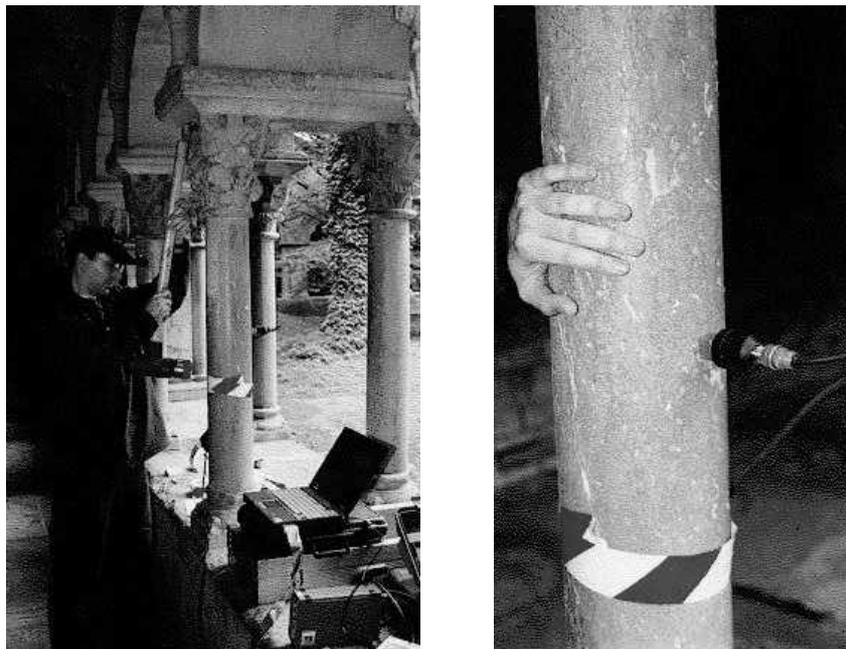
The generation of impulsive force was caused through a 10- pounds hammer applied at mid-span of every column with a single impact. A dynamic transducer consisting of a ceramic accelerometer was attached in horizontal direction (Figure 3).

Figure 3 : Acquisition system (left) and accelerometer attached on a column (right)
