Experimental analysis and modelling of masonry vaults strengthened by FRP

M.R. Valluzzi and C. Modena

University of Padua, Department of Structural and Transportation Engineering, Padua, Italy

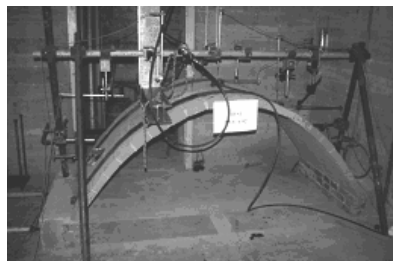
Figure 6 : Experimental set-up and position of the transducers.

Fig. 5 shows the dimensions of the vaults and the load condition, whereas in Fig. 6 a vault ready to be tested and the arrangement of the displacement measure points are given.

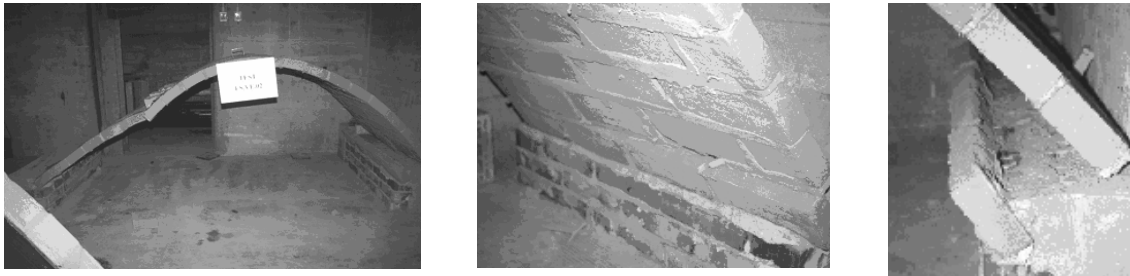
Figure 7 : Shear sliding along a mortar joint: final global deformation and details of the failure in the first joint closest to the springer (EX.C.01 and EX.G samples).

The two vaults strengthened at their extrados with glass fibers (EX.G samples) showed very similar results both in terms of the global deformation and of the ultimate carrying load capacity. The ultimate load was 20.25 and 19.70 kN for the EX.C0.01 and 02 samples respectively. In both cases the collapse occurred because of the sliding between brick and mortar in the first joint closest to the springer; such collapse occurred without any warning. An image of the detected failure mechanism is shown in Fig. 7.

The vaults strengthened by carbon fibers at their extrados presented different patterns of collapse, despite having shown a very similar ultimate load capacity (15.30 and 15.40 kN for the EX.C0.01 and 02 samples respectively). In particular, likewise the EX.G. cases, the EX.C.01 sample failed because of the sliding between brick and mortar in the first joint closest to the springer, whereas the vault EX.C.02 showed a notable global deformation (s. Fig. 8a) that not allowed any further increment in load. Due to the confinement effect caused by the limited width of the carbon strips a notable transversal deformation (Fig. 8b) was detected; moreover, lengthwise cracks were observed close to the middle of the structure (Fig. 8cd).

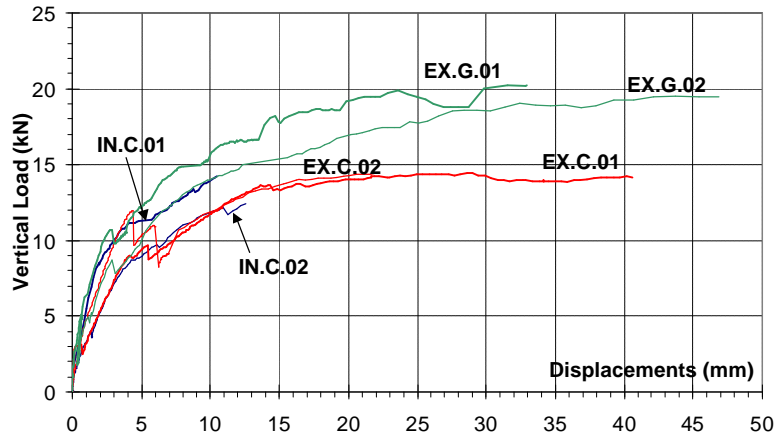
Figure 12 : Load-displacement curves obtained from the experimental tests on the strengthened vaults.

The comparison between the trends of the vertical displacements measured under the point directly loaded for the extrados and the intrados cases is shown in Fig. 12; it concerns the recorded behavior up to about 80% of the ultimate load (when measure instruments have been removed from the specimens).
