Experimental Approach to the Analysis of Historic Timber and Masonry Structures

Miloš F. Drdácký

Institute of Theoretical and Applied Mechanics of the Academy of Science of the Czech Republic, Prague, Czech Republic

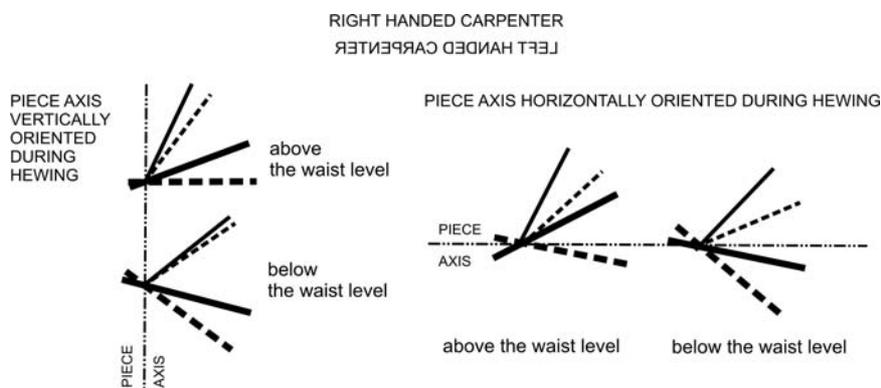
Figure 1a : Splinter marks (bold lines) and licks (thinner lines) help to identify the work mode

Figure 1b : Splinter marks (bold lines) and licks (thinner lines) help to identify the work mode

A simple technique was developed for analysing traces, based on the historic carpentry experience of master carpenter P. Růžička, i.e., working with traditional tools and comparing the results with historic timber structures and objects. The technique takes advantage of the spatial relation between the splinter mark, the lick and their orientation on the surface. When looking at the timber element we can use the self-explanatory diagrams presented in Figs. 1a and 1b. This helps to identify whether the work was done by a right-handed or left-handed carpenter hewing on the block or above the waist in vertical position, and also whether the carpenter worked on the piece in a horizontal position lying on “dogs” or on a stool. For practical survey procedures, a simple transparent sheet with the printed diagrams from the Fig. 1 is helpful and can be used for a very quick analysis of the origin of the discovered traces by overlapping it over the traces.

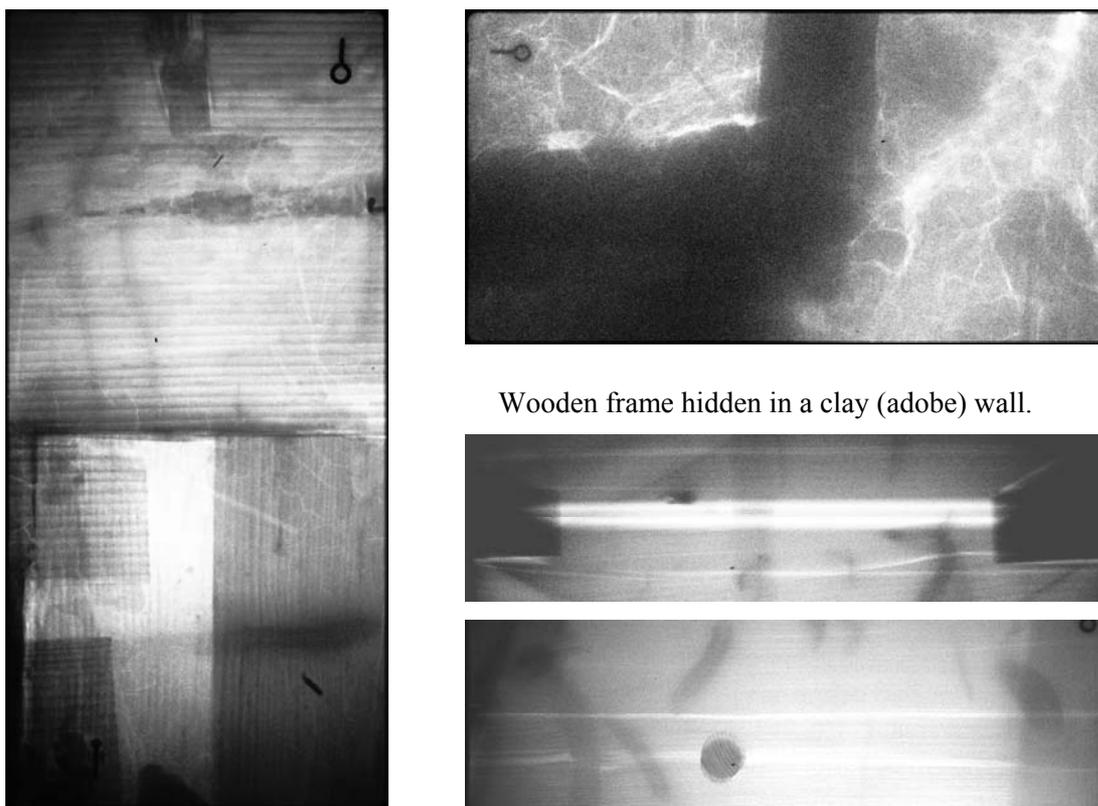
Door frame corner joint and connection of a log wall to a door frame column – in reality all hidden under thick lime paints.

Wooden frame hidden in a clay (adobe) wall.

Layout and side view of a failed halved joint with hardwood conical shear dowels and a hardwood pin connecting the two jointed elements.

Figure 2 : Examples of X-ray visualization of historic timber structures and joints.

X-ray diagnostics can reveal not only decayed wood but also hidden structural defects, types and state of carpentry joints as well as types and imperfections of metal or wooden connectors. Some typical examples are presented in Fig. 2. The measurements are effective on other materials, e.g., clay walls, gypsum sculptures and even slender masonry walls (up to about 25 cm in thickness), see further examples in the paragraph on masonry.

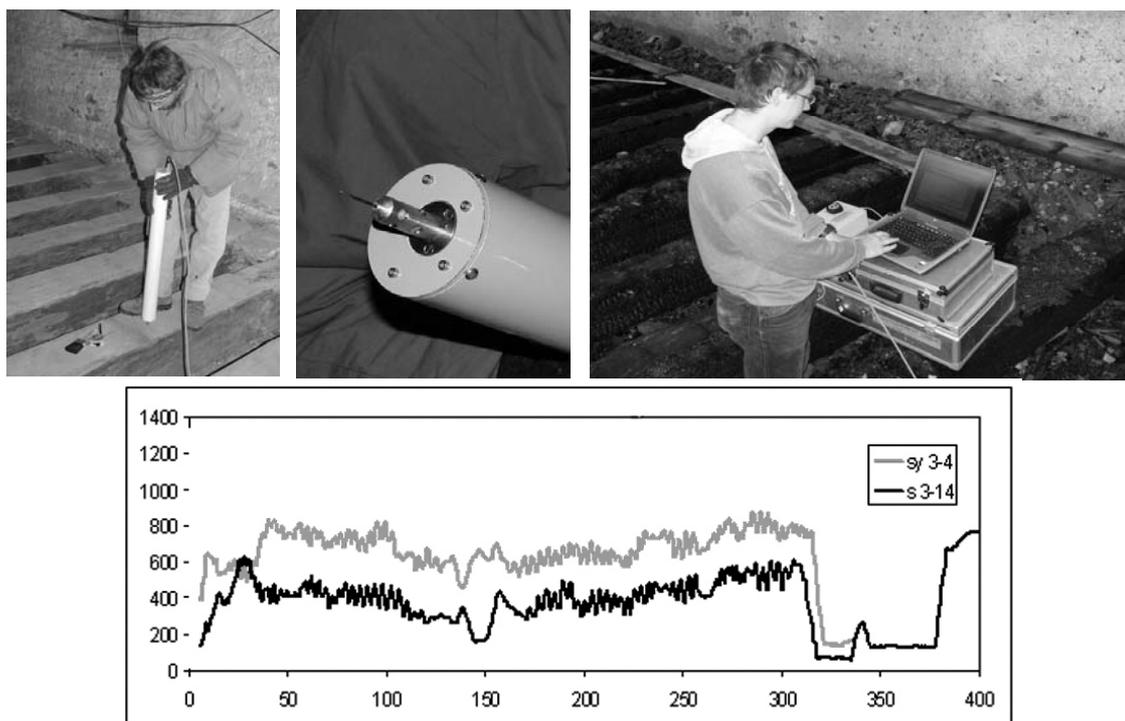
Figure 3 : Testing the resistance of wood to micro-drilling – operation of the Resistograph device (upper left), micro-drill head (upper centre), controlling unit (upper right), typical resistance graph of wet wood (lower curve) and 24% of moist wood (upper curve).

During drilling, the penetration path and also the energy necessary for cutting the hole are recorded and displayed graphically as a function of drilling depth and resistance against drilling. From such a graph it is easy to determine places with low or even zero resistance, indicating deteriorated zones and voids or cracks. The devices are sufficiently sensitive to measure differences between densities of annual rings, which are visible on the graph as peaks.

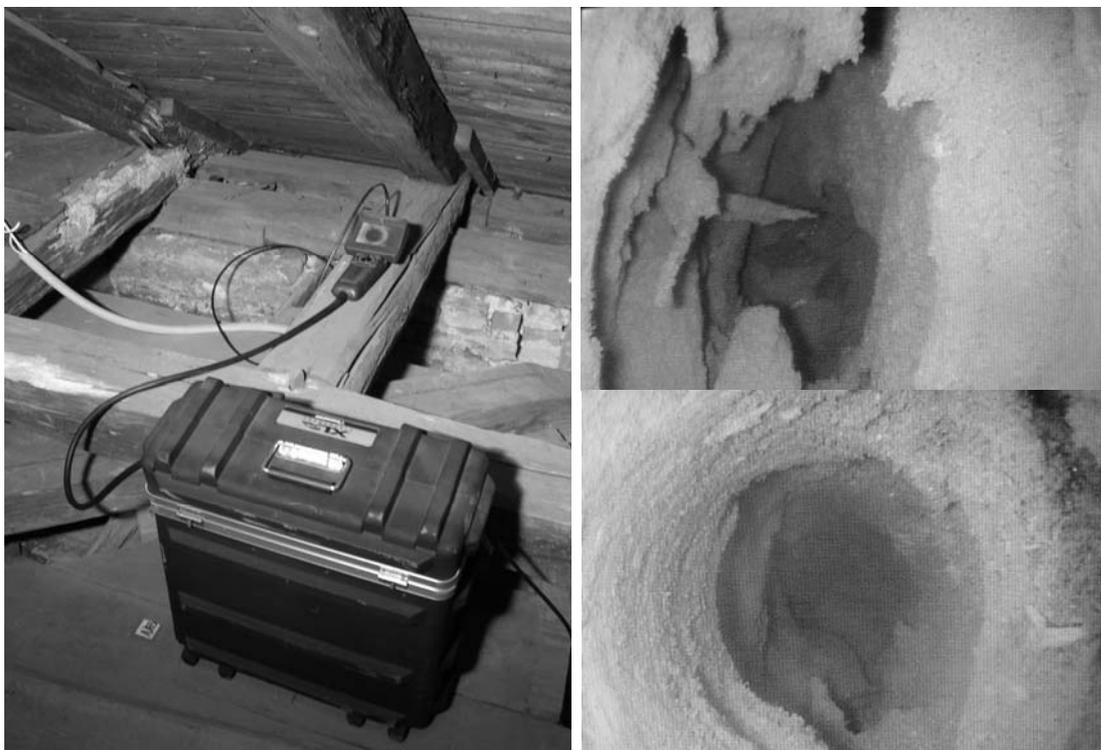
Figure 4 : Videoscapy test arrangement (left), wood decayed by fungi (upper right) and by long horn beetle (lower right)

dicular to the annual rings due to lack of space, mostly drilling the joist heads near the collar beams, Fig. 4. In the above-described cases the drilling needle frequently bends and is deviated from the straight path in an uncontrolled way, and no resistographic investigation is possible. In such situations, another method proved to be very useful and reliable for inspecting structural health: videoscapy, in all its variants.

Videoscapy provides information about the state of the structure, changes of material, and, when voids are present, even about the situation in the void. Thus infection can even be revealed in places remote from the inspection hole. Fig. 4 presents videoscapy measurements with two results identifying biologically decayed timber. In this case the hole was drilled along the surface of a timber joist adjacent to the masonry.

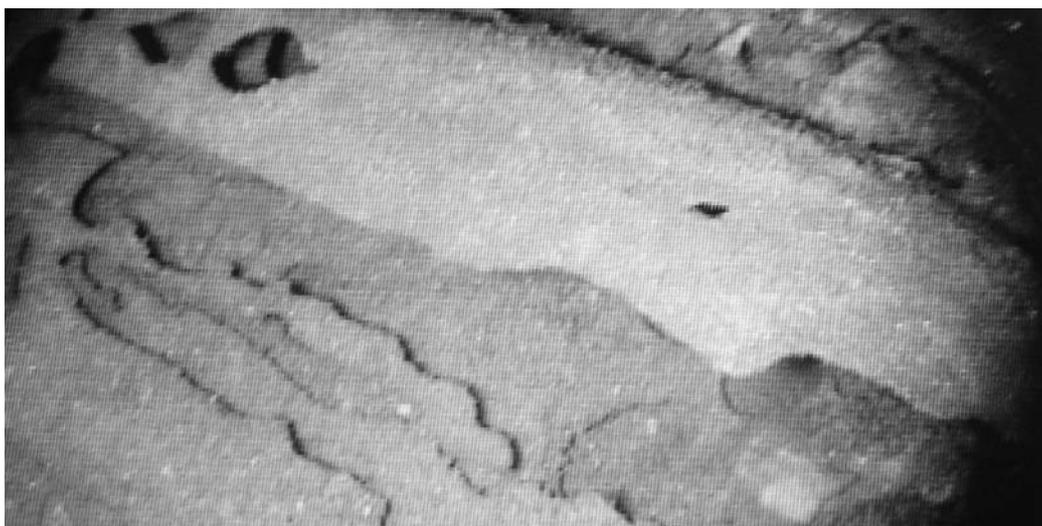
Figure 5 : Remaining parts of a collar beam inspected by videoscopy.

The advantage of distance vision is clearly demonstrated in Fig. 5, which shows the remaining parts of a collar beam under ceiling joists. The holes made for videoscopic inspection can be used for protective and consolidation works, e.g. injection.

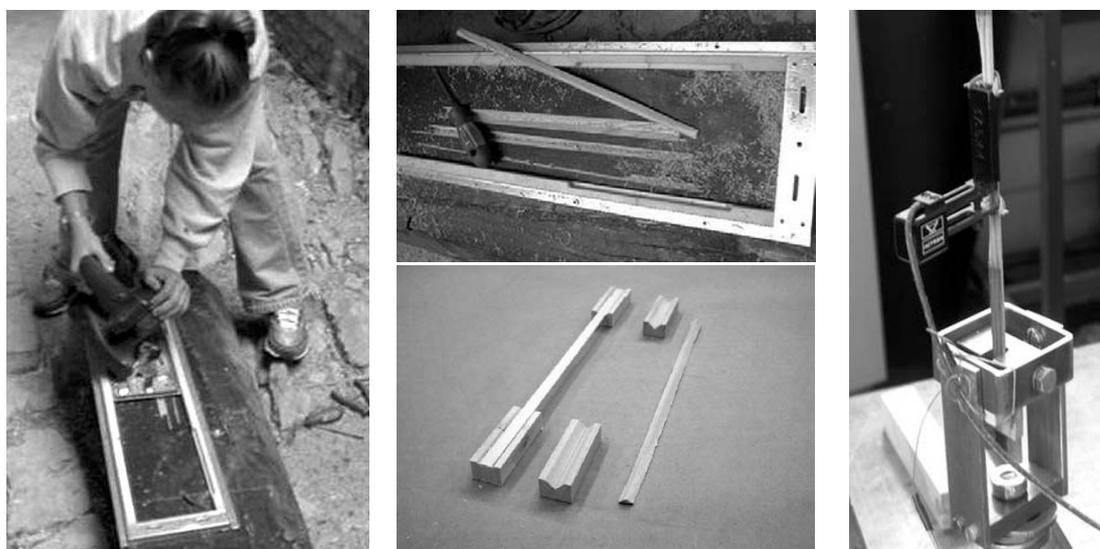
Figure 6 : Extraction of small tension coupons from a timber element using a kerf saw (left), cut triangular strands (upper centre) with head blocks (lower centre) and in hinged grips (right).

A semi-destructive method based on testing small non-standard samples taken from historic timber structures has been developed in co-operation with Bo Kasal, Kasal et al. (2003). The tension specimens are prepared from thin long strands cut out of a real structure along the wood fibres. Various methods can be used for extracting strands from the structure. They are influenced by accessibility, subsequent elaboration of testing specimens and wood species anatomy. On easily accessible structures the following technique seems to be the most efficient. A specimen of small cross section, which is significantly smaller than the area of the beam, is cut out along the wood fibre direction using a small-diameter thin kerf saw inclined 45° with respect to the surface of the beam, Fig.6 left. This means that two cuts are required to obtain a prismatic specimen with a triangular cross-section. The side width of the triangle can be adjusted from 3-8 mm depending on the depth of the cut. A typical test specimen is shown in Fig. 6, centre. Here the thin wood strand is provided with glued head blocks for easy fixing into special hinged testing machine grips, in order to minimize the bending disturbance in tension tests, Fig.6 right. The cross section of the specimens is slightly reduced in the mid-span before the test, in order to allow failure in the central part.

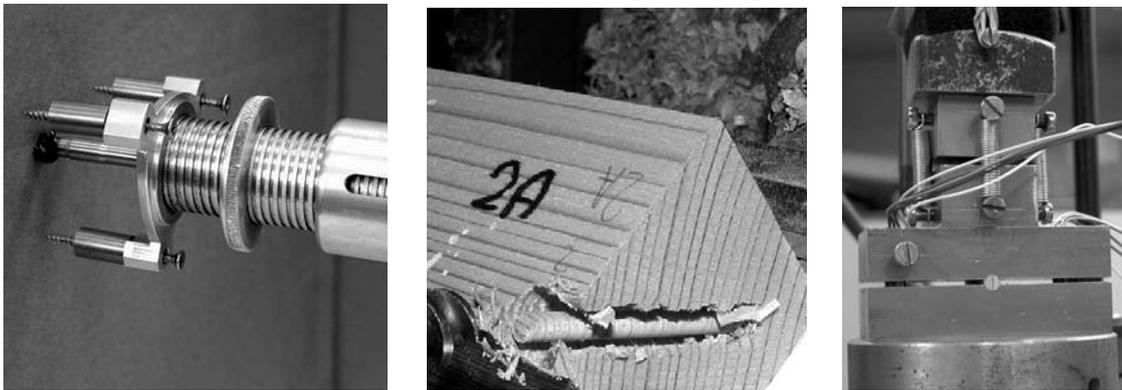
Figure 7 : Drilling machine for extracting a wooden core (left), detail of a drilled core (centre), and testing grips with an inserted oriented core (right).

of wood along the fibres are the most important, since they directly control parameters such as bending, tensile and compressive strength along the fibres. Therefore, accurate orientation of the load with respect to the fibres is critical in estimating the material strength. For this purpose, a concave compression head is used to induce parallel-to-grain force, Fig. 7 (right). The core is then loaded in the direction perpendicular to the longitudinal core axis, and this generates a relatively complex stress-state which moreover significantly changes during the course of the test. Deformation of the core is measured by means of two LVDTs. Although the slope of the load-deformation curve correlates with the modulus of elasticity of the material, and the yield point corresponds to the compressive strength of the material, we cannot calculate the modulus of elasticity from this test directly due to the non-uniform strain and stress distribution. However, the slope of the force-deformation curves maps directly into the modulus of elasticity. Maintaining the correct orientation of the fibres with respect to the applied load is difficult, and a slight error in orientation will result in reduced apparent strength and modulus of elasticity. However, any error in specimen orientation will always result in conservative estimates of material strength. The conservative estimate will result not only from an error in specimen orientation but also from an increase in the variability of the test data, which will result in a conservative estimate of the lower 5th percentile. A special drill and a battery operated drilling machine are presented in Fig. 7 (left).

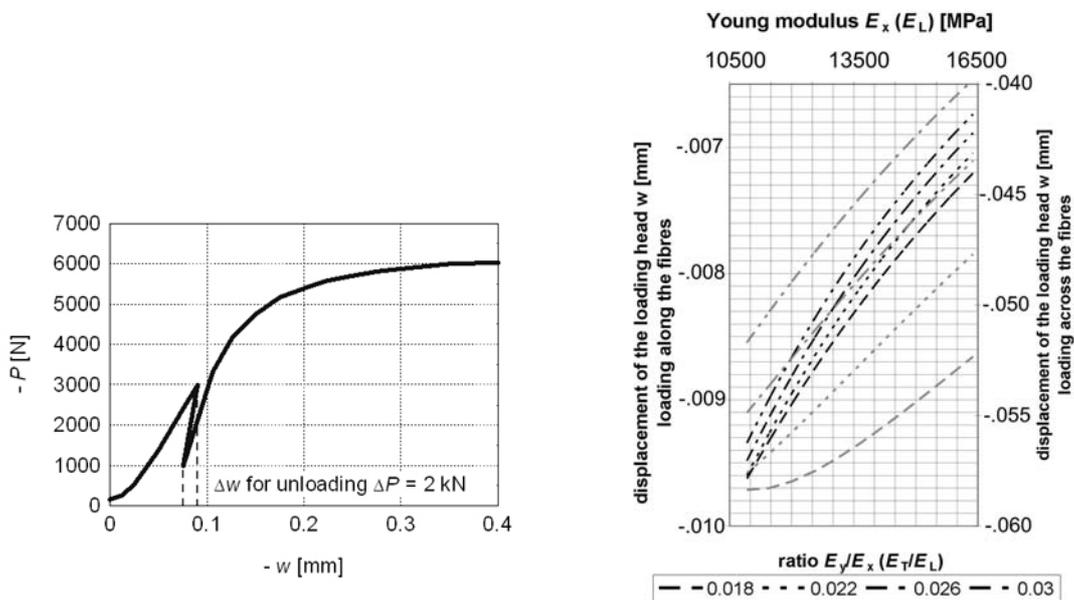
Figure 8 : Load-deformation diagram with the partial unloading for estimate of elastic deformation (left) and graph for estimate of optimum modulus of elasticity along fibres for given ratios of E_T / E_L (right).

The equations can be used to estimate probable modulus of elasticity values in the two main axes of symmetry for Czech spruce wood in dependence on knowledge of the elastic response of the sample to a change of vertical load of $\Delta P = 1\text{ kN}$ along the load direction. The optimum Young's modulus value can be read from the graph in Fig.8 (right) for a given ratio of E_T / E_L . The procedure and results have been validated experimentally. It should be mentioned that the experimentally attained elastic overall deformation cannot be measured from the overall deformation of the loading grips, and for practical application the elastic response can be achieved by unloading the specimen in the course of the test in the stage when plastic deformation on the contact between the grips and the wood has developed sufficiently and the central part is elastically and evenly loaded, Fig.8 (left). In the core drilling method, cores 5 mm in diameter and 30 mm in length are typically used.

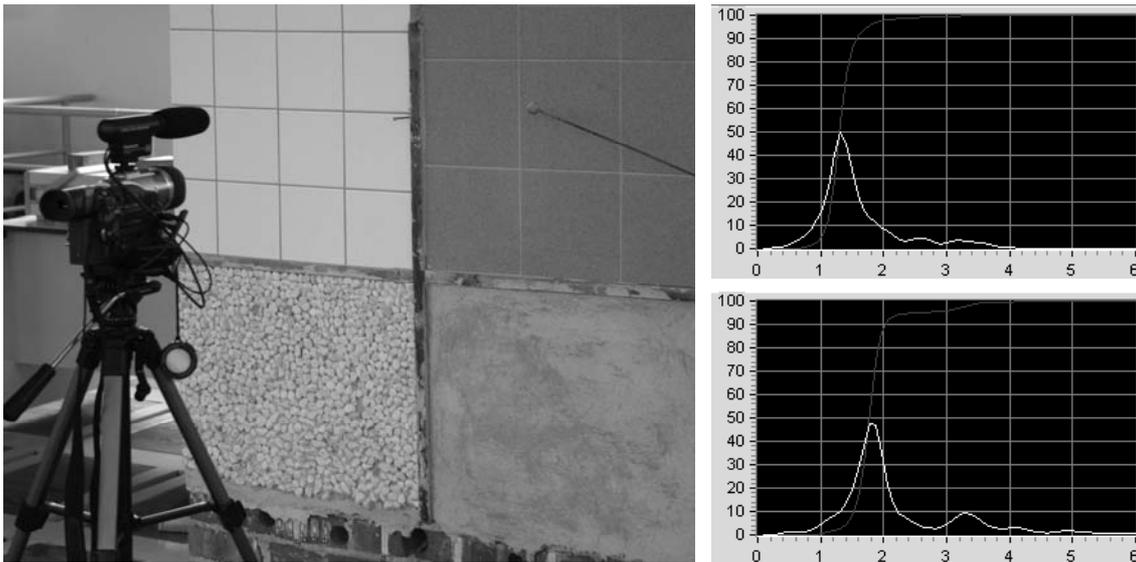
Figure 9 : Test arrangement for semi-automatic acoustic tracing with a video camera and a knocking ball (left), a typical large defect spectrum (upper right) and small defect spectrum distribution (lower right) – horizontal axis projects frequencies in kHz.

Three different methods have recently been analysed or developed at ITAM for a non-invasive survey of subsurface defects of masonry. The first semi-automated approach to acoustic tracing (AAT) was developed in the EC FP5 ONSITEFORMASONRY project. The method is a development of a classical method applied in restoration practice for investigating rendering defects, based on manual percussion and marking the places that produce a different acoustic response. The method takes advantage of various dynamic and therefore also acoustic characteristics of detached parts, in comparison with parts that are perfectly adhered. The signal can be analysed simply by an operator or by means of electronic signal analysis. The position of the changes is usually marked with chalk directly on the surface, and then can be recorded optically (by means of photography or video). There is a faster variant that takes advantage of “natural” percussion, which is generated by surface irregularities and rebounds of a hard sphere dragged along the surface. This phenomenon is accompanied by a distinct acoustic signal that enables subsurface voids to be detected. The method is also known as the “acoustic tracing method”. During application of the AAT method, the investigated surface is excited by a slight knocking of a hard rubber sphere, e.g. the ball from a computer mouse. The location of the sphere is recorded on a video camera, together with the acoustic response associated with the knocking. The recorded data is consequently evaluated by means of special software tools, and a map of the defects is created. The measured acoustic signal can be evaluated by various approaches. In any case, the frequency spectrum at individual points is determined first, then the frequency spectra that are found are marked by means of pseudo-colouring, and are used for creating maps of possible defects, Fig. 8. The position of the knocking sphere is localised by means of image analysis and recognition of a contrastive “ball-shaped” body on the evenly grey surface. The pixel coordinates of the centre of the ball are determined and then used to create a map of possible defects. The method is especially suitable for hard and polished surfaces, where the methods described below usually give inferior results, Drdáký, Lesák (2006).

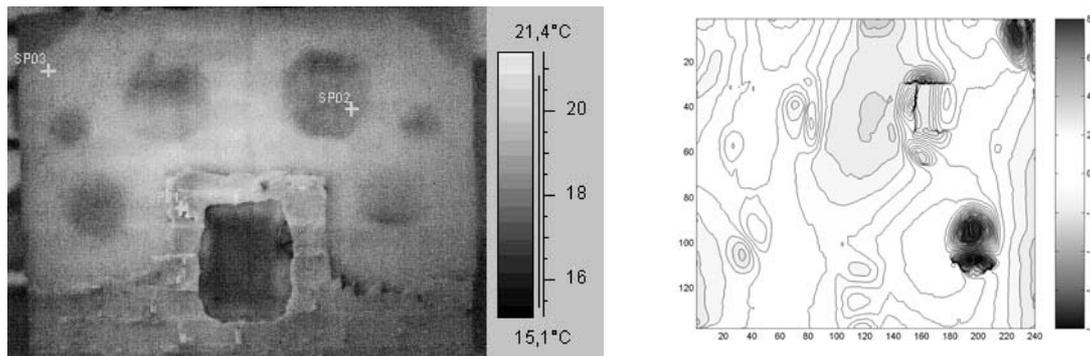
Figure 10 : Temperature distribution on the plaster surface (well visible different material layers, joints between bricks etc.) – (left), vibration modes of plaster defects on the identical test wall at the excitation frequency of 990 Hz (right).

Natural daily sun heating and the usual drop of air temperature in the evening are sufficient to develop the necessary temperature gradient for infrared visibility of subsurface defects, Fig. 10 (left). Practical measurements can be effectively done after a few minutes (about 3-5) of cooling, Drdácý, Lesák (2006). Thermography is generally the most suitable contact-less method for detecting subsurface defects, namely plaster detachments. The measurement is very simple. Of course, the necessary equipment is quite expensive but it is widely applicable for NDT analysis. Interpretation of the results requires some experience and detailed documentation of the measured surface quality, at the best by means of usual photography. The method is significantly disturbed by moisture content, and this phenomenon should be further researched because it can bring about both negative and positive effects.

The second presented method takes advantage of the fact that during dynamic excitation the attached plaster follows the velocities and frequencies of the vibrations of the wall in contrast to the detached parts, which vibrate at different frequencies and velocities that can be measured optically. The third method takes advantage of the fact that the best measurement results are provided by laser Doppler interferometry. Such a laser camera can monitor the surface from large distances – without special surface preparation of the order of metres. Scanning allows for

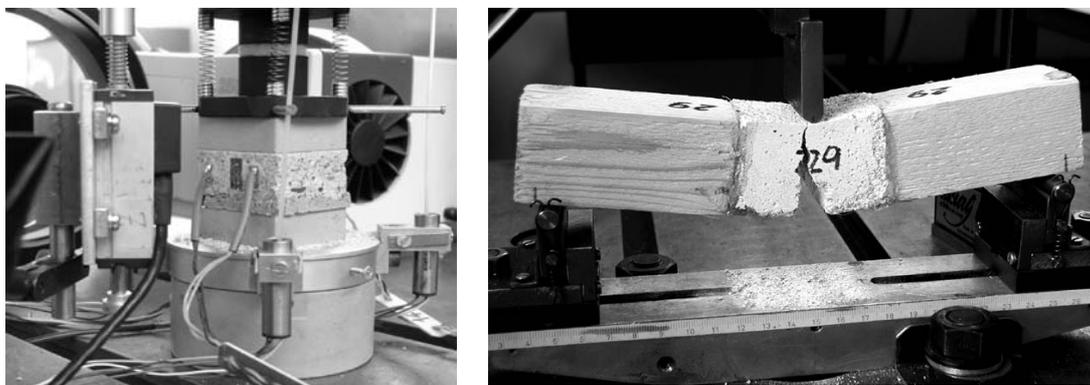
Figure 11 : Compression test with deformability measurements (left) and a three-point bending test of a lengthened mortar sample (right).

According to the results of the tests comparing the flexural strength of pure mortar beams with the strength ascertained on prosthesized identical material, the influence of prosthesization is negligible. The ratio of the strength of the prosthesized sample to that of the “standard” i.e. all-mortar specimens loaded in four-point flexure attained values from 0.98 to 1.02 (Drdácý & Michoinová 2003), if the specimen broke in its central part (undisturbed mortar). Three-point bending tests appear more favourable than four-point flexure, as they place less emphasis on the area of the glued joint. In our experiments we dealt with the problem of disturbance of cut ends by bandaging the glued joint between the mortar and the wooden prosthesis (Fig. 11).

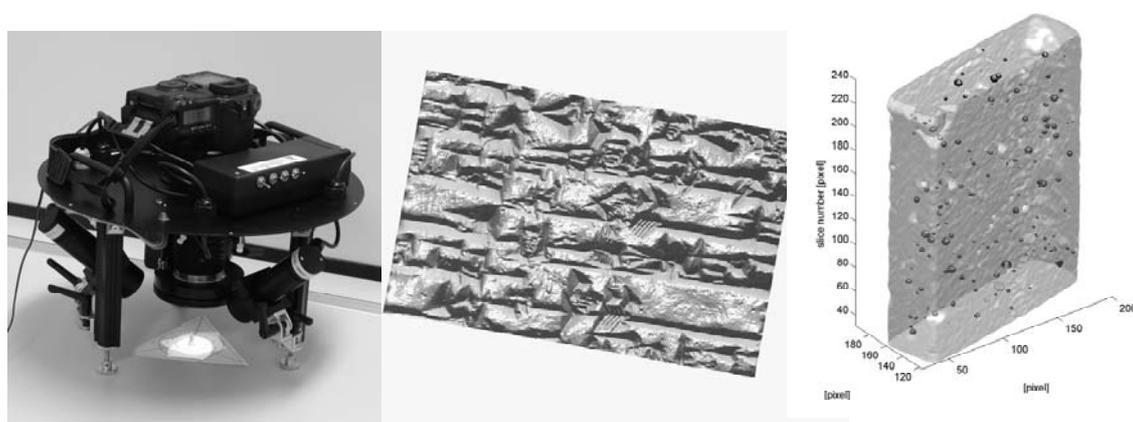
Figure 12 : Laboratory version of the Coded Photometry Stereo device (left), CPS image of a cuneiform tablet (centre) and bulk visualization of a concrete block (2×13×7 mm) – (right).

Advances in computational tools are dramatically enhancing the power of optical methods and enabling large images to be analysed and processed. Let us present two such techniques: i) Coded Photometry Stereo, which provides microtopographic maps of surfaces and ii) computer tomography or microtomography. Both methods have a very wide scope of applications, and two examples are shown in Fig. 12.
