Historical Development of Traditional Earthquake-Resistant Construction Techniques in Anatolia

ABSTRACT: This paper has been written to provide a general overview on construction techniques in Anatolia which were developed to resist earthquakes, which are common occurrences in their geographical location.

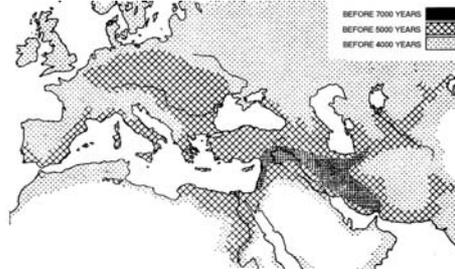
Figure 5 : Invention of agriculture in Near East, Mesopotamia and its spread area (Güvenç, 1972)

In Neolithic period, after the invention of irrigated cultivation, human beings shifted from nomadic life to settled life and established the first cities, building the first houses for protection from the force of nature. The development and spread of agriculture in Near East and Mesopotamia can be seen in Fig. 5, (Güvenç, 1972). This situation can also be considered as a clue regarding the geographical locations of the first houses.

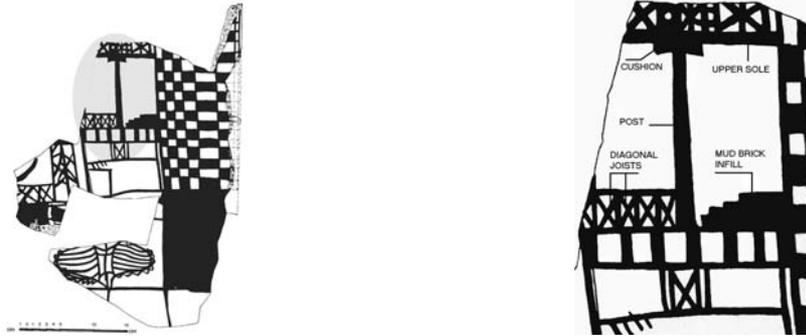
Figure 9 : 18th century B.C. Hittite bath pot with structural description (Darga, 1985)

The historical progress in the use of masonry-wood materials in construction can also be seen on descriptions on ceramic objects like vases and pots, obtained from archaeological excavations. For example, on an 18th century B.C. bath pot piece found at Acem Höyük, there is an informative description from that period about a monumental building: *wooden joists on cushions which stand on wooden posts and parapets were set on cross joists and mud brick-filled wall*. See in Fig. 9 (Darga, 1985).

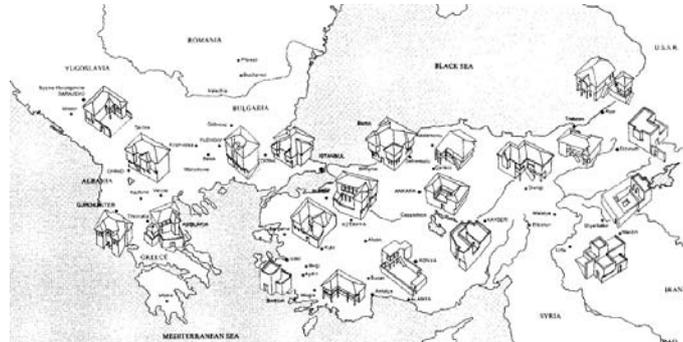
Figure 12 : Distribution of Anatolian traditional houses in the Balkans and Turkey (Eruzun, 1990)

Distribution area of vernacular buildings in Anatolia and Balkans could be seen in Fig. 12 (Eruzun, 1990).

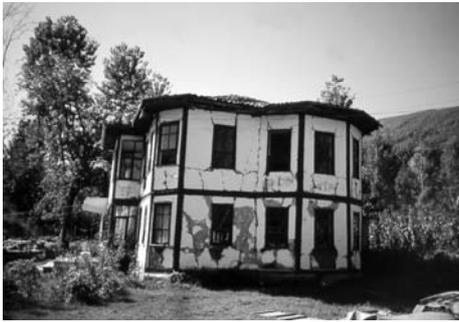
Figure 20 : An infilled timber framed house with a little damage after 1999 Düzce earthquake (Archives: Sezgin, H.)

The high performance of the remaining traditional houses of Anatolia built by using traditional building techniques could be observed during the severe earthquakes in past years. In the 1999 earthquakes in Kocaeli and Düzce, casualties and destruction in modern reinforced concrete buildings was extremely high when compared to the traditionally built houses (Gülhan, Güney, 2000). Despite being extremely old, traditional buildings survived the devastating effects of the earthquake. The minimal amount of damage to the infilled timber framed buildings close to the fault line, in the Düzce earthquake, can be seen clearly in Fig. 20, (Sezgin, 1999). On the other hand, in Fig. 21 the level of damage to a collapsed reinforced concrete building during the same earthquake is shown (Askun, 1999). The fact that these houses which were initially built to protect people against the forces of nature have become graves, is scientifically mind boggling.

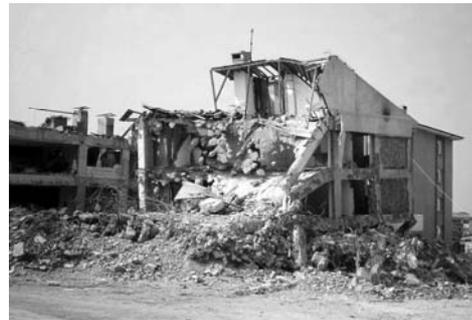
Figure 21 : A damaged reinforced concrete building after 1999 Düzce earthquake (Archives: Aşkun, İ. Y.)
