Comparative Analysis of an Antic Stone with Restored Stone of Restoration Project

ABSTRACT: Comparative analysis of properties of stone is essentially a first step towards the scientific understanding of a conservation project and is unavoidable, if any restoration work is to be carried out. A state listed monument of the mediaeval temple architecture in Nagari style was selected for evolving an appropriate methodology. It is situated in Mandi, Himachal Pradesh, a northern Himalayan state of India. This temple was completely destroyed in major earthquake of 1905 and the restoration work was carried out using locally available stone of similar quality from the same live quarry as per the practice of the time. Thus Trilokinath temple provides the opportunity to study the medieval stone against the stone from the restored work and fresh sample from the quarry. The thin sections were used to understand the character and mineralogical composition of the stone along with structural properties of the stones.

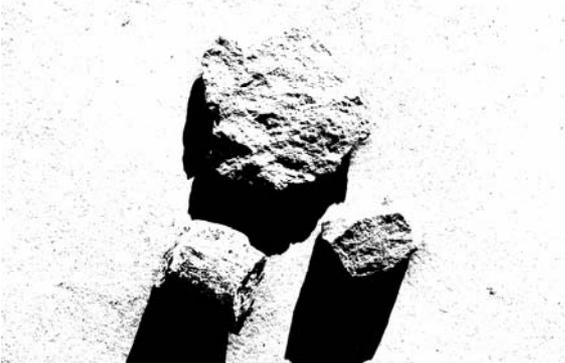
| Serial number | Descriptions | Image |
|---|---|--|
| 1 | Three samples collected from the site consisting of different stones. | |

The samples were collected from the site consisting of the stone samples of the original stone used in 1520 and restored stone used during the restoration work. A fresh stone was also collected from the quarry in the vicinity claimed to be the supplier of the original stone. The samples are named as R1, R2 and R3 for the original stone, restored stone and the fresh stone respectively. As seen in the table 1 the three samples show a marked variation in textural.

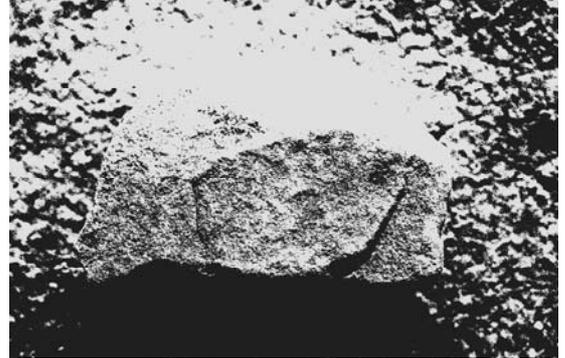
| Serial number | Descriptions | Image |
|---|---|--|
| 3 | R2 is the "restored stone" from the temple | |

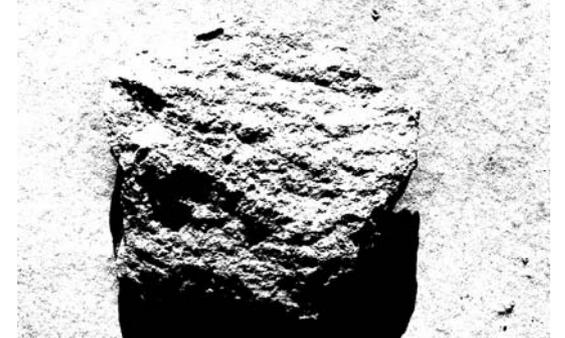
| Serial number | Descriptions | Image |
|---|---|--|
| 4 | R3 is the fresh stone from the quarry | |
