Structural Arguments in the Analysis and Conservation of Some Romanesque Churches in Romania

L. Roşiu

University "Politehnica" of Timișoara, Faculty of Architecture, Department of Architecture, Timișoara, Romania

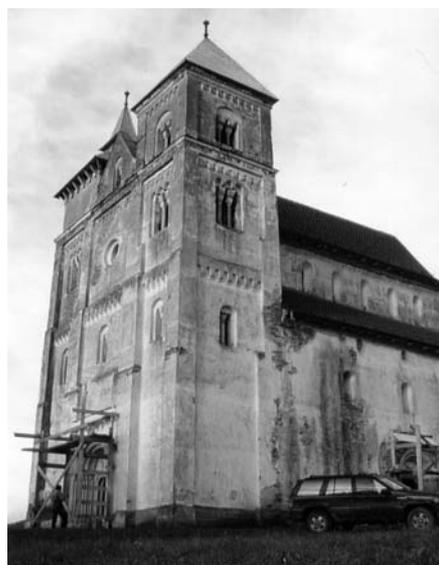
Figure 1 : The basilica of Herina

Although the Romanesque in Transylvania is less spectacular because of the lack of great basilicas, destroyed or transformed in the Gothic period, this pattern offers yet two types of churches. One is the basilica with rectangular choir, apse and chapels at the end of the lateral aisles. Some examples of Cisnădioara, Turnișor, Gușterița represent the oldest group of these Saxon basilicas. The other came in the 13th century from the Hungarian Benedictine church and consists in a basilica with a single apse, like those of Herina or Acîș. (Fig. 1) Part of the basilicas disappeared and offer information as archaeological sites. A small number keeps the wooden structure of the ceiling, most of them receiving cross-vaults in the Gothic period.

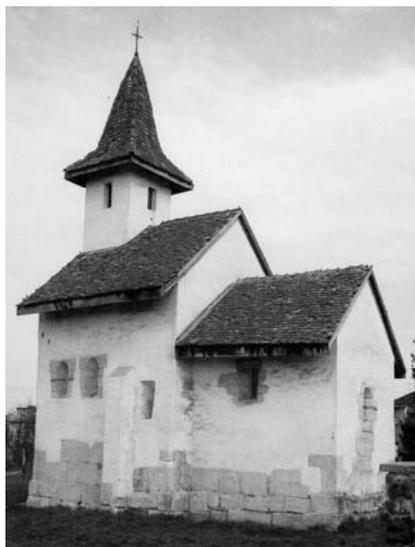
Figure 2 : The church of Streisângiorgiu

Let us take the case of the oldest church from the Haţeg area, the court chapel of Streisângiorgiu. (Fig. 2) It is archaeological dated from the first half of the 12th century, when it replaced a wooden church on the same place (Popa, 1988). The simplicity of the plan makes possible the analysis of a basic structure of a Romanesque church. It has a nave of 4.60 x 4.70 m and a rectangular choir of 3.20 x 2.80 m. In the 16th century a wooden pronaos was added to the west façade, which turned into a masonry structure in the 19th century (Popa, 1988). The walls, thick of almost 1 m, are made of stone, of ashlars spoiled from Roman ruins and bricks. The nave has a barrel-vault and the choir a domical-vault. The tower, crossing the vault, leans on the west wall and on two pillars dating from the same period as the walls. (Fig. 3)

The main unsolved problems of the church are the date of the tower and the role of the two pilasters of the nave. The first form of the church has been considered uncertain, several painted inscriptions indicating phases of rebuilt. The presence of the two pillars has been attributed to an initial tribune for the founder, but their dimension seems to confirm an initial intent to build a tower. The conclusion comes by comparing the pillars of the west side of the nave, with a dimension of about 70 x 70 cm with the structural necessity of a supposed tribune and with other similar constructions, like, for instance, the ruin of the court chapel of Ilidia or the church of Sântămărie Orlea, the first with very strong pillars in the west side of the nave, and the latter with smaller sections and with a certain destination of the pillars for the tribune. Considering also the role of the tower as a place to observe the zone, we can argue the possibility of its existence from the first period of the church, and not from a later date, 1408, when the church became a monastery and the tower was testified by the votive painting.

At Streisângiorgiu, for example, the wooden pronaos built in the 16th century and rebuilt in the 19th, has been demolished without marking its perimeter, according the restoration principles. The solution tried to emphasize the medieval structure, hidden and minimized by the former addition. The same case has been solved completely differently at Gurasada, where the last phase, the tower built in the 18th century, has been maintained. This decision preserved the final picturesque image of the monument, but also accepted the duality of the two dominant towers. On the other side, the only good angle to perceive the old structure is from the altar side and the site does not offer a wide perspective to include the whole monument.

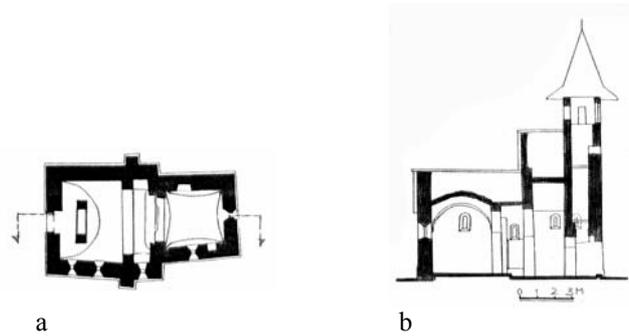
Figure 3 : The church of Streisângiorgiu a plan, b. section

Also the two pilasters of the nave, with a correspondence in two counterforts outside, have lead some authors to the supposition of an initial dwelling tower above the nave, although there was no trace to be found. Yet they drew their conclusion in accordance with some other similar examples in the zone, of a century later. (Popa, 1988) Other opinions appreciate the pilasters sustaining an arch and fragmenting the vault into distinct areas, as elements of a simplified Romanesque pattern (Moisescu, 2001). The two different levels of the nave barrel-vault have been also attributed to an intention of pointing out a choir between the nave and the rectangular altar apse (Ionescu, 1982). The reason of the two counterforts is given of the practice of the counterfort itself in the Romanesque architecture, where it is used in correspondence with a strengthening arch and with the pilaster at the interior. This system could be brought here from a Benedictine pattern in order to detach the choir. So, the necessity of a separation of the nave in two bays using an arch may be simply the reason of the two counterforts.

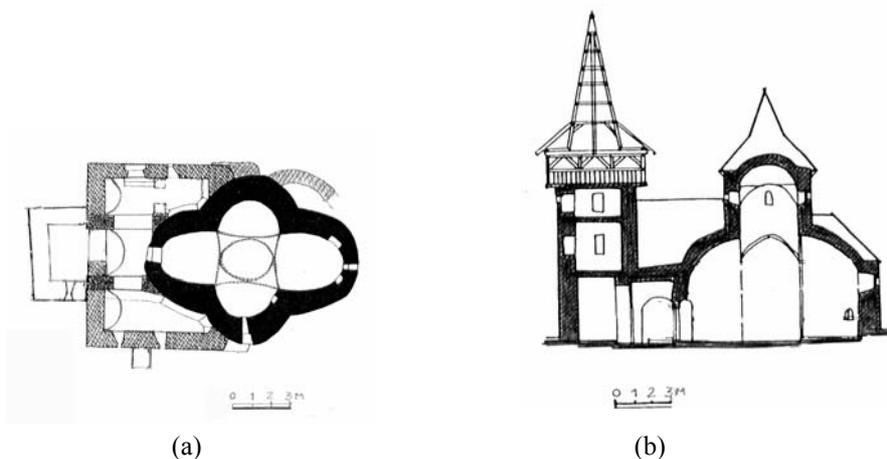
Figure 4 : The church of Gurasada, (a) plan, (b) section

The structure of the four lobed church of Gurasada, corresponding to the first period of the monument, is composed by two lateral apses framing other two extended apses oriented east-west, with a tower above their crossing. All the space is vaulted, in the side apses with a half-dome and with elliptical calottes for the longitudinal apses. The tower is also covered by an elliptical calotte. The church is made of quarry with hydraulic mortar, rich in brick powder. Researchers appreciate that this structure dates from the second half of the 13th century, but they are supposed to be from an earlier time. (Popa, 1988). A three nave pronaos was probably later added to the west side of the church, with barrel vaulted interiors. The traces of four pillars for tower correspond to the central bay of the pronaos and could indicate an earlier space on the west façade (Moiescu, 2001). The last addition, the tower before the pronaos, documentary testified, was built in 1765. These phases have been put in relation with an initial court chapel or with a small monastery, which would justify the large pronaos. (Fig. 4)

The structure proves a good knowledge of materials, the hydraulic mortar being used at a high level. In spite of a clumsy vault technique of the tower, its footing was done on the four vaults without any arch. This unusual mode of removal the loads detaches this church from any supposed south Byzantine influence that would suppose a crossing of barrel-vaults or arches and pendentives. The disposal of the stone is typical for a cupola, not for a barrel-vault and betrays the structural thinking of the builder, who followed another model, not the Byzantine one. Some authors assume the church is older than the 13th century, referring at a possible role of court chapel (Popa, 1988). Existing in the Roman heritage, that begins in the early Christian cemetery chapel, the prototype could be used here also for such a destination, its dedication to Saint Michael being specific for this use (Vătăşianu, 1967). The church could be also the result of a west Romanesque influence from the Hungarian or German pattern of the 12th and 13th centuries.

Another structural element to be taken in account is the springing of a vault upon the pronaos arches, which confirms by a structural element an initial phase, when the church seems to have had an addition on the west façade. While some researchers explain the simultaneity of the three nave pronaos with the four lobed church by presumptive functions, the structural argument shows that beyond any doubt.

The decision to emphasize some elements or others is easier to be taken with the help of the structural argument, which can offer specific reasons to stress characteristic parts. Thus may be explained the apparent vault at the church of Gurasada. Such a fashion has dominated the restoration of the second half of the 20th century, with a strong tendency to express the structure. However it does not correspond to the initial image of the interior space or of the façades, this kind of treatment gives more information about the building trade in the 13th century, about the structural qualities of the monument and facilitates the approach to its history. The same signification has the fragment of vault on the south side of the church of Densuş, reconstituted as a testifier of the structural qualities of the vault. So, the restoration of the church of Densuş has proposed a lecture of its structure from the finite image of the old nucleus, to a section through the intermediary phase and finally to the decayed structure of the last phase.

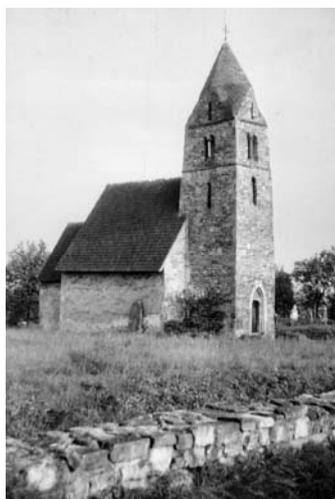
Figure 5 : The church of Strei

The church of Strei, another type of Romanesque church was built after the pattern of Sântămărie Orlea about in the year 1300. (Fig. 5) First, it was also a court chapel. The tower is here added to the west façade and has the base covered in a barrel-vault. It ends at the top in a calotte realized by circular rows of stone resulting in a conical vault as interior of the stone roof. The nave is 4.80 x 6.50 m and has had a wooden board transformed now in a wooden barrel-vault. The rectangular choir maintains its cross-vault on ogival system. In the 19th century, the west façade was continued with a small pronaos including the base of the tower. Other transformations were a second nave built on the north side, later demolished in the 19th century and a covered entrance on the south façade. The model came from Sântămărie Orlea, a parish church for the Catholic community serving the local fortress. The pattern with a nave of 8.50 x 14.20 m covered by a wooden floor has an ogival vault in the choir. In both cases the towers, main pieces of the church, received a tribune at the base. That of Sântămărie Orlea lies on two octogonal pillars considered by some authors as dating from the beginning of the church, and by others from the 15th century. (Popa, 1988) In both cases the structural element has an important role in the appreciation of the initial phase of construction, especially the vault structure and the tower configuration.

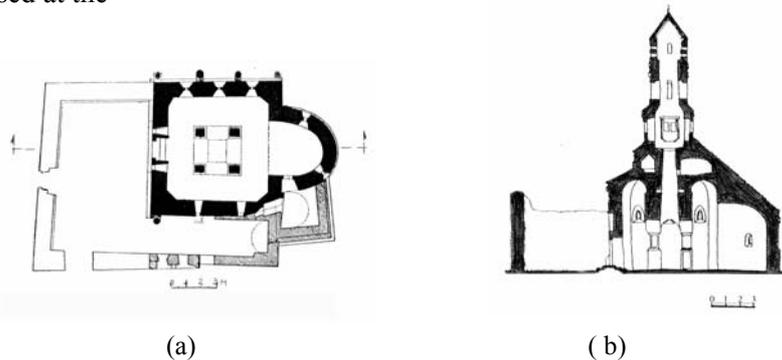
Figure 6 : The church of Densuș, (a) plan, (b) section

The most interesting structural problems appear at the church of Densuş. The Saint Nicholas church has an almost squared nave of 6.40 x 6.25 m and a semicircular apse of 3 m depth. The tower raises in the middle of the nave resting on four pillars made each of them of two Roman altars and bent together with arches. Other spaces have completed this nucleus. (Fig. 6) A sacristy and a lateral room on the south side have been considered by some researchers as later additions and by others, from the same period with the church (Moisescu, 2001). Only the large pronaos was surely built in the 15th century. The main problem of this monument, which is considered one of the most original and valuable cases in the early Romanian medieval architecture especially because of its structure, does not lie only in the building date of the church.

It has an atypical solution for a church of the 13th century. The four pillars of the tower, placed in a square of about 3.00 x 3.00 m, are an independent structure, being not bent to the exterior walls, however there is a small barrel-vault conceived as the cover of an ambulatory around. The tower has a hiding place above the nave and another room accessible from outside at the upper level, under the conical stone roof. The altar has a barrel-vault ended in a calotte, the sacristy a barrel-vault in superposed rows and the lateral room, almost demolished, shows traces of a barrel-vault in radial arrangement of the stone. The structure of the walls has been made of quarry, and of ashlar, altars with inscriptions, parts of columns, all brought from Roman monuments. This building occasioned a lot of theories about its origins, the period of construction and the architectural influences. Some of the ideas have been removed, like the reuse

base of the walls (Rusu, 1997). But it proves the direct relation with the Roman heritage, abundant in the early Middle Ages in the area. The presence of four columns from antique monuments on each lateral side of the nave shows a Roman source of inspiration. These columns have been arranged like the counterforts but seem to be only decorative elements, having no relation with the level of the vaults and their springing. This is proof that the builders followed a model from the roman architecture, without understanding its structural laws very well.

Trying to explain this unique monument, some researchers have suggested a relation between the Byzantine plan of the inscribed Greek cross, pointing out, however, the lack of correspondence between the axis of the pillars and the opening of the apse. If the plan might have an appearance of a Byzantine type, the structure has nothing in common with a Byzantine conception. Anyway the builders seem never to have seen a Byzantine church (Vătășianu, 2001). Then, which was the model? Some details show Romanesque influences at the roof of the tower, at the windows or in the brick decoration in zigzag. (Fig. 7) But the most important argument comes from the mode of the removal of the tower loads. Crossing of barrel-vaults or pendentives are missing and the loads are directly removed to the four pillars. There is a similarity with a structural model of a Roman construction with the same components and structural behaviour: the mausoleum or the Roman tomb. It consists of a central nucleus, a recess where the urn with ashes was deposited, framed by four pillars sustaining on the top a statue or a funeral symbol of the deceased. The proximity of Ulpia Traiana, the capital of the territory during the Roman power (106 – 274), would offer a lot of models at the beginning of the development of the medieval society. A local example of a survived roman tomb could be taken as an adaptable pattern for a small court or cemetery chapel. Therefore, the pattern may become an useful instrument of study.

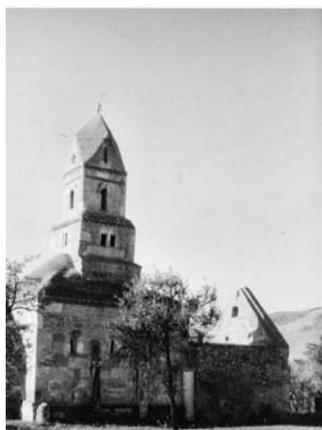
Figure 8 : Church of Densuş, north side

A middle solution has been preferred at Densuş, where the central nucleus with the altar and the sacristy have been restored by completions and repairs and the lateral room and the last added pronaos from the 15th century have been conserved as ruins. (Fig.8) The reason was to detach the old structure. This possibility of choice could have some explanations. Keeping the ruins as a part of the monument marks its history, but also permits the best perspective of the monument. At the same time, unimportant additions that may disappear are not marked in order to prevent confusion with a valuable decayed element. Such is the case of the church of Strei, where the pronaos of the 15th century, ruined in the 17th century, has been restored as a ruin, but the chapel of the north side and the covered entrance of the south façade, late additions, have not been marked any more.
