## The Challenges of Structural Stabilization Following the Hurricane Katrina Disaster

**ABSTRACT:** Katrina was the third strongest hurricane on record to make landfall in the USA. It struck near New Orleans on 29 August 2005. Its surge was as high as 9.5 meters, devastated the Gulf Coast, and breached New Orleans' levees. The region is one of America's great outdoor museums with imported and local typologies that adapted to the region's climate and geographical conditions. In this paper, the damage experienced due to Katrina is described. The damage in Mississippi is compared to that in New Orleans. Heritage recovery efforts along the Gulf Coast are discussed, and "lessons learned" are provided to prepare for future disasters.

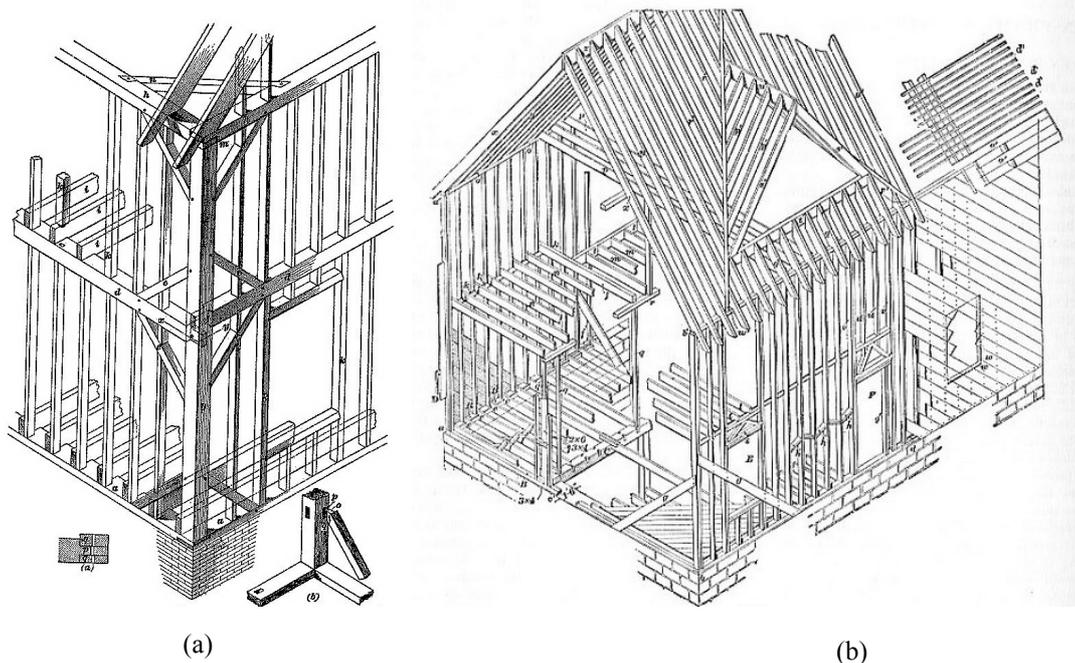
Figure 1a : Diagrammatic sketch of the *braced-framing* technique (left). Figure 1b : Diagrammatic view of a *balloon framing* technique (right).

*Braced-framing*, a German and British import, was a common form of building construction during the antebellum era, see Fig. 1a. This construction was characterized by heavy timber posts at the corners of the building, which extend continuously from a heavy foundation sill to a heavy girt at the floor or roof line. Diagonal braces were used at the corners of the frame to lend lateral support to the structure. Studs were installed between the corner posts. These were mortised into the sills and girt at regular intervals. The main framing members were connected by mortise and tenon, and fastened with wood pegs and tree nails.

*Balloon framing* was developed during the 1830s and was a distinctly American construction technique that fulfilled the requirements of a young and rapidly expanding country, see Fig. 1b. It offered several advantages for wood-frame construction and was characterized by an economical use of wood, rapid construction, and limited skill required by workers. Relatively unskilled workmen were able to erect balloon framed buildings quickly because the labor-intensive mortise and tenon connection was supplanted by the use of cut nails. The stability relies on the external sheathing rather than triangular bracing.

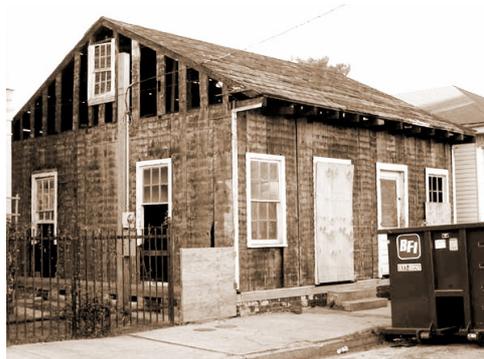
Figure 2 : Contemporary view of a *mardiers debout* framing technique on a building where clapboard siding is removed to reveal standing plank construction

Another form of construction, *Madriers debout* (standing planks), developed about this time and was utilized into the 20th Century, see Fig. 1c. Specific to New Orleans and vicinity, these structures are composed of large planks oriented vertically and set directly onto a wooden sill. The exterior siding and interior finishes, typically wood bead board, were applied directly to the boards. The planks are said to be from flatboats that floated down the Mississippi River and were then disassembled, thus rendering the name of “barge board building.”

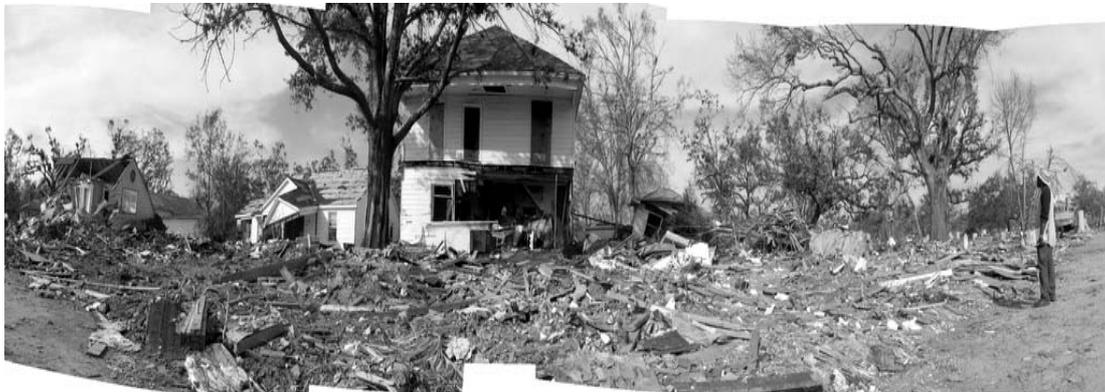
Figure 2 : A typical scene of destruction, west Gulfport, Mississippi, showing the debris field and first-floor damage to one of the few standing structures. A structural engineer (right) surveys the damage.

- Within the surge area, first and second level bearing walls of the structures that remained standing, including wood frame and masonry, were knocked out, see Fig. 2.

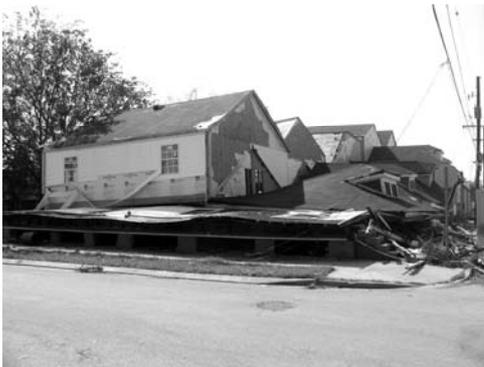
Figure 3a : This row of houses in New Orleans, were originally one story wood frame buildings. Termite damage caused one to buckle (left) at the lower level, causing all four to collapse in succession

- A handful of collapses entailed two-story wood frame structures. In all observed cases the lower level gave way under the weight of the upper story; the upper structure was an addition; and the lower level had been weakened by termite decay, see Fig. 3a.

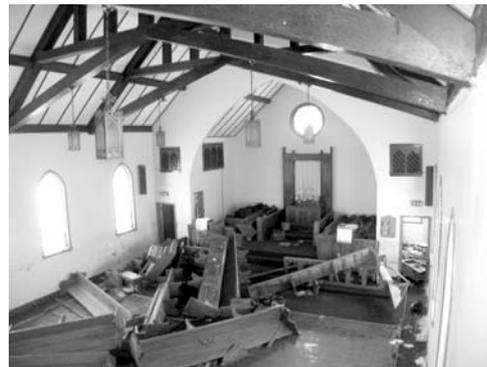
Figure 3b : In this historic church in New Orleans the water was 2 meters deep and was not drained away for a week. Three months after the storm, no clean-up had begun, leading to growth of mold and fungi.

Following the Hurricane, time was of the essence for heritage recovery efforts. Decay of building materials in the hot and humid climate would occur rapidly, especially considering wet debris and sediment accumulation on the floors, see Fig. 3b. The rapid response, however, had to be tempered with the understanding that recovery had to first focus on the human condition - the search for survivors and the feeding and housing of the homeless.
