## Conservation and Restoration of Brazilian Colonial Architecture

**ABSTRACT:** In this paper we examine the principal conservation problems and challenges in the restoration of buildings of the Brazilian colonial period. This era cover the years from 1500, the year of the Brazil's discovery, until 1822, the proclamation of independence from Portugal. Even prior to independence, a French cultural mission arrived in 1816 with the aim of spreading the neoclassical style throughout Brazil, contributing to the abandonment of traditional colonial building techniques. The Portuguese settlers encountered construction techniques and materials used by the native Indians, such as wood, clay, and palm leaves, that were later to be incorporated into their own constructions. From this emerged the traditional Brazilian building system, based on lath-and-plaster, adobe bricks, rammed earth, and rows of brick and stone work bound with lime plaster whitewash.

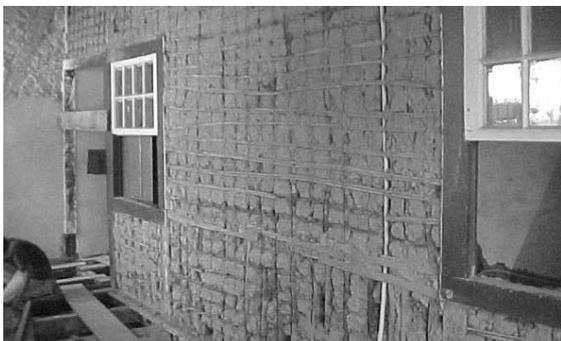
Figure 1 : Lath-and-plaster wall, Casa da Baronesa, Ouro Preto - State of Minas Gerais (Source: IPHAN’s collection).

The vast territory of Brazil with its diverse climate and topography imposed the adoption of techniques that varied from region to region. For instance, rammed earth was used in the state of São Paulo, stone and brick masonry in the north and northeast regions, and lath-and-plaster in the state of Minas Gerais. There predominated the use of stone masonry in the foundations, wood for autonomous structures, and lath-and-plaster or adobe for walls. This building system, also known as hand lath-and-plaster ("taipa de mão" or "taipa de sopapo"), employs interwoven wooden sticks or rods, bound with rope or leather strips, and that are filled in with clay. This technique was widely applied to construction in Minas Gerais, due to its appropriateness to the declivities characteristic of the region. Monuments and stately buildings were usually built in stone set with lime. Internally the use of wood in floors, ceilings and frames predominated. Roofs were also made of wooden structures covered with clay tiles. Both interior and exterior walls were finished with lime plaster whitewash. Wood was widely used during 18th and 19th centuries, even in the structures of buildings. In Minas Gerais, these structures are formed with vertical pieces (supports) and horizontal elements (master beams), bound by dividing walls and

diagonal pieces (“Saint Andrew’s Cross” or “French quotation marks”). In these cases, walls are made of lath-and-plaster or adobe bricks. Stone or brick masonry set with lime is found in most of the ground floors in houses, forts, religious or stately buildings. These methods also predominate in residential construction in the north and northeast regions of Brazil.

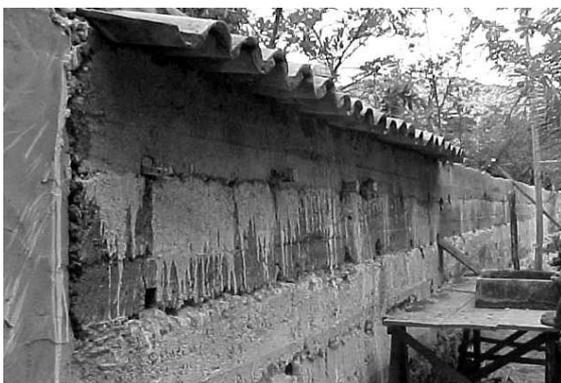
Figure 3 : Rammed earth wall under rebuilt, Casa Cora Coralina, city of Goiás - State of Goiás.

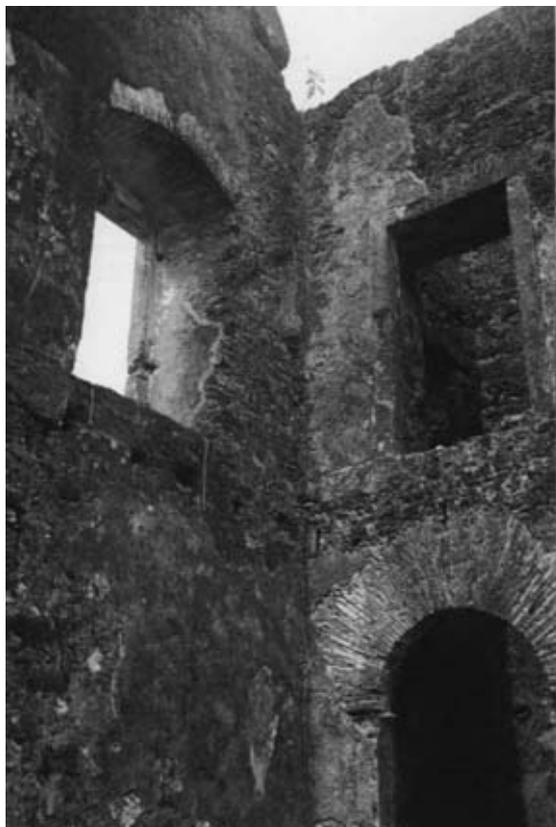
Figure 2 : Stone masonry, Church of São Matias, Alcântara - State of Maranhão (Source: IPHAN’s collection).

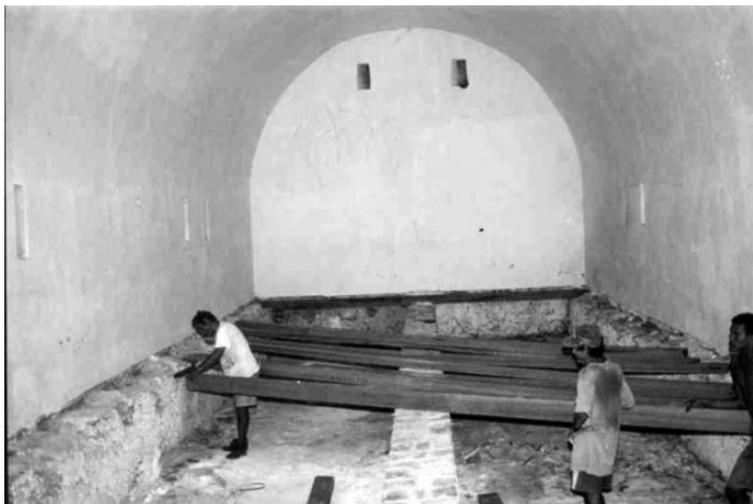
Figure 4 : Air chamber under the floor, Magazine, Fort São José de Macapá - State of Amapá (Source: IPHAN's collection).

Those problems which are hard to solve are related to permanent sources of humidity such as those resulting from the direct contact of old building materials with humid soil. The solution adopted for wooden floors involves the revival of the use of air chambers consisting of a ventilation space between the wooden floor and the soil. This solution, widespread in traditional Brazilian architecture, is usually ignored in inappropriate restorations and interventions that set wooden floors directly onto the pavement, leading to wood-rot and infestation of xylophagous insects in the structure. In the case of structures in direct contact with humid surfaces underground or supporting structures in hilly places, the solution has been to provide natural ventilation, and, on occasion, even separate the floor from the walls in order to reduce effects of humidity.

In the case of humidity in the vaults of São José de Macapá Fort, in the state of Amapá, the slope of the upper earth embankments was altered so as to prevent rainwater accumulation at certain points, and a new covering made of lime whitewash was applied. Due to excessive humidity, the original coating had deteriorated significantly, leaving the brick masonry exposed and subject to the continual actions of humidity from the soil.

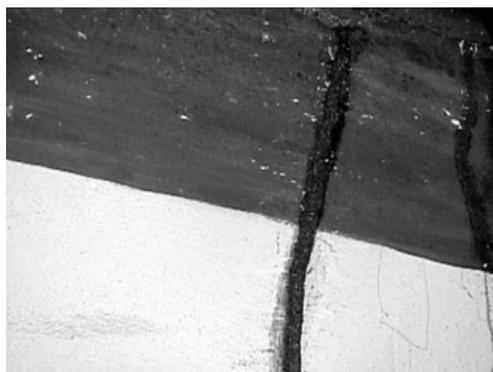
Figure 5 : Xylophagous insects in the Church of São Francisco de Paula, Ouro Preto - State of Minas Gerais (*Source: IPHAN's collection*).

Dry-wood termites restrict their nests to the interior of the wooden pieces they have infested, and their presence can be confirmed through the existence of dry flakes of wood nearby. The “underground” or soil termites make their nests in soil or in any permanent source of humidity. Their infestation can be identified through the existence of underground galleries or earth-covered tunnels on the walls. Exterminating this type of termite is quite difficult, as it does not restrict itself to the infested piece, but continually moves its shelter. Borer is the common denomination for xylophagous beetles, whose infestation can be identified through the existence of a fine yellow powder and small holes in the piece of wood. Fungi change the color of the wood; their infestation is characterized by the appearance of mold or mushrooms and the softening of the piece.

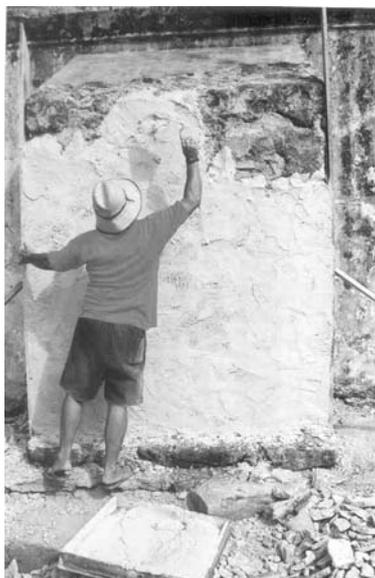
Figure 6 : Lime mortar coating, Fort São José de Macapá - State of Amapá (*Source: IPHAN's collection*).

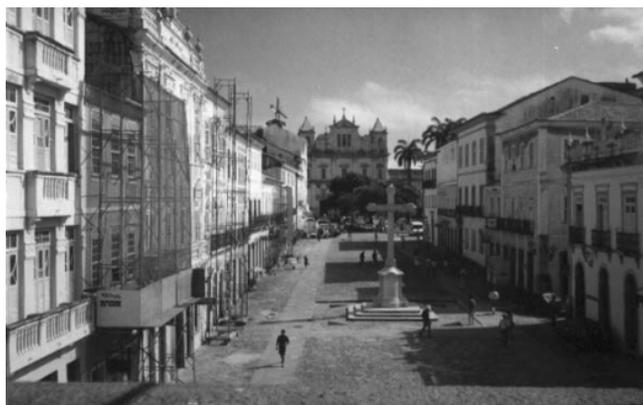
Figure 7 : Square in front of the Church of São Francisco de Assis, Salvador – State of Bahia (Source: IPHAN's collection).

The use of squares as parking areas decharacterizes historic places, prioritizing vehicles instead of pedestrians. The solutions usually adopted in Brazilian historic cities, aiming at returning public spaces to pedestrians are as follows:

- Prohibiting the traffic of vehicles in some streets and the creation of parking areas near the historic centers, as in São Luiz (state of Maranhão) and Salvador (state of Bahia);
- Placing curbs in the center of squares, preventing vehicles from parking; a solution to be adopted through the Program Monumenta-BID- in Ouro Preto (state of Minas Gerais).

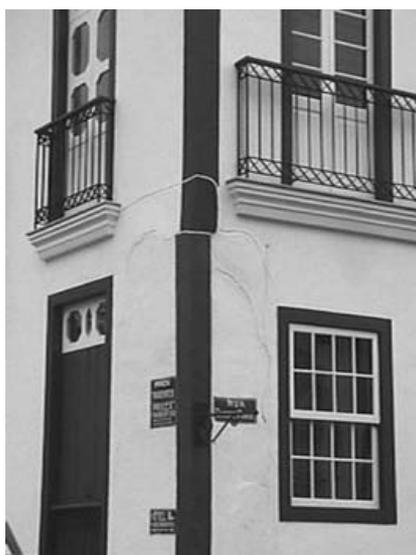
Figure 8 : Reintegration of coating cavities, Centro Cultural da FIEMG, Ouro Preto - state of Minas Gerais (Source: IPHAN's collection).

This approach is frequently not an option when recoating mortar. Therefore a sand-granule type is used for the differentiated new coating, taking care to ensure that this is not noticeable on the surface. In enclosed spaces we usually encounter significant loss of materials due to humidity and xylophagous insects. The filling of cracks and gaps is difficult, as the addition of new materials must take into account their physical properties together with the final appearance of the assemblage.

The restorations in the texture of lath-and-plaster walls use those pieces that are well-preserved, concentrating them in same section of the wall in order to achieve an interpretation of the preserved assemblage. In these cases, the original clay is reused, being mixed with water and reapplying it into the weave. When filling in cage-like structures, it is almost impossible to achieve this distinction, since the mixture must be homogeneous to prevent new clay from shrinking with time.
