## Historic Timber Bridges in New Zealand –Restoration Works and Lessons for the Future

**ABSTRACT:** The paper studies two historic bridges, the Tauranga Track and Manganuku Stream. The Tauranga Track Bridge is a rare ‘harp’ suspension structure and has an elegant appearance. The Manganuku Stream Bridge is a Howe truss structure and its important lessons, for the designers of future timber industrial timber structures, are discussed. The paper reports on the stresses in the historic bridge members and their significance for future maintenance works.

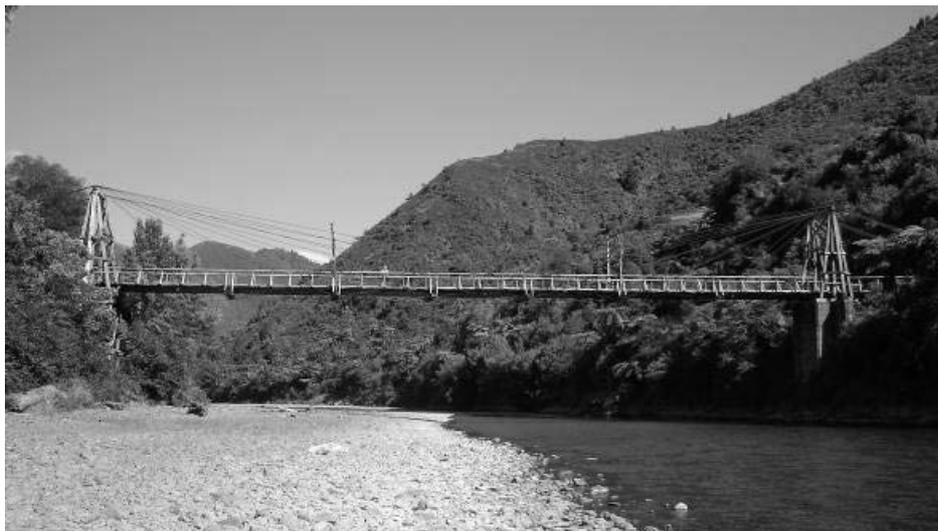
Figure 1 : Tauranga Track Bridge, harp suspension structure.

The 58m span Tauranga Track Bridge was built across the Waioeka Gorge in 1922 to serve a fledging farming community. It is a ‘harp’ suspension bridge, which is rare in New Zealand. Except for the steel suspension cables and reinforced concrete pier on the left bank, the bridge elements are Australian hardwood.

“A framed timber tower supports the bridge on each bank of the river, on the true right hand bank the tower is continuous with a framed timber pier or substructure and on the left bank the tower rests on a concrete pier. The deck is supported by transoms at six points between the piers; each transom in turn supported by a steel cable that is continuous between the anchor sets on each side of the river, running over the towers and down to the transoms. There are twelve cables altogether, six on the upstream and six on the downstream side; two timber cable stays structures at transoms two and five act to stabilise the cables.

Between the transoms, a timber deck and handrail is carried on four longitudinal timber beams or stringers. The handrail is braced both to the transoms and to cantilevered deck planks. Wind bracing cables fixed to the transoms are anchored on each bank, two upstream and two downstream.”, DOC (1998), see Figs.1,2 and 3.

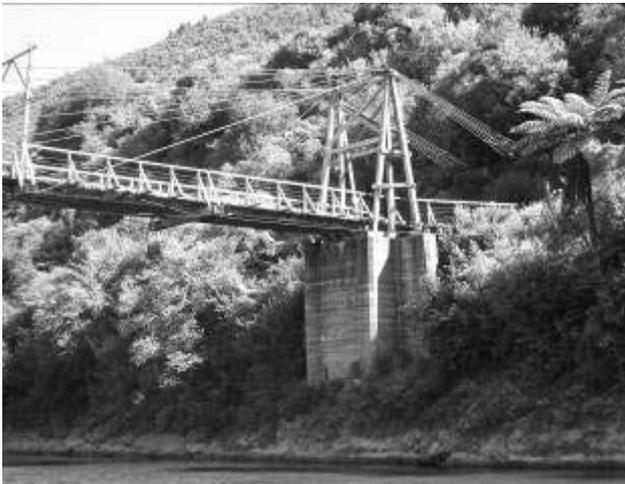
Figure 2 : T.T.B. true left tower

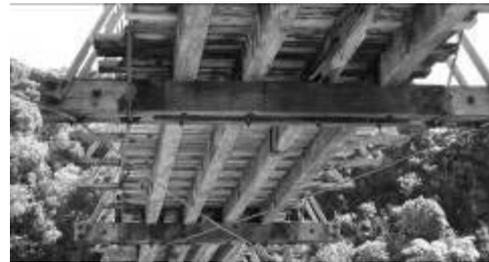
Figure 3 : T.T.B. transoms and stringers

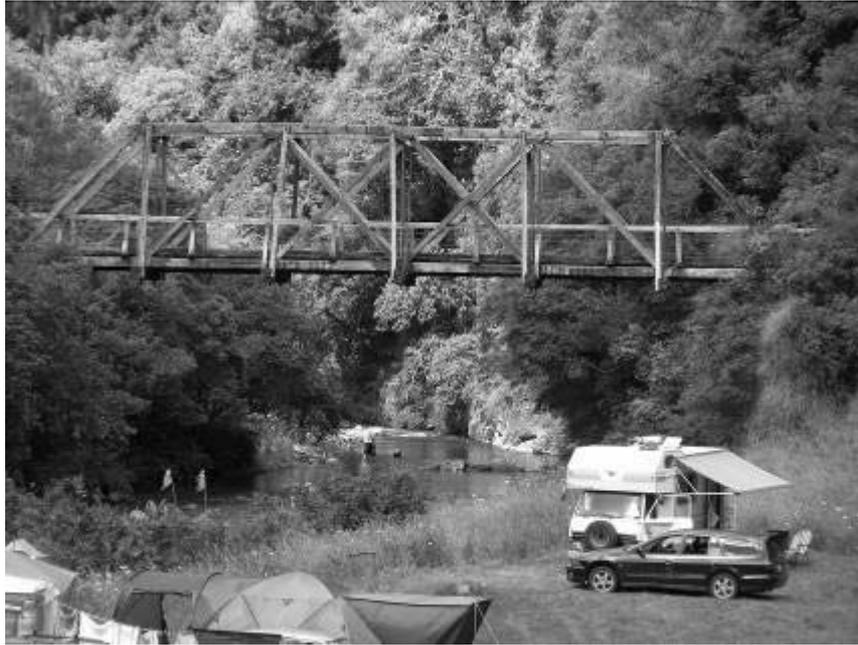
Figure 4 : Manganuku Stream Bridge, Howe truss structure

The Manganuku Stream Bridge, built by the Public Works Department and completed in 1928, has a Howe truss spanning 24.8m across the Manganuku Stream. The carriageway is 4.7m wide, see Fig. 4. Most timber bridges constructed in New Zealand for road and rail, had a Howe truss structure.

We notice, when studying the Manganuku Stream Bridge that each element has been sized according to the load it carries. An example is the diameters of the vertical steel rods, which reduce towards the middle of the span because the loads in them get less. This avoids waste, but also adds to the visual elegance and sense of correct proportions to the observer.

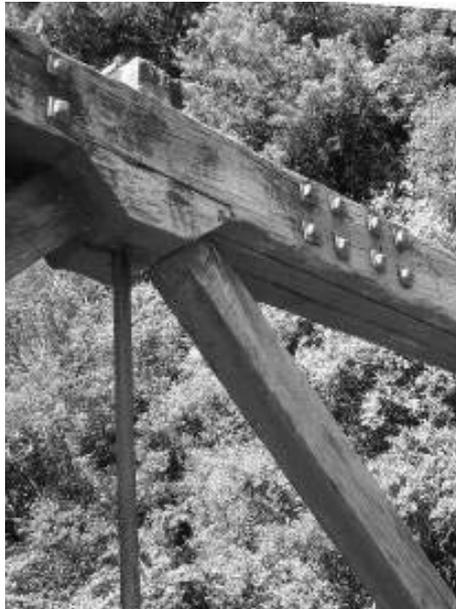
Figure 5 : M.S.B., top chord joint

When observing these bridges, the most obvious form of decay is the fibre loss of the timber elements, see Figs. 5 and 6. Because the bridges are now required to support pedestrian traffic, and no longer required to support road and rail traffic, the present degree of fibre loss is, typically, not a problem. However, the strength of a piece of timber is not always evident from its external appearance. I understand that the present method, to assess the strength of the timber elements, is to measure the deflection of each element under a known load. If the deflection is excessive, then the element is weak.

The advantage of the Howe truss is that the web tension members are vertical. Because they do not carry compression that causes buckling in slender elements, they can be made out of steel rods. The rods pass through holes in the top and bottom chords and their ends are threaded and are secured by nuts. Large washers are placed under the nuts to reduce bearing pressures on the timber chords, see Fig. 5.

The truss joints have clever 'intermediate' lengths of timber, which are placed between the webs and chords, see Fig. 5. They are shaped so as to receive the squared ends of web compression members and thus relieve joint congestion and the bearing pressure normal to the timber grain. Also, they are keyed 25mm to 50mm into the top and bottom chords to assist in transferring vertical and horizontal loads into them from the webs.

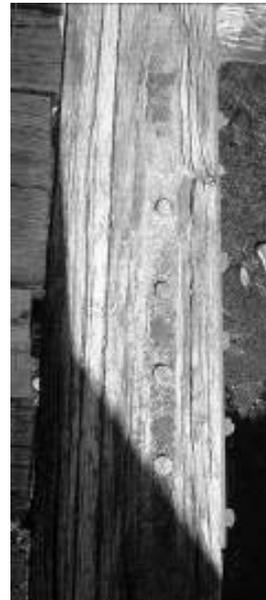
Figure 6 : M.S.B., chord splice

The bridge designers' ability to design tension members in timber structures is also evident in the compact chord splices of the Manganuku Stream Bridge, see Fig. 6. The tension forces are transferred through bolts and round steel shear keys. The bolts, as well as transferring tension load, bind the joint together and thus hold the shear keys in place. By applying the New Zealand timber structures code, (NZS3604 1999), the total splice tension capacity is 407kN. This capacity will be suitable for a bridge deck live load of 6.1 kPa. One of the largest live loadings expected for these bridges was for cattle, with a design loading of around 4 kPa.

design details to inform us. One of these is the tension chord splice detail, which is explained above. Another interesting feature is the intermediate timber elements for making the joints less congested but also assist with load transference.

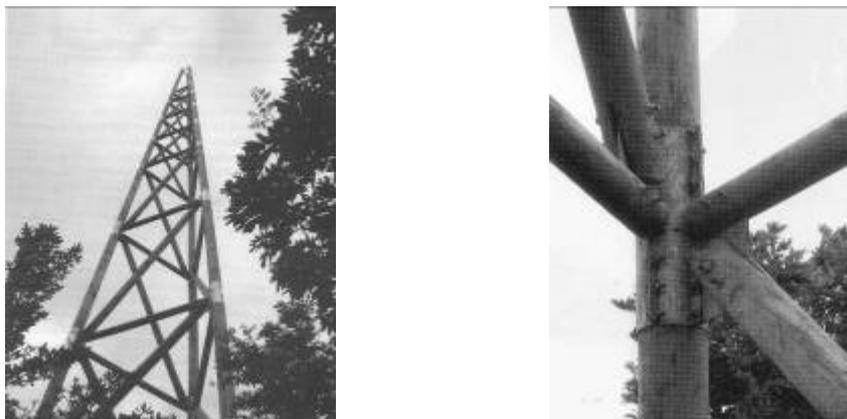
Figure 7 : Uniform round timber communications tower and joint detail

Round timbers, also known as logs or poles, are tree stems that have had their bark removed by peeling or shaving processes. In New Zealand and elsewhere around the world the usefulness of round timbers as elements for building structures is being recognised (Chapman 2004), see Fig. 7. Further references can be found on [www.unilog.co.nz](http://www.unilog.co.nz).

At present, we are out of the habit of building large industrial structures in timber. However, their viability is being recognised. An example of this is the recently constructed round timber telecommunication towers whose pole elements support loads of up to 200 tonne, Reelick and Reelick (2004), see Fig. 7.
