On Acceptable Levels of Safety in the Breeding Barn at Shelburne Farms

Douglas W. Porter

David C. Fischetti

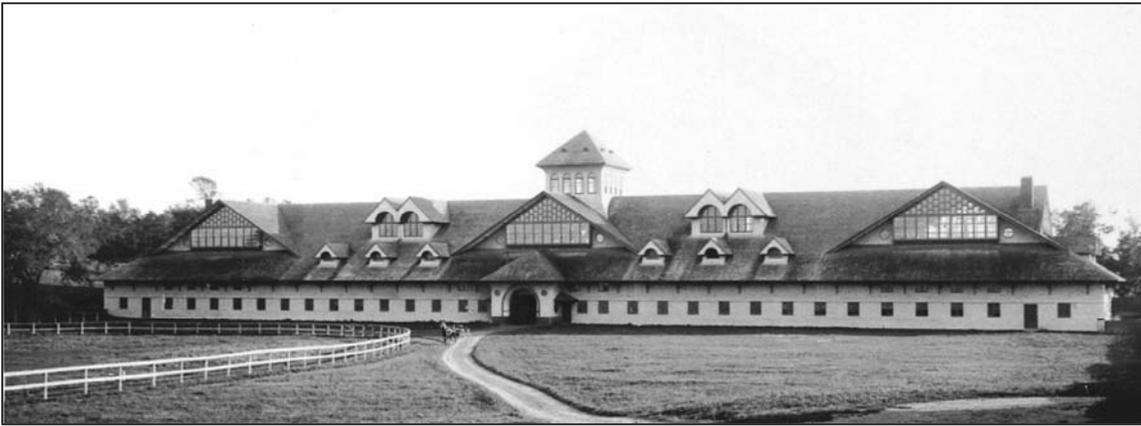
Figure 1 : The Breeding Barn at Shelburne Farms is approximately 418 feet long; the lantern at the center of the building springs from purlin timbers approximately 55 feet above the barn floor.

The main block of the building is approximately 32.6 m wide by 127.4 m long, with a two-story annex centered on the rear facade. The building is largely timber-framed, supported on a redstone foundation, and clad in wooden shingles. Building elevations are dominated by the complex-sloped two acre hipped roof, with multiple dormers and enormous central lantern. The walls are punctuated by scores of multi-pane windows that admit light and ventilate the interior space. A gable-roofed arched entry is centered on the front façade.

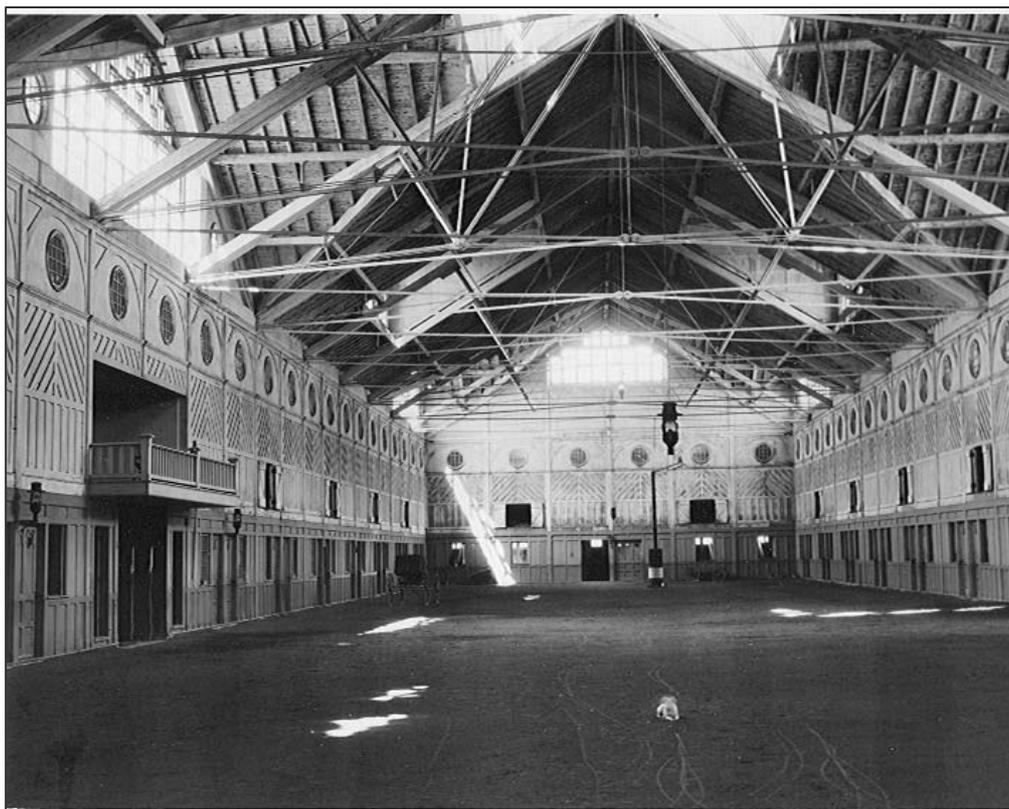
Figure 2 : The Breeding Barn interior exhibits an extraordinary level of interior finish. The use of iron rather than wood for truss elements except top chords helps to convey the impression of great volume in the riding ring space.

To support the roof over the riding ring, Robertson designed a composite truss of timber and iron. Each truss has wooden (Southern yellow pine) top chords trussed with wrought iron tension members and struts; a raised bottom chord of wrought iron completes the truss form. At the lower end, principal rafters are captured in cast iron housings that also receive the ends of tension members. Housings are fastened to timber plates at principal post locations. Principal rafters support a deck of purlins and common rafters. Aisle roofs are comprised of a deck of common rafters on timber purlins supported by king- and queen-rod trusses. The firm of Post & McCord, one of the largest iron and steel fabricators in New York City (the firm was the principal steel contractor involved in the construction of the Empire State Building), supplied the iron truss elements.
