Iterative System Identification for the Assessment and Retrofitting of a Historical Pre-Stressed Concrete Bridge in Berlin

Werner Lorenz

Brandenburg University of Technology Cottbus, Department of Architecture, Civil engineering and Urban planning, Cottbus, Germany

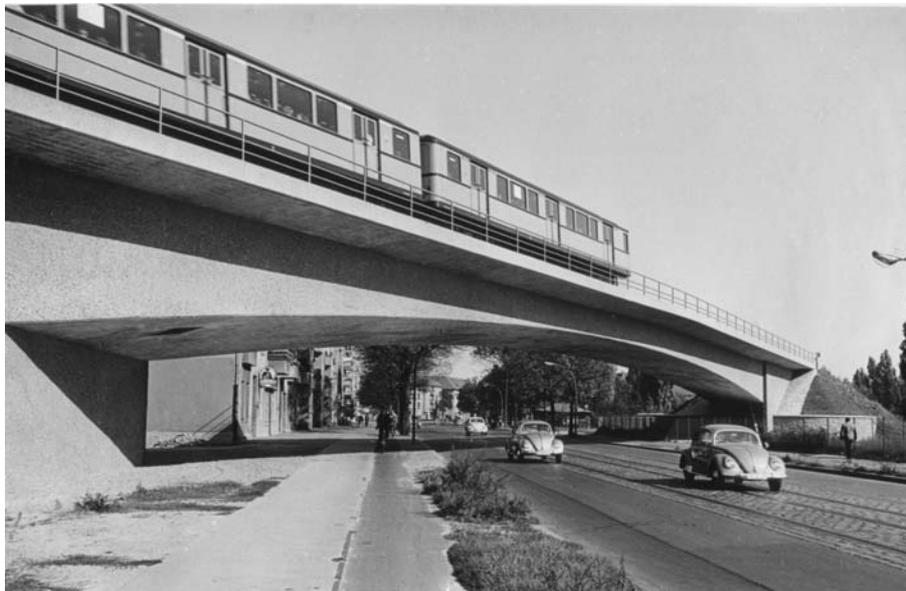
Erected in the late 1950s, the overpass of the Seidelstraße, is one of the oldest pre-stressed concrete bridges in Berlin. The skew bridge heavily used by the Berlin metro line No. 6 with a span length of approximately 65 m crosses a six-lane inner-city road. The frame structure consists of a strongly haunched hollow box, whose two cells are alternately shifted because of the skewed situation of the bridge in longitudinal direction. They were pre-stressed in the longitudinal and transverse direction using the Freyssinet system.

Figure 1 : The Seidelstraße Bridge, just after completion in October 1959.

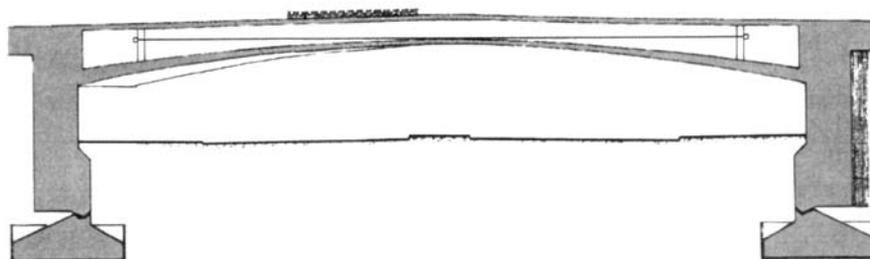
Cracks were first discovered as early as 1981 in areas which had, according to plan, been fully pre-stressed. In 1997 finally the bridge was strengthened by adding an external pre-stressing within the two cells of the hollow boxes to recreate the originally intended, but in fact no longer existing condition of fully pre-stressed structure.

Figure 2 : The load-bearing structure of the bridge on Seidelstraße with the subsequently added external pre-stressing in the two cells of the boxes

The measured data confirmed that although the external pre-stressing had been carried out properly and maintained the planned pre-stress force, the calculated pressure-stressing in the centre of the bridge had not been achieved. A considerable part of the pre-stressing force was in reality being absorbed by the clearly not hinged, but stiffly restrained portal frame struts.
