Investigation Techniques Carried out on the Qutb Minar, New Delhi, India

ABSTRACT: In the framework of the Eu-India Economic Cross Cultural Programme “Improving the Seismic Resistance of Cultural Heritage Buildings”, aimed at the preservation of ancient masonry structures with regard to the seismic risk, different NDT were applied to the Qutb Minar, New Delhi, India, in September 2005. The paper describes the different investigation techniques applied (Ambient Vibration and Pulse Sonic Velocity Tests), intended to define the dynamic response of the tower and to qualitatively define the masonry conditions. For the dynamic modal identification analysis different test equipments were used, in order to compare the data and to have more reliable results. The dynamic parameters resulted from the acquisition campaigns will be used to estimate the mechanical properties of the masonry walls and the boundary conditions of the structure, to be considered in successive seismic nonlinear analyses of the Qutb Minar, aimed at the assessment of the safety level of the construction.

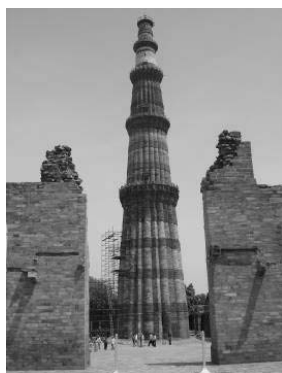
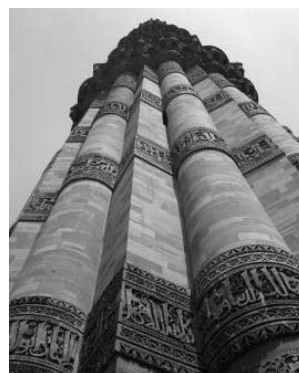
Figure 1 : (a) General view of the Qutb Minar; (b) detail of the Koran's inscriptions carved in the stone.
