Experimental Study of Synthetic Mesh Reinforcement of Historical Adobe Buildings

Marcial Blondet, Julio Vargas, Jose Velasquez and Nicola Tarque
Catholic University of Peru, Department of Engineering, Lima, Peru

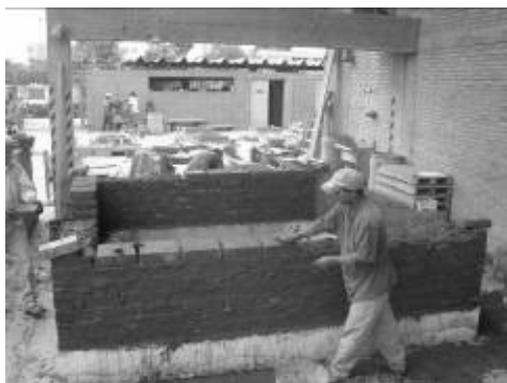
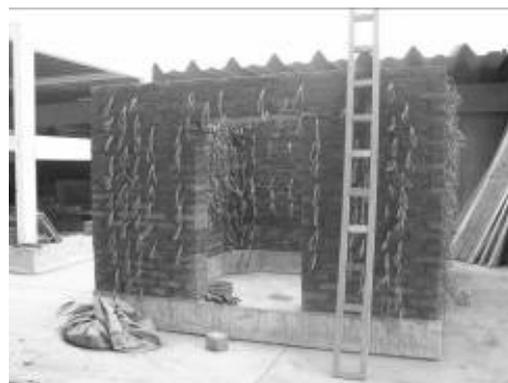
(a) Model M000

(b) Model M075-T11

Figure 2 : Construction of adobe models.

Both windows had flexible lintels made of cane rods, except model M100-T12, which had wooden lintels. The flexible lintels were used as an attempt to avoid local failure, observed in previous tests, caused by the impact of the stiff wooden lintel against the earthen walls. Bricklayers with experience in building adobe houses were hired to fabricate the adobe blocks and to build the housing models. Figure 2 shows two models under construction. Observe the plastic strings that have been left across the walls of M075-11.

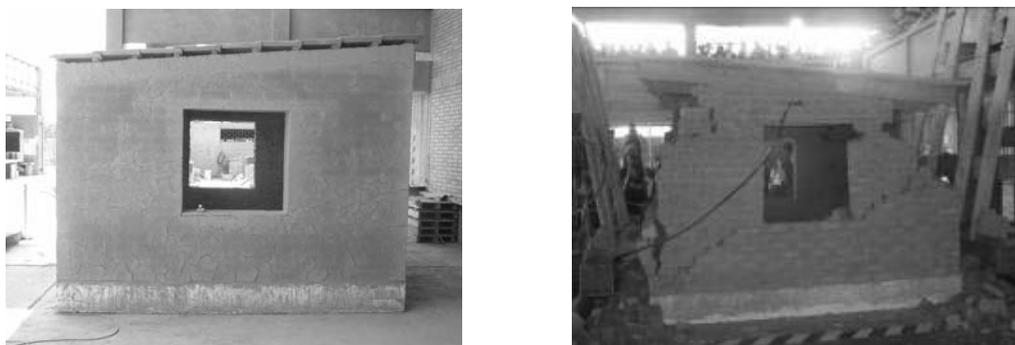
This unreinforced model represented a typical vernacular adobe building. During test phase 1 (30 mm) diagonal cracks appeared on both longitudinal walls, and the wooden beams supporting the roof detached from the walls. In phase 2 (80 mm) important vertical cracks appeared at the corners of the transverse walls, which collapsed during phase 3 (Fig. 5). This type of failure is representative of that of vernacular earthen structures: a few large cracks divide the walls in several pieces, which afterwards fail independently.

Figure 5 : Unreinforced Model M000 before the test (left) and after the test (right)

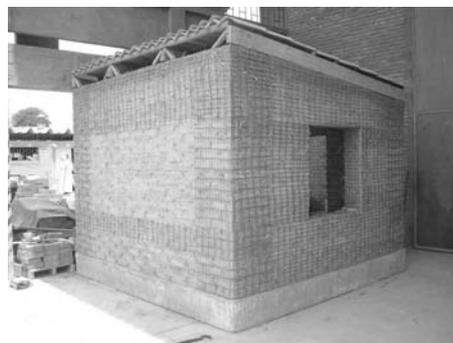
Since geogrid is quite expensive in Peru, it was decided to study the use of a cheaper plastic mesh, usually employed as a soft safety fence in construction sites. The left wall was completely covered and the right wall was partially covered, as shown in Fig. 12. Around 80% of the wall surface was thus reinforced.

Figure 12 : Reinforcement arrangement and finished model M080-E.

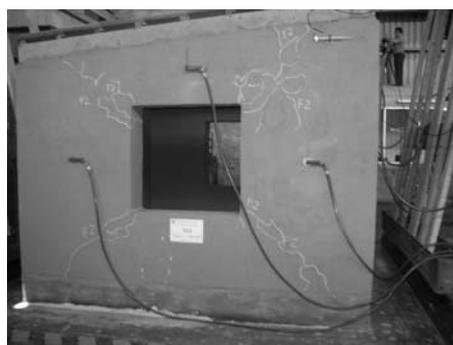
During phase 1 (30mm) the model showed an elastic behavior and remained practically uncracked. Some sliding was noticed at the base of the walls. In phase 2 (80mm) diagonal cracking started from the corner of the windows of both longitudinal walls (Fig. 13). Also, some mud plaster fell apart. The transverse wall also showed significant cracking, but did not collapse.

Figure 13 : Seismic behavior of model M080-E until phase 2. Hysteretic cycles and model view after testing.

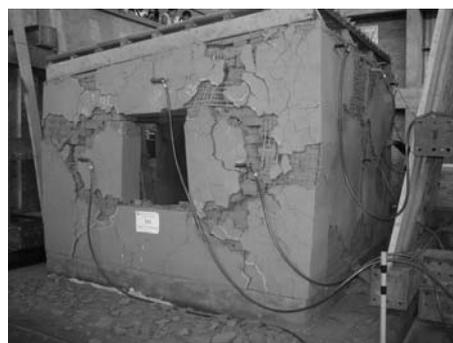
In phase 3 the model suffered significant damage. The left wall (totally reinforced) had many uniformly distributed cracks. The right wall (partially reinforced) had fewer, larger cracks and was practically broken into several pieces, held together by the plastic mesh (Fig. 14). The mesh was deformed and broken in several places, indicating that the amount provided was barely adequate.

Figure 14 : Model M080-E phase 3. Acceleration response and model view after testing.
