Testing for Assessment of Load Carrying Capacity of Masonry Arch Bridges

ABSTRACT: A significant number of masonry arch bridges in India, constructed in the pre-independence era are carrying vehicles with axle loads and speeds far beyond their design load. The tests have been conducted on four test arches with 2.53 m span, 0.70 m rise, and 0.717 m width with two rings of bricks. Two of these were vault only arches and other two had spandrel walls and fill also. Each of the arches had two half brick thick rings. The arches were loaded at the quarter point till the formation of hinges at four locations leading to a mechanism failure. Although similar tests have been carried out previously by many researchers, the properties of the masonry are influenced by its constituents so for the type of bricks available in India, it was deemed necessary to conduct a series of the tests. The paper presents the results of tests conducted on the arches in the laboratory to determine the load carrying capacity of the arches, and to understand its behaviour till failure. The testing was carried out for the validation of non-linear finite element analysis program using the experimentally developed co

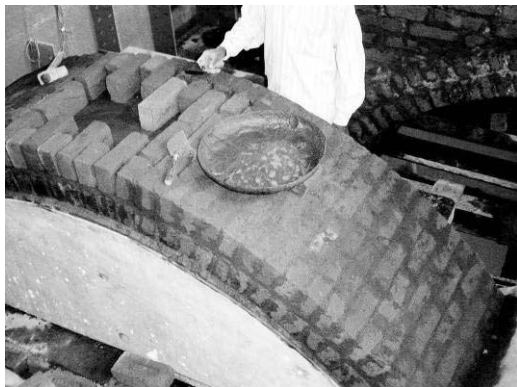
Figure 3 : Construction of arch barrel in progress.

The arches had two rings separated with a mortar joint of 12 mm. The two rings together represented a thickness of one brick i.e. 236.38 mm. The joint thickness was kept uniform throughout the circumference of the arch. The bricks were laid in header bond across the width as seen in the Fig. 3. The arches consisted of 39 bricks in the inner layer and 42 bricks in outer layer through the circumference, 3 bricks across the width, which was equivalent to 717 mm.

The first layer of the bricks was laid over the formwork starting from one abutment up to the quarter point of the arch. Subsequently starting from the second abutment the first layer was laid up to the quarter point. Thereafter following the same procedure the remaining courses were laid simultaneously from both the ends such that the joint thickness could be attuned to adjust the full brick at the crown. The procedure was then repeated for the second layer of the bricks. The verticality of the joints was staggered by the use of the brickbats in the alternate courses, in order to avoid the direct planes of weakness and minimize the possibility of shear failure. The arches were then covered with wet gunny bags in order to prevent premature hydration and were allowed to cure for 28 days

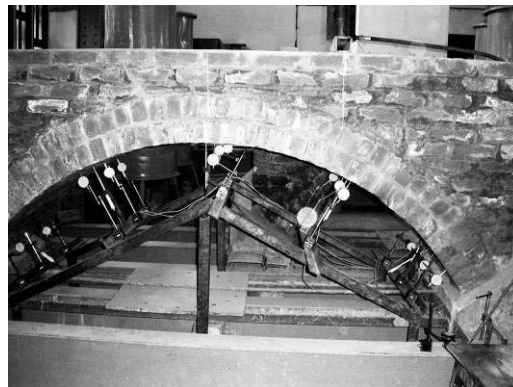
Figure 4 : Placement of dial gauges and LVDT's.

Proving ring of 200 kN with a least count of 1.635 kN was used for the measurement of the applied load on the arch. To measure the deflections in the radial direction, the dial gauges having least count of 0.01 mm were positioned at the crown, quarter points, and near the abutments on the intrados of arch. The gauges were mounted over an independent platform fabricated of rolled steel angle sections (Fig. 4). This was done to avoid the interference of the deflections induced in the supporting girders of the loading frame. Over each section three dial gauges were mounted, two over the end and one in the center of the barrel to check that the arch was deflecting uniformly across the width. The dial gauges were positioned over the $25 \text{ mm} \times 25 \text{ mm}$ brass plates glued to the surface of the brickwork. For second set of the models, LVDT's were placed along the centerline of the arch at two-quarter points and under the crown.

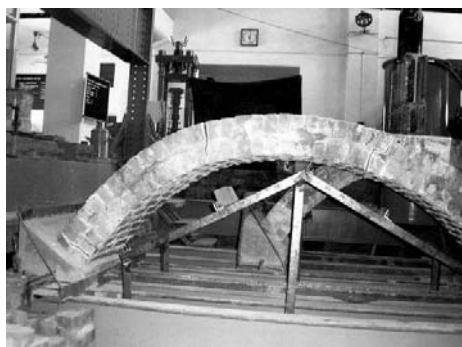
Figure 5 : Cracks developed near left abutment, left quarter point and crown for arch AV1.

A uniformly distributed line load across the full width was applied to the arch at quarter span. The arch did not collapse, but failed due to the formation of the four hinges at the joints near the abutments and quarter points. The arch was loaded in increments of 2.5 kN upto a load of 54.18 kN, at which the arch cracked simultaneously under the point load and left quarter point. The load suddenly dropped to 43.39 kN and the corresponding displacements increased, due to the loss of the stiffness and the widening of cracks took place. The load was again increased in even smaller increments up to 45.35 kN at which the arch cracked at the third location near the left abutment (Far from load point), and load again fell to 43.39 kN. At this instant the dial gauges were removed and the load was further increased, the load did not go beyond the last load level but another hinge was formed near the right abutment and the cracks further widened

up. No signs of the compressive failure of arch material were observed. The arch failed due to conversion to a mechanism after the formation of the hinges at four locations as seen in Fig. 5.

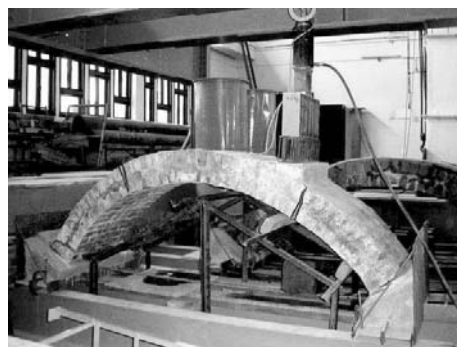
Figure 6 : Cracks developed near left abutment, left quarter point and crown for arch AV2.

This arch was also loaded in increments of 2.5 kN up to a load of 49.05 kN, at which the arch cracked simultaneously under the point load and left quarter point. The load suddenly dropped to 34.34 kN and there was sudden increase in the displacements. The load was again increased in even smaller increments up to 39.34 kN at which the arch cracked at the third location near the left abutment (Far from load point), and load again fell to 37.87 kN. At this instant the dial gauges were removed and the load was further increased. Another hinge formed near the right abutment and the cracks further widened up. No signs of the compressive failure of arch material were observed. This arch also failed due to formation of mechanism after the formation of hinges at the identical four locations as seen in Fig. 6.

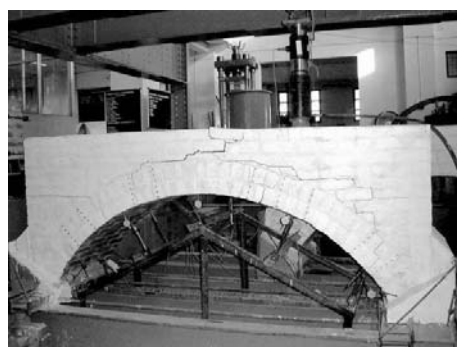
Figure 8 : Cracks in the arch barrel and the spandrel wall in AF2 arch.

The arch was loaded at right quarter span. The load deflection behaviour of arch AF2 was observed almost similar to AF1. The first visible crack occurring under the load in the arch was observed at 42.5 kN. The crack led to initiation of separation of spandrel wall from the arch barrel progressing towards crown as well as right abutment. When load reached 67.5 kN another crack splitting the spandrel wall over the left abutment appeared and led in to arch barrel (Fig. 8). With further increase in the load these cracks kept on opening. A crack in the vicinity of this crack appeared on the extrados that led up to the top of spandrel wall when the load was raised to 74.8 kN. In the meantime, the crack propagating towards right abutment also entered the barrel when load was being raised to 75.5 kN. Finally the load dropped to 73.2 kN. Further application of load merely increased the deflections and load levels did not increase.

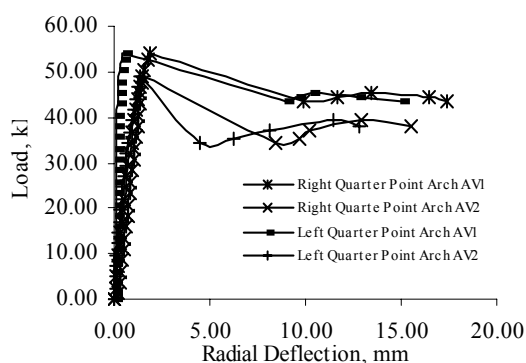
Figure 9 : Load deflection plot for Arches AV1 and AV2 under load point and left quarter point.

The load deflection plots for arches are presented in Fig. 9 and Fig. 10. It can be readily observed that after the formation of the crack under the load point and left quarter point almost simultaneously, the stiffness of the structure in these regions reduced significantly. The deflections observed at this instant include the adjustments of the arch profile on account of insertion of two hinges. This simultaneously followed a drop in the load observed. Although the failure of the arch sections was due to material tensile failure, but the final failure of the arch as a whole took the form of the mechanism.

For the arches the load deflection is almost linear up to the formation of the first hinge or crack. The deflections after this load level increased because these include the rigid body movements due to the adjustment of the thrust line within the arch barrel.

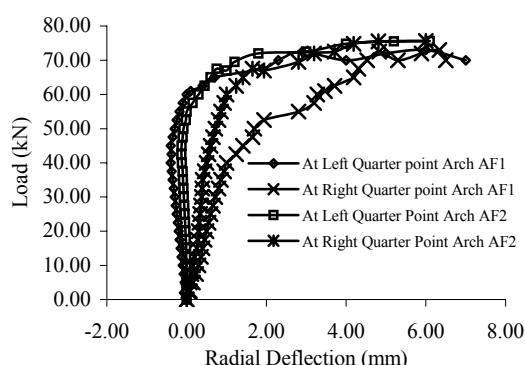
Figure 10 : Load deflection plots for arches AF1 and AF2 under load point and left quarter point..
