Construction and Structural Behaviour of Lead Joints in Gothic Stone Structures

Rainer Barthel and Matthias Beckh

Technische Universität München, Faculty of architecture, Department of structural design, Munich, Germany

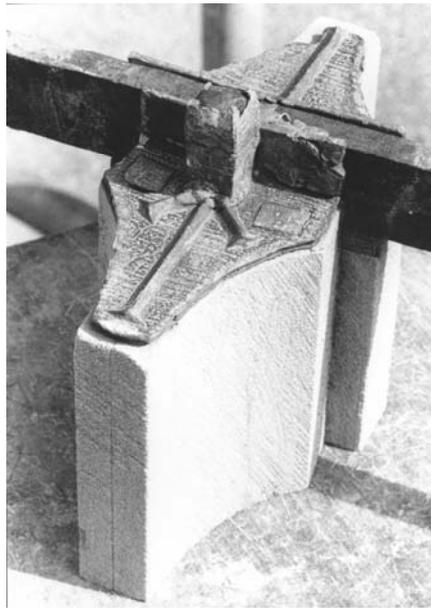
Figure 1: Mock-up of lead joint with horizontal wrought iron tie by M. Scherbaum, Nördlingen. The positive imprint of the grooves, distance keepers and iron pin are clearly visible

Arnold Wolff, the former master builder of Cologne cathedral, describes the technical process of crafting this kind of joint in detail (Wolff 1989). Radial flutes or grooves, originating from the centre of area, are cut into the faces of the stone bars at the joint. The grooves not only facilitate the quick spreading of the lead, but also prevent differential rotation of the stone bars afterwards. The lead is brought into the joint through an inclined channel, which is drilled into the upper stone element. Small pieces of wood or lead are usually used as distance keepers. For the casting procedure the joint is sealed along its edges with a temporary collar of clay. As casting material thin fluid lead is used, sometimes with additional wax or tallow as a fluxing agent. The thickness of the joint typically varies between 3 and 6mm. Fig. 1 shows an open lead joint between the vertical stone bars of a tracery window, displaying the positive imprint of the grooves.

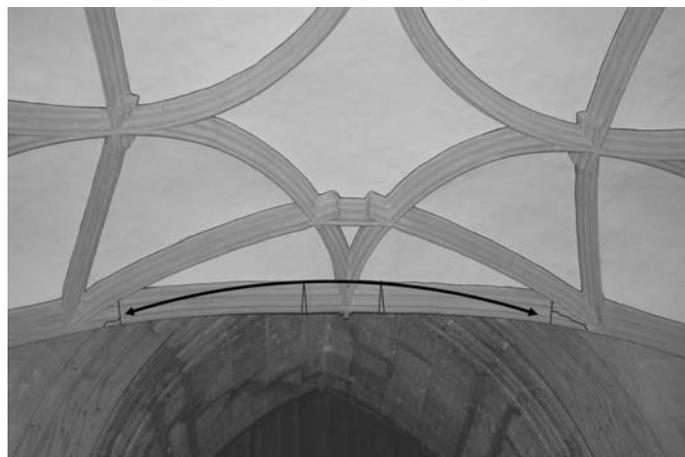
Figure 2 : Deformed arch of the gallery vault with the resulting thrust line. Seen from below, looking West

The reticulated vault above the Western entrance of the church was examined and analyzed to assess its capacity for additional loading. The sophisticated rib pattern showed some local damages at its Western edge, where diverging abutments had lowered the arch by about 5cm, causing the opening of some joints and local spalling of the sandstone bars. (See Fig. 2).

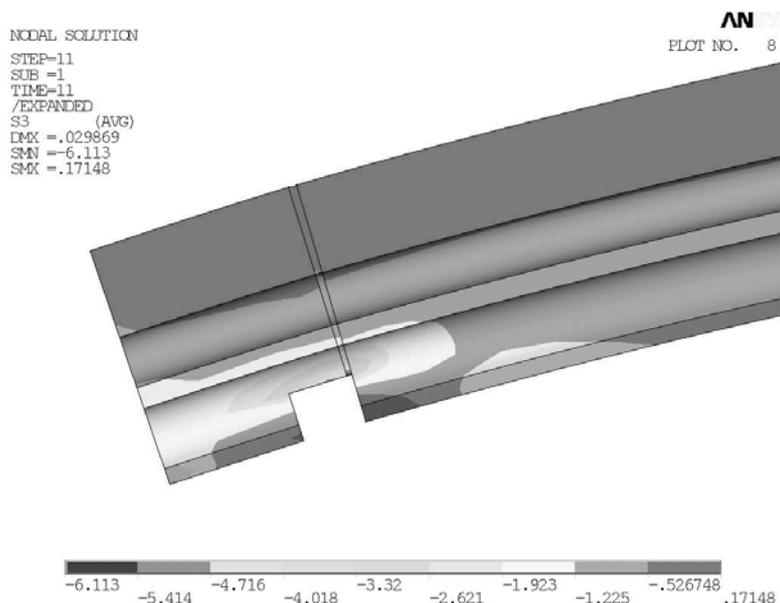
Figure 3 : ANSYS FEM model, detail at Southern support, showing principal compression stresses

For restoration, the arch was lifted up by hydraulic jacks in its original position. During this process, the joints opened and missing stone parts were carefully inserted. The joints were then closed with “leaden wool”. (See Figs 3 and 4).

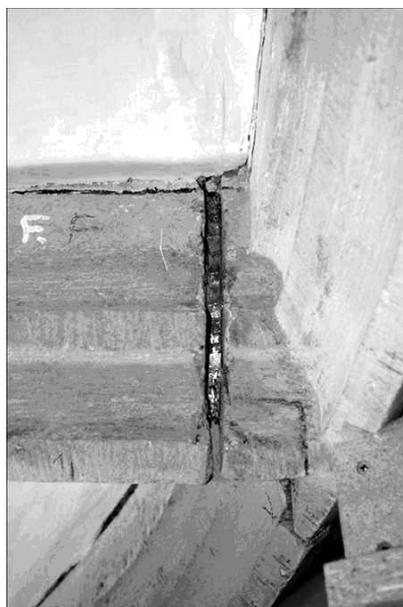
Figure 4 : repaired historic lead joint in a reticulated vault. Here, the lead stops before the lower fillet to prevent excessive edge pressure.

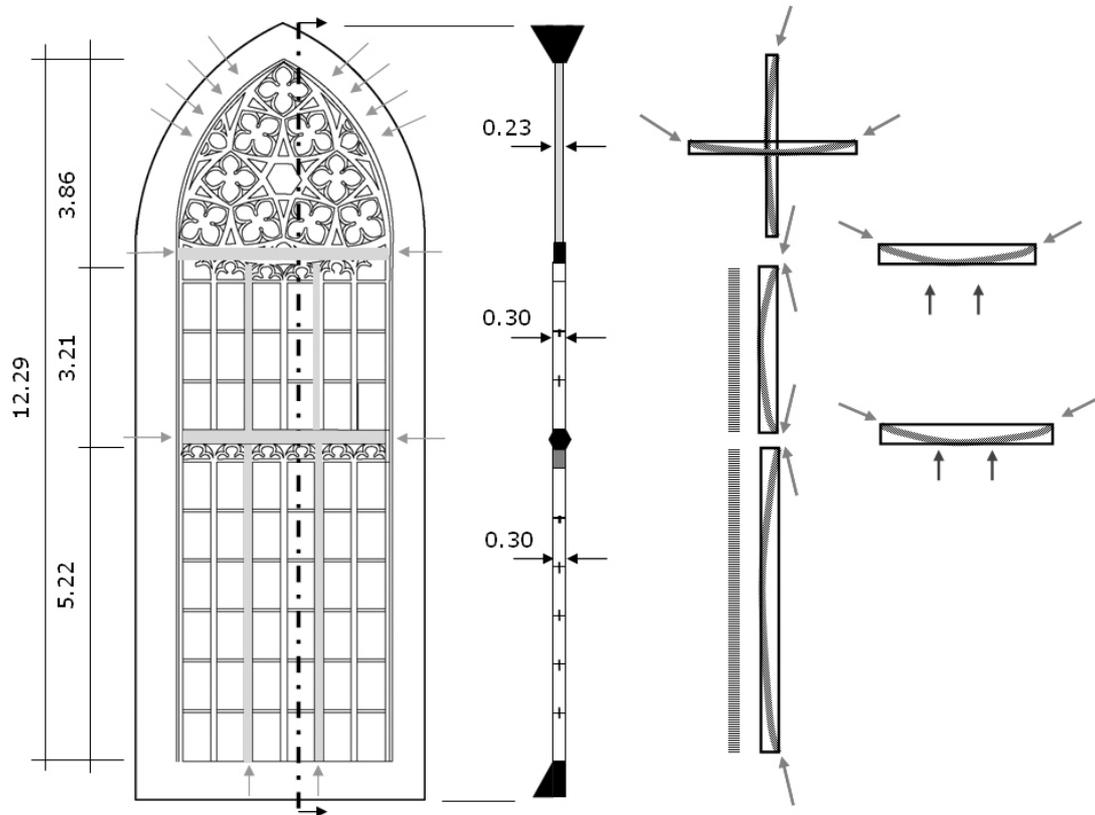
Figure 6 : Diagrammatic load bearing behaviour under horizontal wind load

To understand the load bearing behaviour of the window, the structure was first conceived in its original state. It was assumed that all the supports of the bars at the reveals were rigid. If sliding can be precluded, the stone structure will clamp between the rigid supports under horizontal loads. This requires a very stiff structure (including stiff joints!), so that a flat arch can form between the supports. If the supports are slackening or the structure is too elastic, the joints begin to open and the rise of the arch decreases. As a consequence, edge pressures increase drastically, often leading to spalling of the stone. Fig. 6 illustrates the flow of forces in the flat arches under wind load.

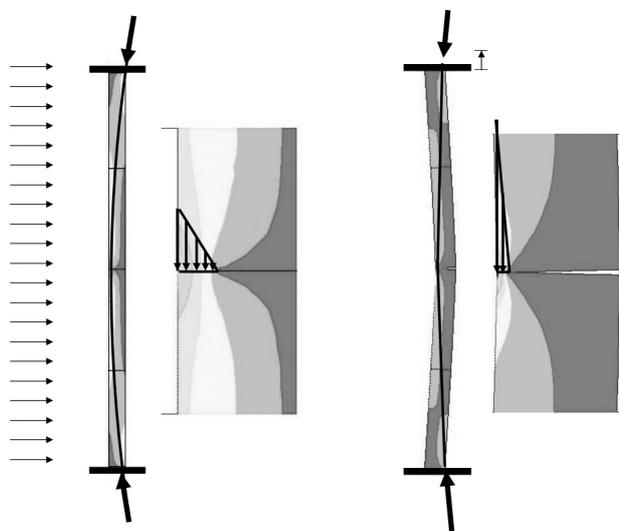
Figure 7 : Edge pressure of vertical stone bars under wind load with (a) rigid supports and (b) elastic supports

For the structural analysis of the window a Finite Element model using the program *Ansys* was created. The stone bars of the vertical bars and the horizontal beams were modelled as 3-dimensional volume elements, while contact elements were used to model the joints. The contact elements only allow compression and shear forces but exclude tension forces. Linear elastic material behaviour was used for the sandstone with lower and upper limits for the modulus of elasticity to evaluate its influence. In a similar fashion, a lower and upper limit was established for the superimposed dead load of the tracery on the vertical bars. Precisely because it is impossible to determine to which extent the tracery is supported by the vertical bars, or whether most its self weight is transferred by friction into the reveals. The calculations were based on the undamaged structure but included all the relevant deformations. The analysis, allowing large displacements and rotations, is geometrically nonlinear and iterative. By means of numerous parameter studies, the stability of the structure was calculated. In Fig. 7, thrust lines and edge pressures are shown for a rigid and elastic support conditions. A span increase of a few millimetres already results in a major increase of edge pressure.

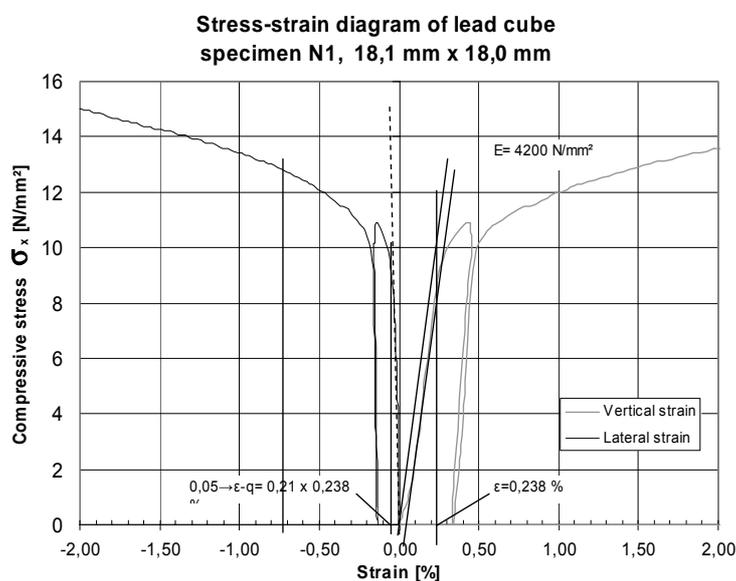
Figure 8: Stress-strain diagram of a small specimen of new lead

In 2004, a small sample of roughly 20mm wide lead cubes was tested to research into the stress-strain relations. Four specimens were examined; two of both historic and new lead. The average modulus of elasticity was found to be about 4000 N/mm^2 , with the old lead being a little bit stiffer than the new one. The yield point was found to be 10 N/mm^2 . Due to the small range of specimen and the high scatter, the results are only indicative. Fig. 8 shows a stress-strain diagram of a cube made of new lead with vertical and lateral strain. As a result of the inhibited transverse expansion of the small and compact specimens, the resultant Poisson’s ratio appears to be underrated.

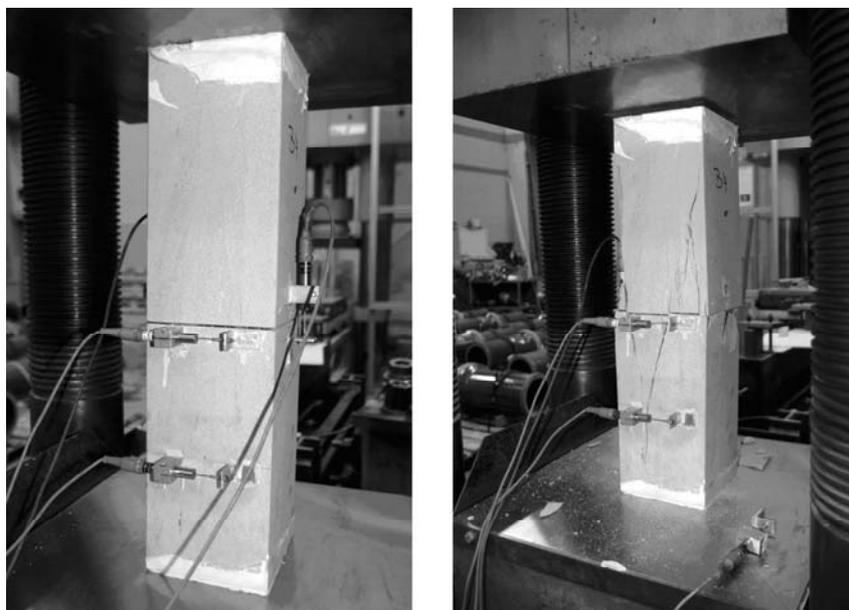
Figure 9a, 9b : Sandstone duplex with lead joint before and after the breaking test

Displacement transducers were placed at three different locations: a vertical one at the joint and horizontal ones at top and mid height of the lower stone. Figs 9A and 9B show a duplex specimen with displacement transducers inside the testing machine before and after the breaking test. Both single and duplex sandstone units were tested for stress-strain relations and breaking load. The average breaking load of the single Schönbrunner sandstone unit was found to be $39,1 \text{ N/mm}^2$, of Udelfanger $51,3 \text{ N/mm}^2$.

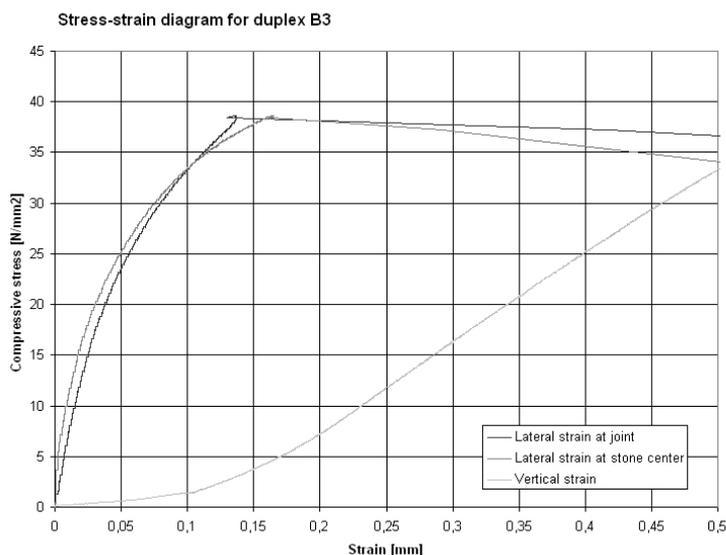
Figure 10 : Stress-strain diagram of duplex specimen B3 made of Schönbrunner sandstone

Lead joints, in contrast, seem to have an entirely different impact on the stone. The lateral expansions measured at the joint and at stone mid height are almost similar. Just before reaching the peak stress, the lateral expansion of the stone was actually even lower at the joint than at mid height. (See Fig. 10). This suggests that the Poisson's ratio of the lead is lower than the one of the tested sandstones. Therefore, lead would inhibit the free lateral strains of the adjacent stones.
