Weathering Forms and Properties of Laterite Building Stones Used in Historic Monuments of Western India

ABSTRACT: Laterite, a world wide occurring weathered rock, is one of the most predominant building stone used in permanent structures along the west coast of India. This paper focuses on characteristics of alteration of laterite building stone used in historic monuments along the west coast of India. Field study was conducted on laterite monuments of international importance in Goa and Kerala to identify the locations of decay and to classify them based on the causes. Engineering properties of fresh laterite stone samples from local quarries of Malabar region, Kerala were also determined on a scientific basis. It is seen that decay processes rarely operate in isolation; they are due to a combination of several causes. Dampness was identified as a major factor involved in weathering of laterite, hence protection from dampness will prevent deterioration of laterite structures to a large extent. This study suggests a base for the conservation strategies and selection of material for repair of laterite monuments.

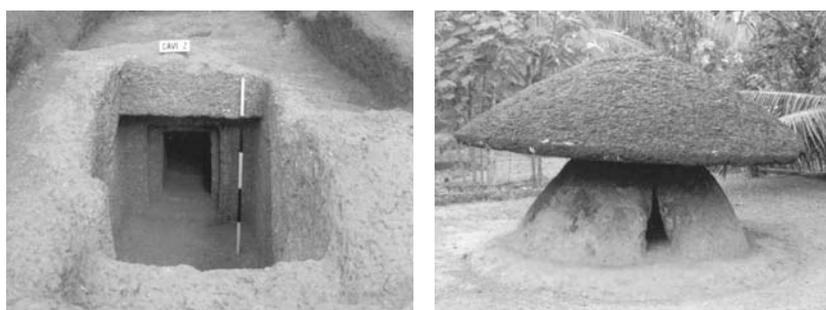
(a) Umbrella stone (Kodakkallu) (b) Entrance to a Megalithic cave
Figure. 2 : Prehistoric megaliths of Kerala (2nd Cent. B.C. to 1st Cent. A.D.).

Prehistoric megaliths of unique forms made using laterite namely Kodakkallu, Thoppikkallu, menhirs and caves were found located in lateritic zones of Kerala as shown in Fig. 2. These vestiges made using laterite are the earliest remains of human embellishments. They stand as testimony of sound construction practices adopted in laterite in the distant past and the remarkable resistance of the material to weathering.

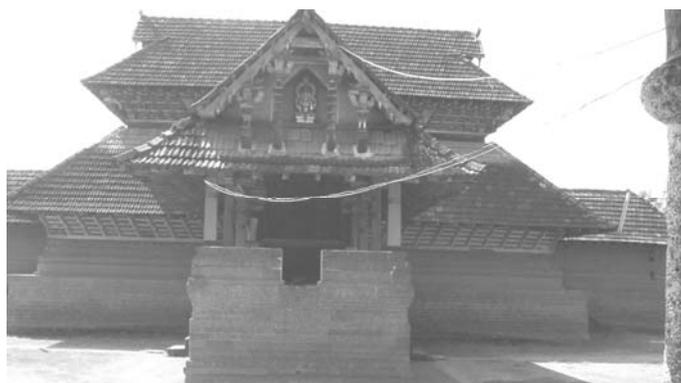
Figure.3 : Typical traditional temple in Kerala built using exposed laterite masonry.

The rich and unique architecture feature of exposed laterite masonry is seen in temples and traditional residences of Malabar region. The workability of laterite combined with the technical skills of Stapathis (master craftsmen) is reflected in decorative and molded basements (adhistanana) of temples (as shown in Fig. 3). Laterite was also used for variety of other ancillary applications like pavements, steps, and special structures like arches and vaults.

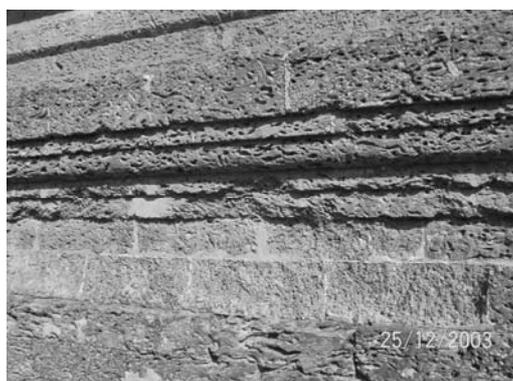
(a) Granular disintegration

Figure 4 : Damage due to loss of material.

Physical damages caused due to lashing rain, wetting and drying cycles and thermal changes. Loss of cohesion of minerals causes granular disintegration and surface loss of material. Disintegration of laterite mainly in exposed areas of basement was mainly due to the growth of salt crystals. The soft clayey part within the matrix is washed off by means of rain and wind resulting in honey combing.

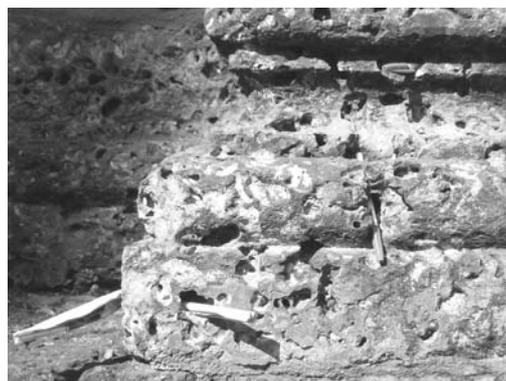
(b) Honey combing due to action of rain

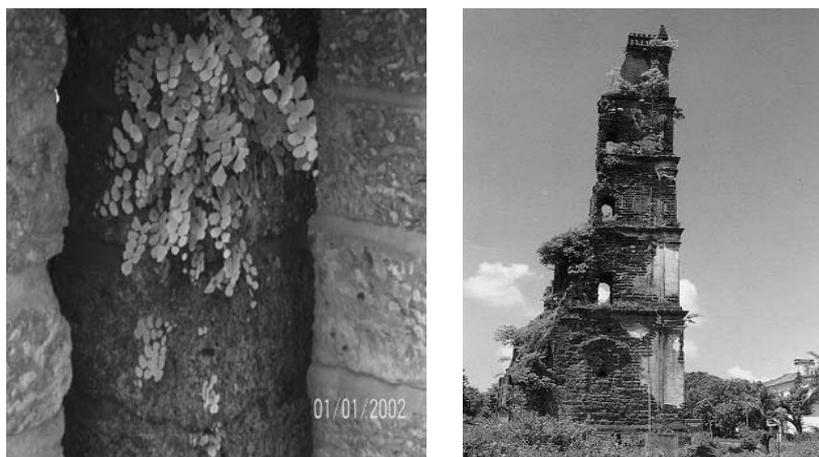
(a) Growth of moss and lichens (b) Damage due to growth of trees
Figure 5 : Bio-degradation.

Damp surface of laterite attracts dust, dirt, insects, termites and other microorganisms. If this is uncontrolled it gives rise to higher plants and trees. The acidic secretion produced by lichens induces a bio-corrosion in stones. The surface is rendered damp and soft. Causes unsightly appearance and results in progressive damage. Laterite, unlike other stones, is weak and porous and serves as a good background for vegetation. Trees grow fast on laterite. Rough surface texture and clay filled cavities allow easy propagation of roots. If plant growth is uncontrolled, it causes progressive damage leading to collapse of the building as seen in the ruins of St. Augustines tower, Old Goa.

The maximum damage seen in exposed laterite structures was due to bio-degradation such as growth of moss and lichens and vegetation. The warm humid climate and inherent properties of laterite (high water absorption) provide a conducive environment for growth of vegetation. Growth of moss and lichens cause unsightly appearance and material destruction. Formation of moss and lichens on exposed laterite renders the surface damp and soft, which promotes growth of higher plants and trees. Protecting the walls from dampness will control salt attack and bio-degradation.

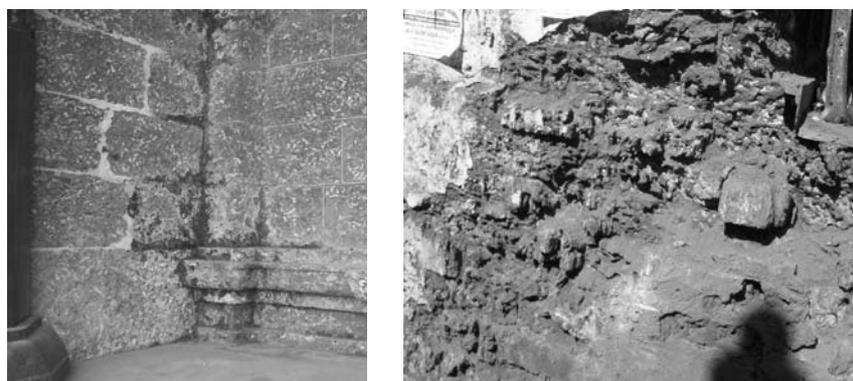
Figure 6 : Salt crystallization attacks on Laterite.

(a) Efflorescence due to deposition of salts on surface (b) Progressive damage due to deposition of salts internally

Formation of efflorescence on exposed surfaces of structure causing unsightly appearance. Formations of salt crystals below the exposed surface result in blistering and scaling of outer layers. Salts seeps into the building by capillary action of ground water. Salts are deposited within the structure (in basement portions) near the exposed surfaces resulting in granular disintegration (as illustrated in Fig. 6b).

cause, but a combined action of various causes. Salt attack occurred due to ingress of salts into the structure (from atmosphere and ground) by moisture migration. The salt decay found in the basement portions of buildings suggests that the salts must have originated mainly from ground by capillary action.
