Protection from the Effect of Horizontal Forces of Remains of High Walls within Hilandar Monastery Block, on Holy Mount in Greece

ABSTRACT: It is necessary to protect – support adequately the independent walls and free standing chimneys, which have been - due to different reasons, (demolition caused by earthquakes, fire, or dilapidation and fall of certain parts of a building) - left alone and free in space, in a way which will enable them to receive the effect of horizontal forces: seismic forces (earthquake) and the effect of wind. Considering the fact that the effect of these seismic forces endangers directly the stability of above mentioned parts of buildings, which, due to unfortunate concurrence of circumstances, had remained statically endangered and unstable in space; their protection is necessary in order to prevent a fall.

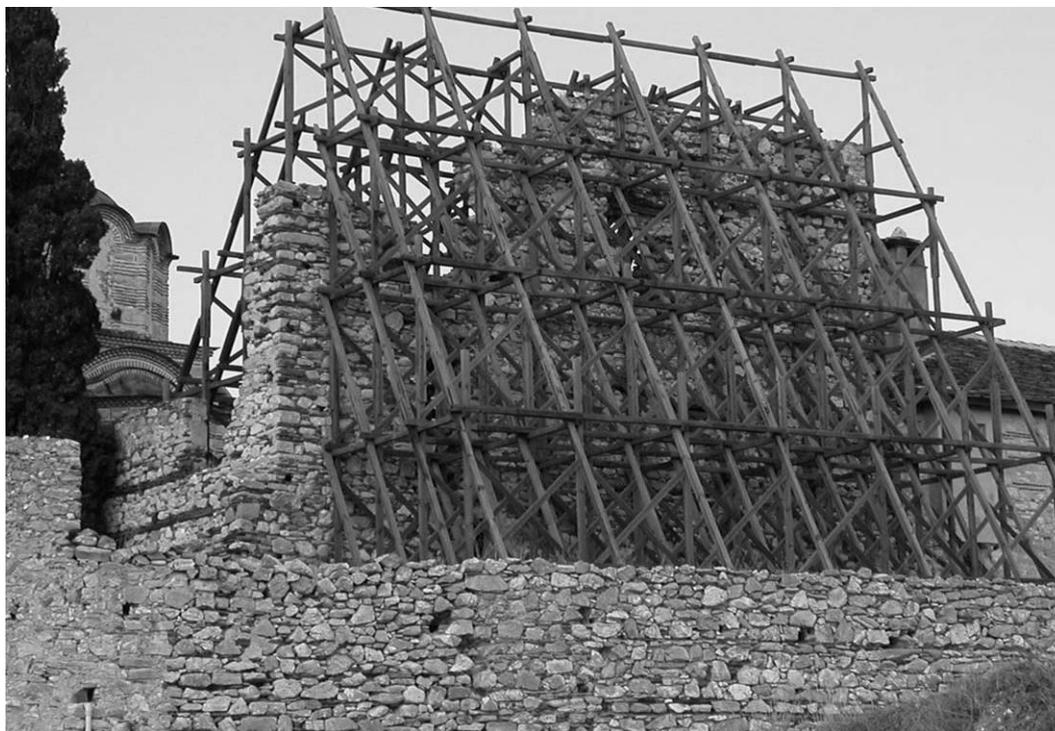
The age and height of this wall endangered stability of its parts, as well as the fact that its perpendicular side walls had been torn down. Thus this wall remained alone and unstable and it was necessary to protect it with an auxiliary construction to prevent its further destruction and possible fall. This wall has been protected with a wood truss construction. Wood truss construction has been installed within the system of a spatial wood truss structure made of timber (converted timber). Spatial wood truss structures had been installed on both sides of the wall (Figure 1). This type of protective construction has a temporary character and it serves as a

protection until the final rebuilding of this wall. This construction does not enable covering of the remains of the wall which are subject of protection and does not prevent the effect of atmospheric conditions (rain, snow); that is its disadvantage. The wood truss is exposed to the effect of atmospheric conditions (rain, sun), therefore it may be ruined and its durability is limited.

Figure 1: Protection of wall of stone with a wood truss, St. Vasilije

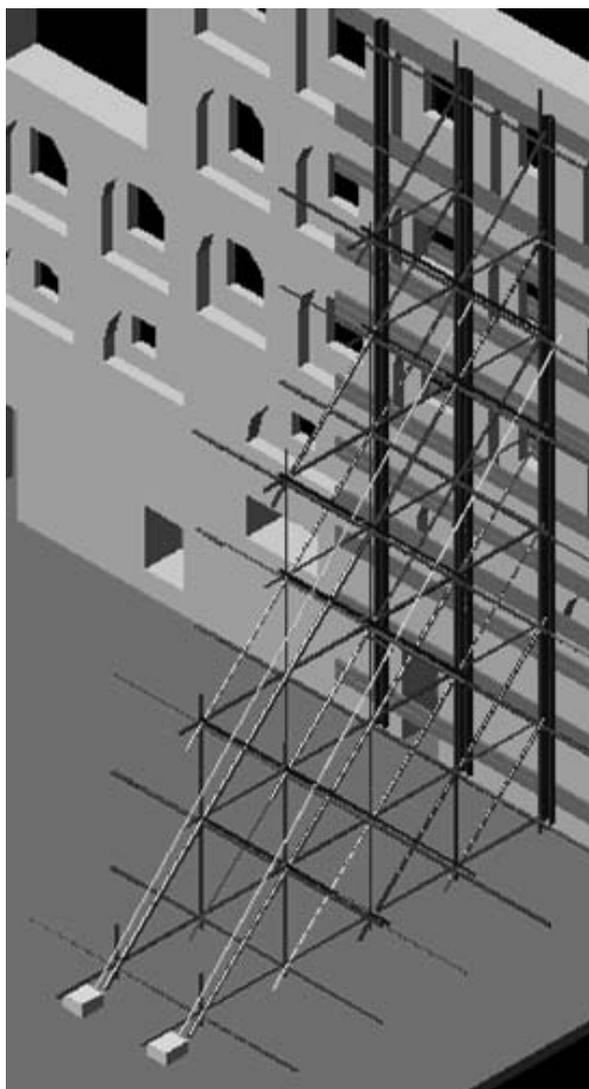
The wall in Palace from 1640 is an example of this type of protection. It has been anticipated to protect it with a tube–shaped scaffolding placed only on one side of the building – face side. This solution has been selected because it allows an access to the wall from one side and easier work on rebuilding and reconstruction of whole building.

It has been planned to protect a mud brick wall higher than 16m by placing timbers, interconnected with screws, in both directions (horizontally and vertically) on both sides of the wall. It is necessary to connect this wood construction with a construction made of a tube-shaped scaffolding. Considering the fact that joints on a tube-shaped scaffolding cannot receive the tightening force that may appear in them, it has been anticipated to install a tie-beam from the top of the construction to the anchor block (only one) (Figure 2), which would be buried into the ground at a necessary distance from the wall. It was not physically possible to lay more foundations on this location, so one anchor block and one tie-beam had been placed. Anchor block is placed on the level of a truss (a plane perpendicular to the wall that is being protected).

Figure 2 : Animation of the proposal for protection of the wall of stone with a tube-shaped scaffolding, Palace, 1640

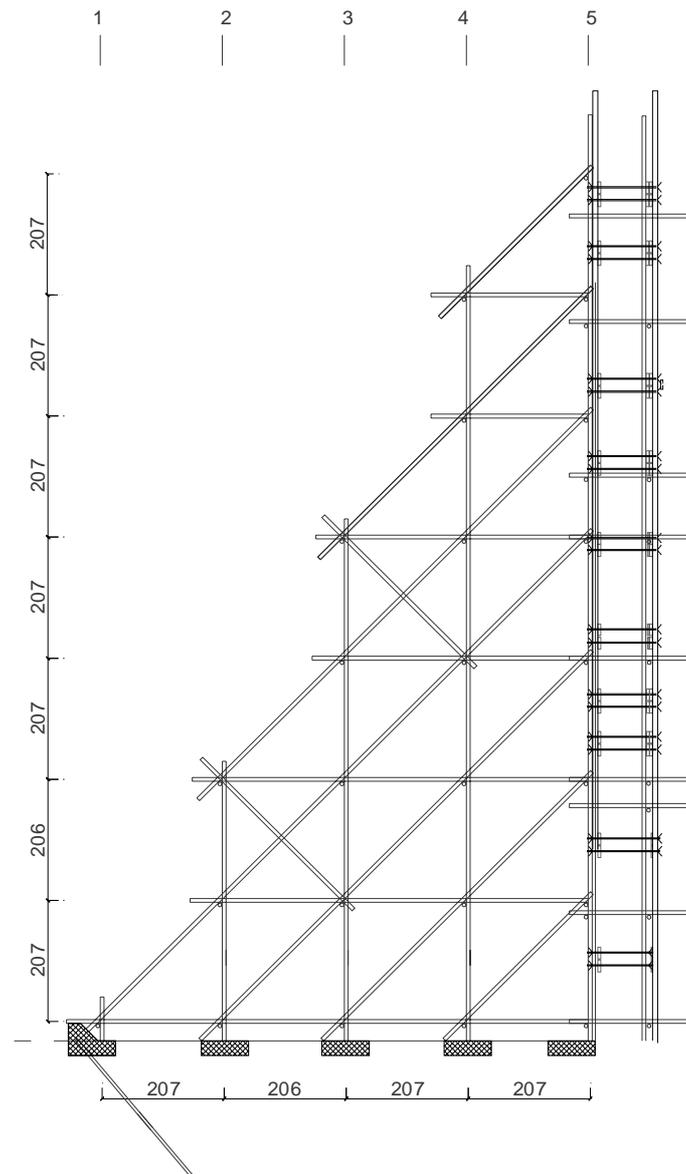
It is also feasible to protect the walls with a tube-shaped steel scaffolding, and the project documentation for particular walls has been made. Proposal for the protection of walls of Priory has been made with a tube-shaped steel profiles as a spatial truss placed on one – face side of the building (Figure 3). This built wall has also been protected from one side only in order to enable easier access and work on rebuilding and reconstruction. As in the previous example, first timbers interconnected by screws had been placed in both directions (horizontally and vertically) on both sides of the wall. This construction was then connected to a tube-shaped scaffolding construction. It has been planned to place large number of anchor blocks, which is allowed by the environment (location) and terrain against which the tube- shaped scaffolding construction is leant.

Figure 3 : Proposal for protection of the wall with a tube-shaped scaffolding with more anchor blocks – only protective construction of the wall is shown

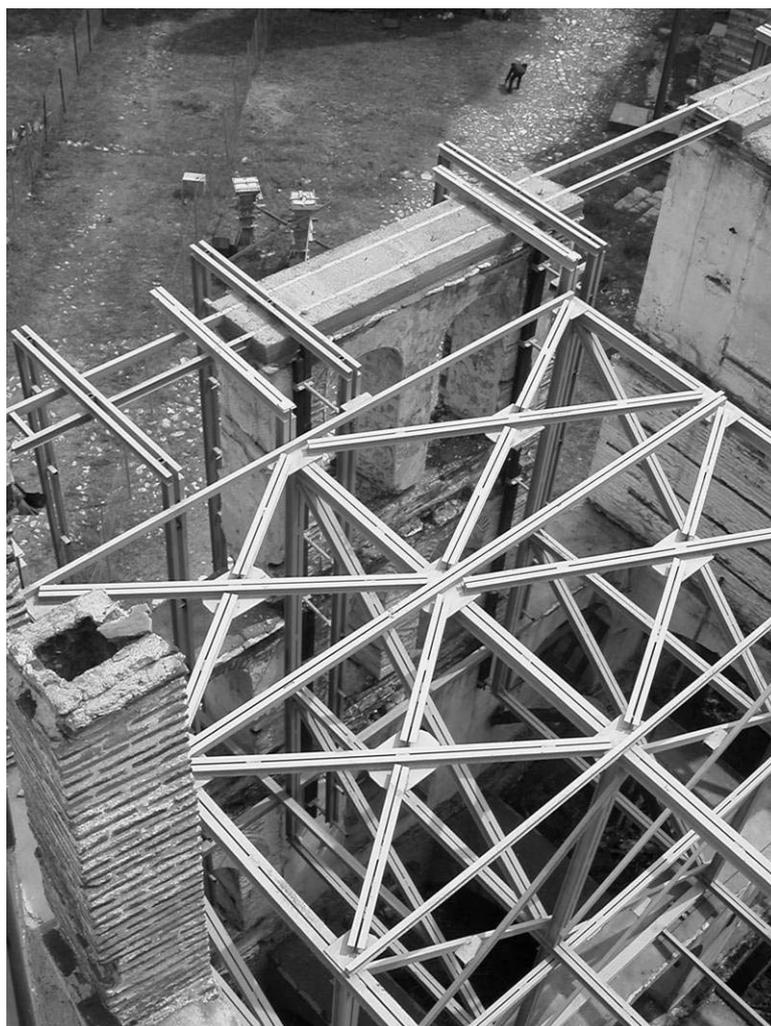
It is also possible to protect the walls with hot-rolled steel profiles; the proof of that is an auxiliary construction installed in order to protect the face walls of Palace (1816 – 1821). This spatial steel construction made of hot-rolled bearers (interconnected by welded joints) links face walls to interior walls. Timbers have been placed on the contact between the wall and a steel construction. Spatial construction within the building has been placed through two stories of the building and it occupies completely the interior of the building. The disadvantage of this construction is that is necessary to use machinery –crane– for its installation and that its spatial position within the building makes work on rebuilding and reconstruction difficult, so it will be necessary to remove it during the operations on the renovation of the building.

Figure 4 : Spatial construction for protection of walls

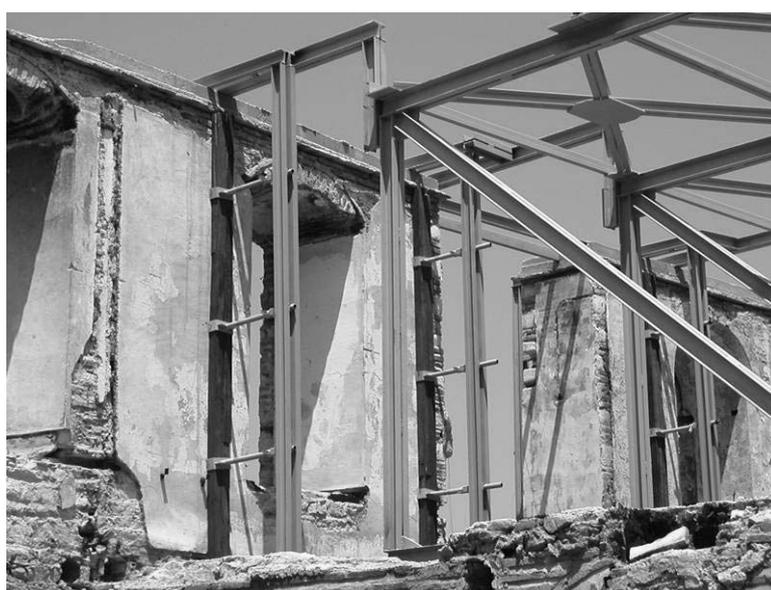
Figure 5 : Way of supporting the walls

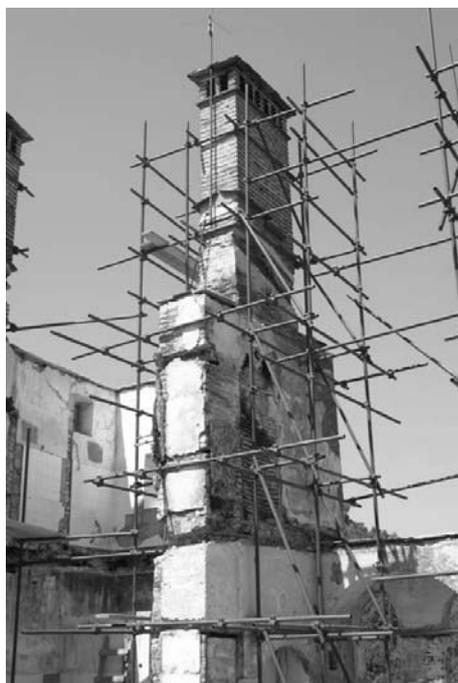
It is feasible to protect high free-standing chimneys which were left alone in space after the fall of surrounding walls with a tube-shaped scaffolding (Figure 6), by building a spatial truss construction around them and connecting the whole structure to a stable part of the building.

Figure 6 : Protection of walls with a tube-shaped scaffolding
