Experimental and Numerical Analysis for the Strengthening Intervention of the Bell-Tower of St. Sisto's Church in Bergamo

Bortolo Balduzzi and Dario Mazza
Municipality of Bergamo, Italy

Diego Papis, Christian Rossi and Pier Paolo Rossi
R.teknos s.r.l., Bergamo, Italy

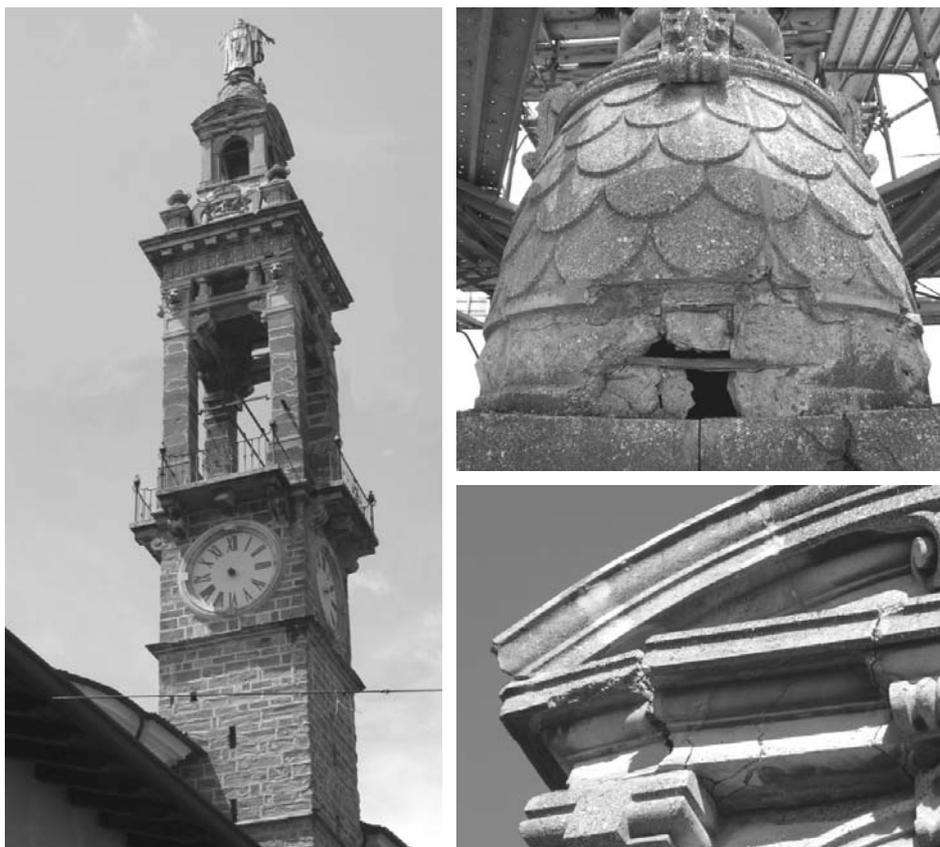
Figure 1 : View of the St. Sisto's bell-tower and particular of the damages induced by the impact of lightnings against the walls.

A view of the upper part of the bell-tower is shown in Fig. 1.

In the last few years, the bell-tower was seriously damaged by several impacts of lightnings against the walls and some decorative elements collapsed. In Fig. 1, some particulars of these damages are shown. After the last impact of a lightning in July 2002, which caused the falling of a concrete decorative globe from the top of the upper cell, the Municipality of Bergamo realized that the structural conditions of the bell-tower were unable to guarantee a satisfactory safety level of the whole structure. For this reason they decided to confine the bell-tower with a strong structural scaffolding and to start a wide program of diagnostic analysis with the aim of obtaining all the information required for a correct definition of the restoration and strengthening design of the whole tower.

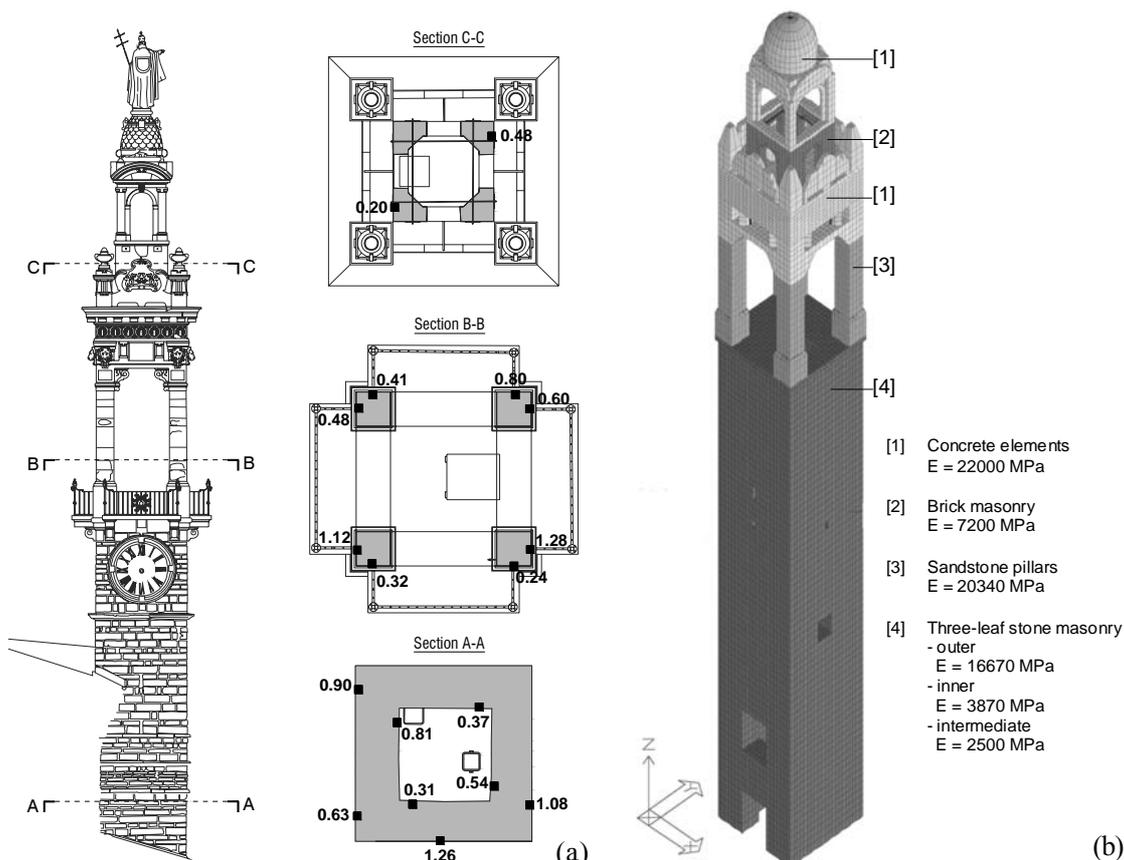
Figure 2 : (a) Values of the state of stress in MPa measured by flat-jack tests; (b) Deformability characteristics of the different materials which compose the tower.

The state of stress of the masonries was measured at different levels by using flat-jack testing technique. Special attention was devoted to the four sandstone pillars at the corners of the lower bells-cell, where an average stress value of about 0.65 MPa was measured, and to the masonry of the old tower where an average state of stress of about 0.97 MPa was measured in the outer leaf and about 0.42 MPa in the inner one. The values of the state of stress measured at the different sections are shown in Fig. 2a (Rossi and Zaldivar Guerra 1996, Rossi 1995).

By using two parallel flat-jacks, the deformability characteristics of the masonries were determined. The masonry of the lower part of the tower (built at the end of XVI century) shows a mean deformability modulus of about 16670 MPa in the outer leaf made with regular stone blocks, and 3870 MPa in the inner one where the masonry is made with bricks and irregular stones; for the filling masonry between the two leaves, a Young modulus of 2500 MPa was estimated. The deformability modulus of the sandstone pillars at the corners of the bells-cell was estimated on the basis of the results of single flat-jack tests; an average value of about 20340 MPa was estimated. The deformability characteristics of the precast concrete elements were determined by means of laboratory compression tests on samples cored by small diamond drilling machine; a mean value of 22000 MPa was estimated. The analysis of the deformability characteristics of the brick masonry pillars which support the upper cell was determined by using flat-jack test; a mean value of 7200 MPa was determined. The schematic view of the materials which compose the tower is shown in Fig. 2b with the indication of the corresponding deformability moduli (Casarin et al. 2004).

The mechanical properties chosen to describe the materials follow the results of the diagnostic investigations described in paragraph 2. The values of the Young modulus chosen for the construction of the numerical model are summarized in Fig. 2b. The finite element model, including 28980 solid elements, was validated both in static and dynamic field by the comparison between the results of the model and those obtained by the experimental investigation (flat-jack and vibration tests).

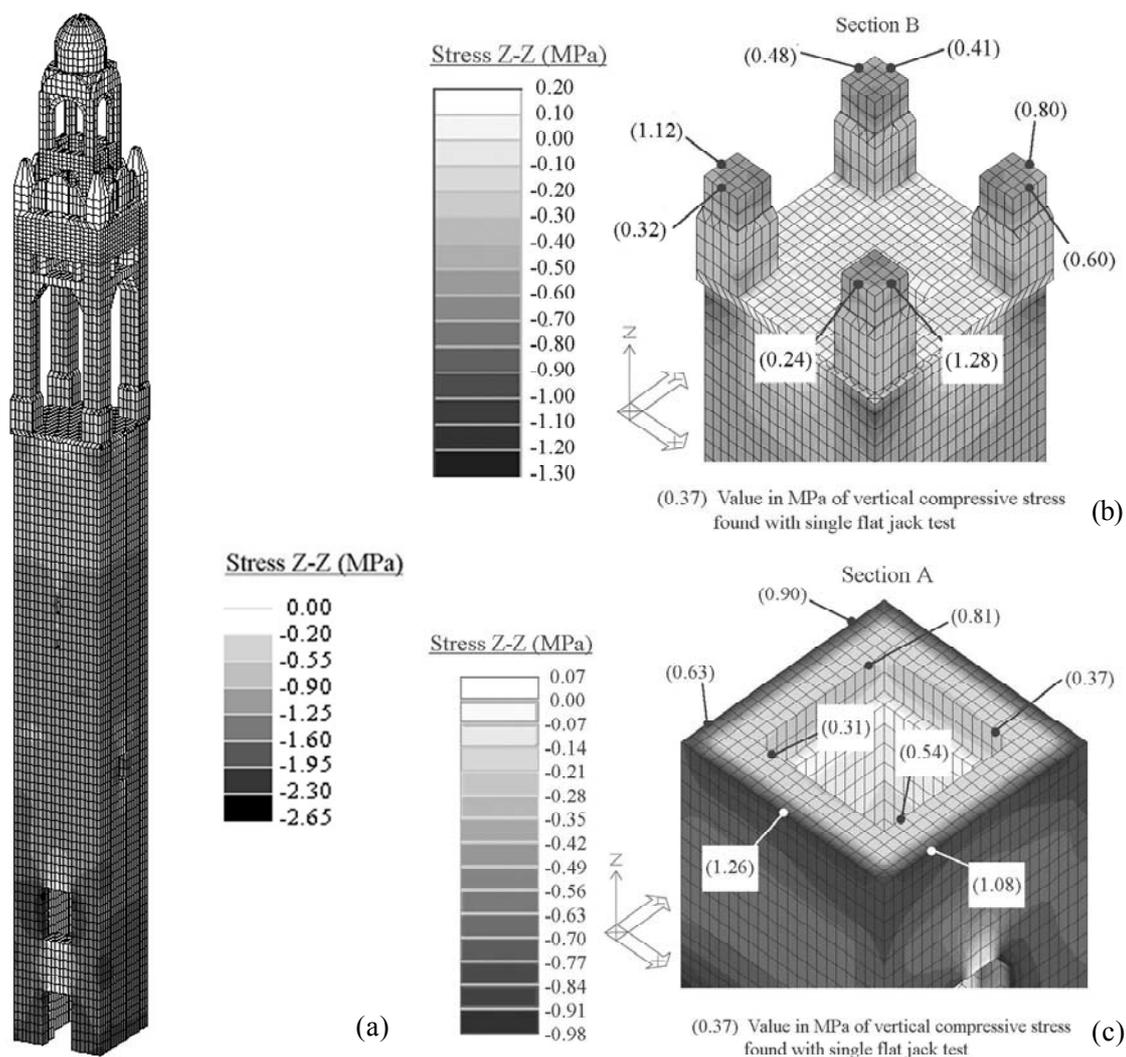
Figure 3 : (a) Results of the static analysis for dead loading conditions; (b) (c) Comparison between the experimental and numerical vertical stresses in section B and A.

The results of the static analysis for dead loading conditions are shown in Fig. 3a.

It can be observed that quite all the elements are subjected to compression and the tensile stresses are quite negligible and may be considered “acceptable” within the limits of the linear elastic analysis.

Fig. 3b and Fig. 3c show a comparison between the values of the state of stress measured by flat-jack test and those calculated with the numerical model. Fig. 3b shows the comparison of the results in the section A of the old tower; in the external surface the mean value of the state of stress measured by flat-jack is 0.96 MPa which is very close to the value 0.91 MPa calculated by the model and in the inner surface the mean value of the measured state of stress is 0.42 MPa which is higher than the calculated value 0.22 MPa. This difference is probably due to local stress concentration in one of the two testing points due to irregular shape of the stone elements. Fig. 3c shows the comparison of the results in section B, at the base of the four sandstone pillars which supports the bells-cell. The mean value of the state of stress measured by flat-jack along the joints between the sandstone blocks which compose the pillars, is 0.65 MPa which is very close to the calculated value 0.62 MPa (Casarin et al. 2004).

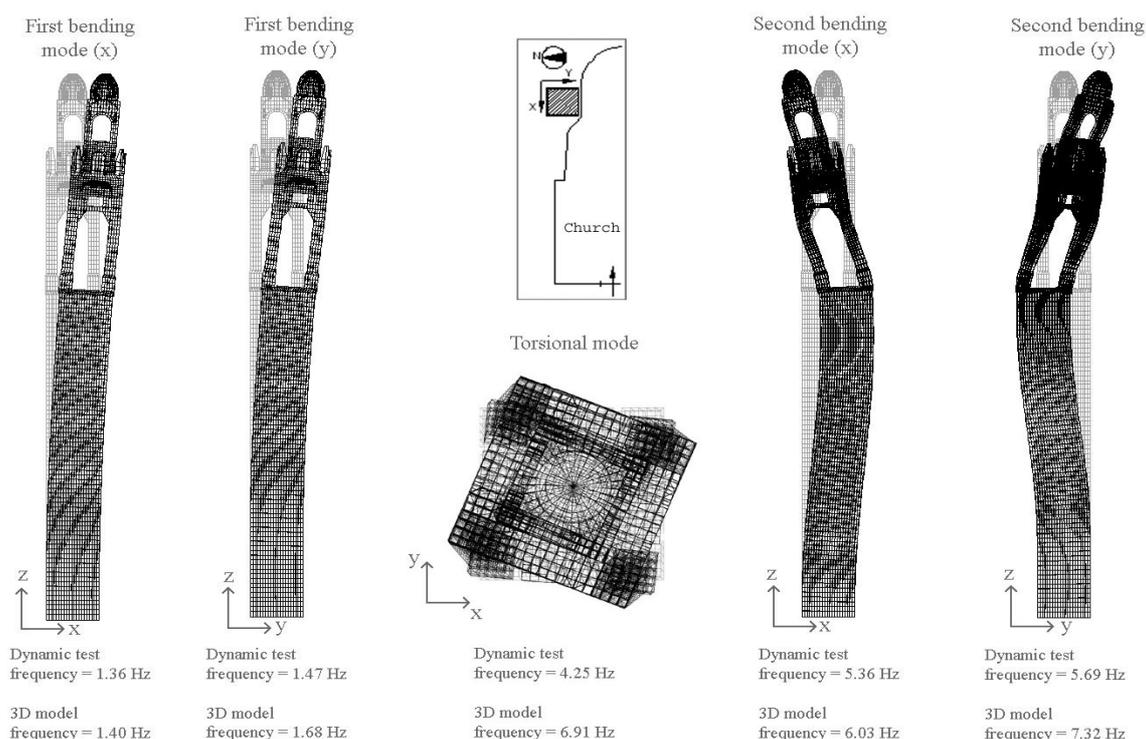
Figure 4 : Comparison between vibrating modes determined by the model and those measured by experimental vibration tests.

termine the first five vibrating modes of the structure. These vibrating modes determined by the model have been compared with those measured by experimental vibration tests, as shown in Fig. 4. As concerns the first two modes, a very good agreement can be observed between the calculated frequency values and those measured by vibration tests. As concerns the three remaining vibration modes, small differences can be observed in the frequency values but their entity is not able to influence in a significant manner the dynamic behaviour of the structure.

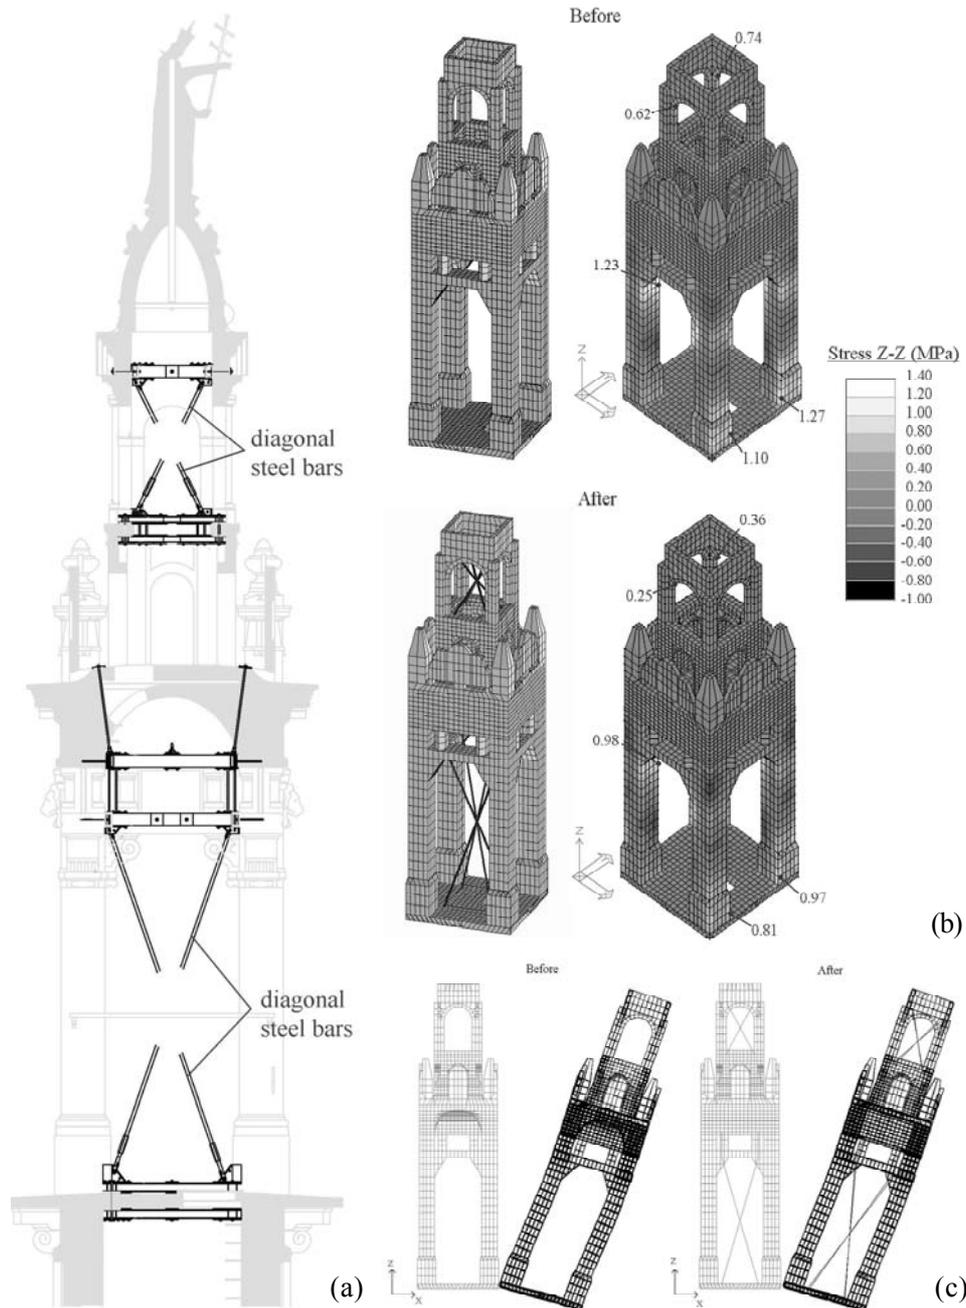
Figure 5 : (a) Scheme of the strengthening solution based on the use of steel frames and diagonal bars; (b) (c) effect of the strengthening structure on state of stress and lateral deformation of the cell.

The scheme of the strengthening solution which was chosen is based on the use of steel frames and diagonal bars, as shown in Fig. 5a. The strengthening of the lower bell-cell consists of two systems of steel frames installed on the base and on the top of the cell, connected each other by means of steel bars with tendons. A similar system of steel frames connected by diagonal steel bars is used for strengthening the upper smaller cell.

reduction of the lateral deformation of the cell, as shown in Fig. 5c. The presence of the strengthening structure sensibly decreases the flexus of the deformation line which was observed with particular evidence in the sandstone pillars of the lower cell before the intervention. As a consequence of the reduction of the lateral deformations, a decrease in the maximum compression and tensile stress values can be observed. As an example, figure 5b shows the difference between the maximum tensile stress values before and after the intervention.
