Static History and Structural Assessment of Masonry Domes: The Treasure of St. Gennaro's Chapel in Naples

ABSTRACT: The paper focuses the attention on an interdisciplinary research programme concerning the preservation of the double calotte dome of the Treasure of St. Gennaro's Chapel in the cathedral of Naples. Recurring to the correlation of archival and iconographical documentation with a precision survey and numerical analysis (3D F.E.M. analysis based on a continuum masonry elastic material), the contribution aims to demonstrate a methodological and interdisciplinary experience which, making use of a deep informative base, puts in evidence structural 'weak points' and problematic nodes for the conservation of the monument.

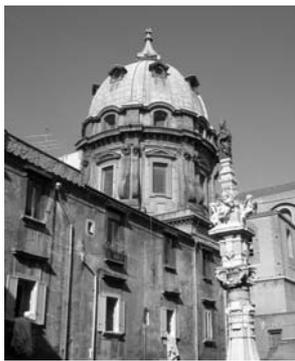
Figure 1 : Naples, The Treasure of St. Gennaro’s Chapel. South-east external side.

Avoiding preclusive attitudes regarding "intuitive" or, on the contrary, uncritically "quantitative" interpretations, the study concerning the Treasure of St. Gennaro Chapel's dome (Fig. 1) has been carried out with a strongly interdisciplinary approach in order to correlate the diachronic history of the monument with the structural behaviour undertaken by itself during past centuries. The complex variability of factors that have been involved in the structural analysis of the dome has not allowed rapid schematizations but it has demanded a punctual and deep analysis of the baroque dome: this also in order to reduce, in the future, any operation, however dangerous, on the ancient structure and in order to direct towards strengthening solutions which have to be compatible with the monument for materials and techniques. The still existing historical documentation, relative to the building site and to multiple, successive consolidation and restoration programmes, has supplied extremely detailed information about the static history of the building: a history of settlements, crackings and proposals regarding the structural and covering elements. It has been possible to construct an articulated database developed during four centuries which has represented an indispensable instrument for the analysis of the dome's present structural conditions. The knowledge of historical strengthening and repairing interventions and, moreover, an accurate knowledge of its geometry obtained by using a terrestrial laser scanning system, have constituted the first steps towards the evaluation of stresses and deformation states of the masonry. The extreme "variability" of ancient materials, whose evolution towards more sensitive and vulnerable progressive stages is well-known, has directed the research group to a "relative" approach rather than to "conclusive" interpretations of structural characteristics of the building. Taking into account that the dome, as explained later, has undertaken during time an architectural configuration extremely different from the initially designed one, the study has turned to distinct interpretative models; particularly, subsequent and significant strengthening interventions have been taken into account which, in some cases, have been only planned while, in other cases, have been effectively carried out with methods recorded in archival documents, too. The "variability" of parameters to consider has appeared very large, indeed; the decay of materials, measurable only by laboratory tests,

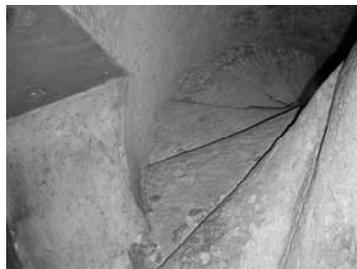
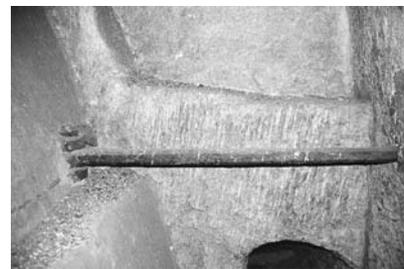
Figures 5(a,b): Naples, The Treasure of St. Gennaro's Chapel.

The spiral staircase in the drum and the double chain which connects the two vaults.

staircase arranged in the drum's masonry (Fig. 5a). Eight rectangular windows, surrounded by grey tuff cornices and standing above the vaults, are placed around the "attic" (Fig. 3b); both the calottes are connotated by a progressive reduction of their thickness which, as surveys have demonstrated, is about 70 centimeters near the upper part of the vaults. Finally, the upper vault's external surface is covered by compacted pumice stone and lead sheets. Perhaps during construction, the internal vault was connected to the external one by eight internal buttresses standing in correspondence of groins; a double circle of pillars, joined by a barrel vault, made up a lantern placed between the two vaults and unloading on a brick "oculus" (circle window), afterwards closed. The keystones of the groined vaults were distant, so, about 3.70 metres. Completed in the stone parts in 1618, the dome is concluded by an external pinnacle, planned by architect Dionisio Lazzari; this latter replaced an heavy piperno and brick lantern after the 1688's earthquake and it was lightened by a wooden structure between 1724 and 1726.

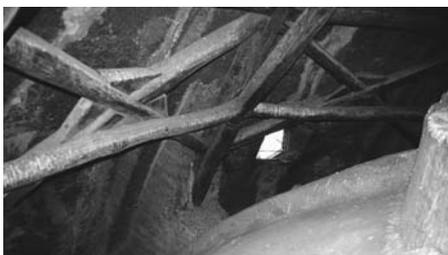
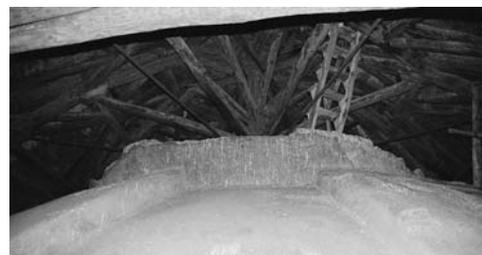
Figures 8(a,b) : Naples, The Treasure of St. Gennaro's Chapel. The wooden truss between the vaults

The aim of this intervention (arch. D. Gallarano, 1724-1726) was to concentrate the weight of the upper vault directly on the pillars of the drum and, consequently, to unload the internal vault from the weight concentrated on its keystone "oculus". Gallarano's aim was obtained with the

demolition of the internal lantern and with the placing of a three-dimensional wooden and iron truss in the cavity between the vaults. Eight timber trusses were connected to a central wooden pier (Fig. 8a), recurring to eight corresponding iron tie-beams, too; the same trusses were connected to the internal buttresses on the opposite side in order to punctually unload the weight of the external dome (Fig. 8b). This latter one was partially covered, at intrados, by a complex wooden carpentry which concentrates upper weights on singular wooden nodes.
