Structural Rehabilitation Historical Buildings Affected by Subsidence in Mexico City

R. Meli and A.R. Sánchez-Ramírez
Institute of Engineering, National University of Mexico (UNAM)

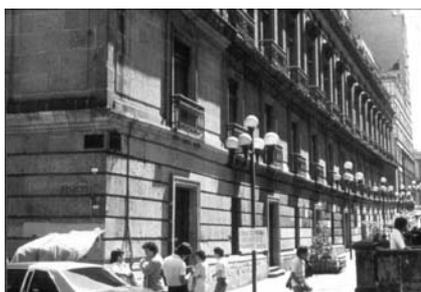
Figure 1 : Great distortion of the old School of Mines without visible cracking in stone masonry

stiffness to generate a uniform pressure on the soil; therefore, they tend to show a typical concave configuration of settlements (Fig. 1); nevertheless, very frequently, the weight of the building is not uniformly distributed over the ground, but is concentrated in its periphery, as in temples of large nave span or in palaces and convents with large internal courtyards. In these cases pressures on the soil are smaller in the central part of the lot than in its periphery, thus generating a convex pattern of settlements which is particularly harmful to the building structure, because it produces an outwards rotation of the supporting walls which adds to that of the thrust of vaulted roofs.

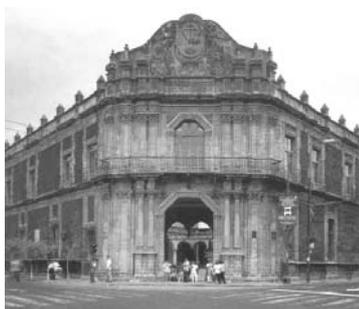
Figure 5 : View of the Old School of Medicine zone is highlighted

The building is located in a corner plot that had a long history of previous constructions; among others, it had been part of the palace of the last Aztec emperor, and in early colonial times, part of the convent of the Dominican friars. Unevenly distributed loads from these previous constructions produced different levels of consolidation of the underlying soft clay layers; moreover, remains of foundations of buildings from different ages were partially taken advantage of, for the foundation of the present construction. This situation set the basis for a long history of significant differential settlements of the building.

The main entrance to the building is on the corner of its two long façades, and leads to the main courtyard, surrounded by arcades supported by solid stone columns (Fig. 6). Around another smaller courtyard, an eastern wing has been partially separated from the main building by means of construction joints, as an attempt to deal with problems derived from differential settlements. Masonry of different kinds and qualities was used in the building: ashlars for columns and arcades and stone conglomerate for walls, frequently with rubble from previous constructions. Floors and roofs were by clay tiles over closely spaced wooden beams.

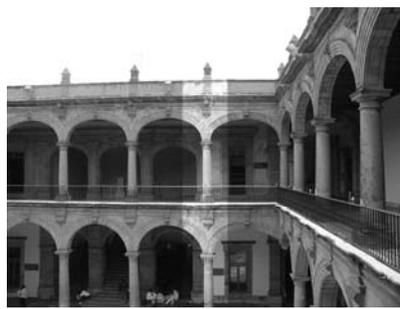
Figure 6 : Arcade of the main courtyard. Damaged
