## Structural Behaviour of a Masonry Wall Under Horizontal Cyclic Load; Experimental and Numerical Study

**ABSTRACT:** This paper presents a numerical and experimental study on the structural behaviour of a stone masonry wall recovered from a house in Faial island, Archipelago of Azores, that collapsed during the 9th July 1998 earthquake. The wall was identified and tested under cyclic horizontal loads at the Laboratory of Seismic and Structural Engineering (LESE) of the Faculty of Engineering of Porto University, to simulate the effects of a horizontal seismic action. In particular, the experimental response allowed accessing the cyclic behaviour and estimation of energy dissipation and ductility capacity of the structure, as well as its strength and stiffness. Afterwards the wall was simulated numerically using a finite element method. The stones and the infill were simulated separately using different behaviour models and the link between the two materials was simulated with joint elements (Pegon, 1999). Finally, the numerical results were compared to the experimental response.

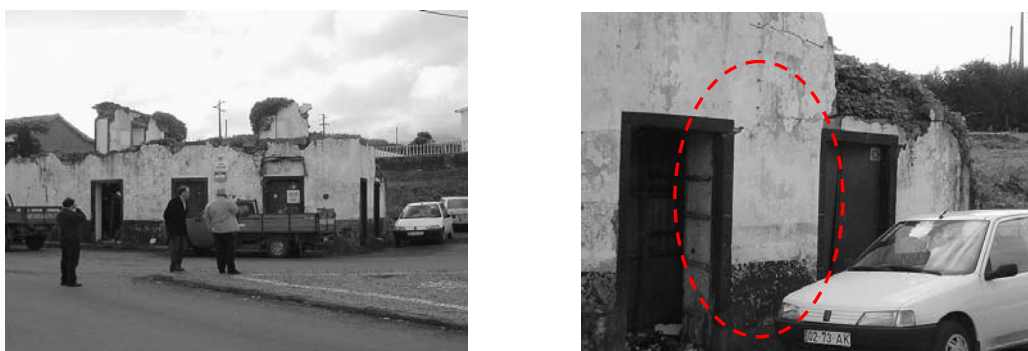
This work presents the experimental behaviour and the numerical simulation of a wall recovered from a two storey house located at the parish of Pedro Miguel, Horta council, Faial Island of the Archipelago of Azores, Fig. 1. The wall was located at the ground floor between two main doors of the house façade.

Figure 1 : Original location of the wall

It is a traditional two-sleeve stone masonry wall with a poor cohesionless infill material as found in most of the old constructions in the Archipelago, with a mortar cover. The wall was transported from its original location to the Laboratory for Seismic and Structural Engineering of the Faculty of Engineering of Porto University (LESE - Laboratório de Engenharia Sísmica e Estrutural da FEUP) by sea, where it was set on a reinforced concrete block. The connection between the wall and this block (foundation) was meant to be weak; a sand pillow was set between

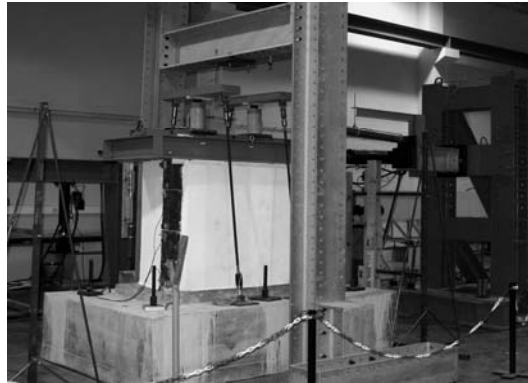
Two hydraulic jacks were set on the top of the wall against a reaction structure linked to the foundation through steel rods, to reproduce the existing vertical load. This system allowed a good distribution of the vertical load applied to the wall. The horizontal displacements were imposed using a hydraulic jack linked on one side to a reaction structure and, on the other, to the wall cap structure through a hinged connection. The wall foundation was connected to the lab floor through high strength pre-stressed steel rods (Fig. 2).

Figure 2 : Wall view and testing scheme.

the two structures. A rigid concrete plate and a steel profile were set at the top of the wall to allow a uniform distribution of the horizontal and vertical loads applied to the wall during the test.

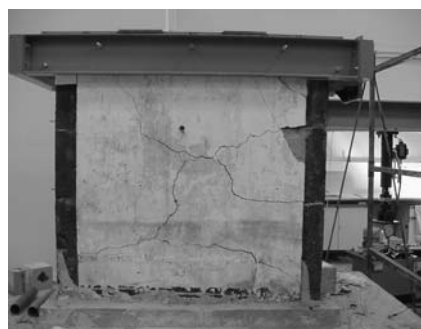
According to the results, damage is concentrated on the joints immediately above the base-ment i.e., spots 5 and 13. This situation expresses a formation of an inclined strut from the top till that position, confirmed by an important crack towards this direction as it can be seen in Fig. 6. It should be noticed that the concrete foundation may have contributed to this result avoiding a higher concentration of damage near the basement.

Figure 6: Wall façade after the experiment.

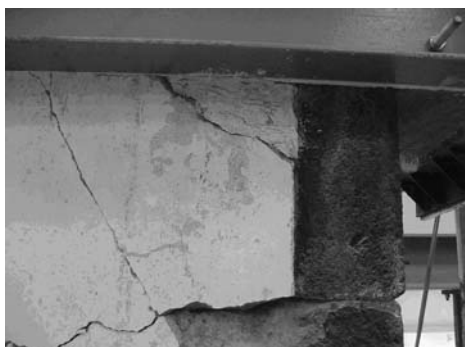
Figure 8 : Damaged area.

The behaviour of the spot 12 can be considered as unusual, comparing with the corresponding spot on the other side of the wall. The behaviour of this joint was in the opposite sense to the expected one. As the cyclical horizontal displacements were imposed, instead of opening (for displacements in the positive direction) and closing (for displacements in the negative direction), the joint displacement trend was always towards closure (almost 2,5 mm). Probably this was due to an accidentally damage before the test at the spot where the LVDT 12 was positioned (Fig. 8). Although the stones were reset into their original position, this measure was inefficient to reproduce the expected behaviour of the wall on that area; the existing link between the materials, as well as the contact between stones was lost. However, the joint at the spot 21

acted as expected, with a closing trend upon horizontal displacements applied in the positive sense and an opening trend upon horizontal displacements applied in the negative sense. This joint showed an opening of  $\sim 0,6$  mm.

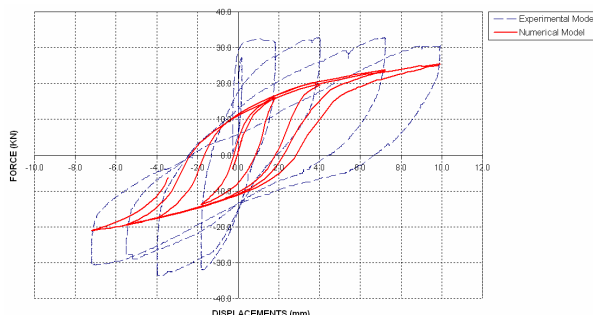
By comparing the experimental results with the numerical ones, it is possible to conclude that the model used to characterize the infill was inappropriate, showing lower stiffness than the one observed at the physical model (Fig. 13). Besides, some properties typical of such kind of walls, such as the link between the materials, could not be reproduced in the numerical model. However, values such as the peak force or the horizontal displacement at two thirds of the wall height are quite close to those achieved during the experimental test. These values show that more accurate results could have been obtained if another type of model had been used to char-

Figure 13 : Numerical and experimental horizontal top force vs top displacement curves.

acterize the infill. On the other hand, the numerical model managed to reproduce the rotations and the horizontal displacements in height of the wall during the test. Besides, the energy dissipation and the forces transmission mechanisms, the sliding surfaces and the blocks movements were sufficiently well reproduced and located through this model too.
