FRP Mesh Technique for Retrofitting Historical Structures: A Proposal

ABSTRACT: Shaking table tests is the most powerful method for assessing the seismic capacity of buildings. The tests can avoid a series of technical difficulties such as the establishment of motion equations of the non-linear system and their solutions. Not only the seismic responses of buildings were obtained from the test but the damages of buildings can be visually observed. A single story dry stack interlocking block masonry building system was designed, constructed on a specially designed shaking table at the Spoornet Laboratory in Johannesburg, South Africa. The building was subjected to a series of simulated earthquake ground motions ranging from minor to severe. The damaged building was repaired and retrofitted using fibre reinforced polymer (FRP) mesh technique, and retested under the similar loading conditions. It was found that the retrofitted structure exhibited more ductile response and better resistance to dynamic (seismic) loading. This paper presents experimental test program, test results, evaluation and conclusions. Based on the test results and performance of the present technique, recommendat

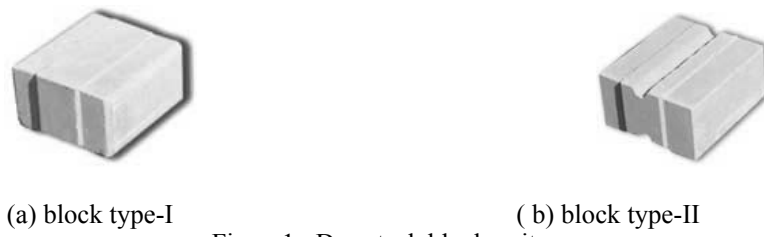
Figure1 : Dry-stack block units

Typical interlocking blocks used in this experimental investigation are shown in Figure 1 (Hydraform 1996). The wall structures were built according to the guidelines given in the Hydraform user manual (Hydraform, 1996). A uniformly distributed roof load of 0.75 kN/m^2 was simulated by placing reinforced concrete (RC) beams on top of the in-plane walls. The test structure before testing is shown in Figure 2a. More details about the test structure can be found elsewhere (Senthivel 2004).

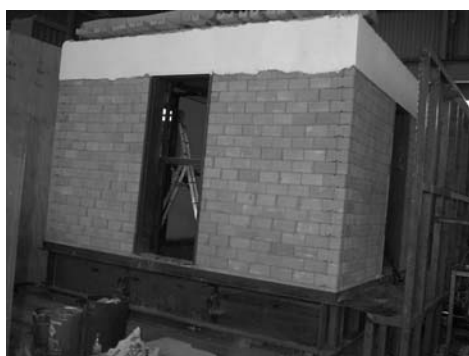
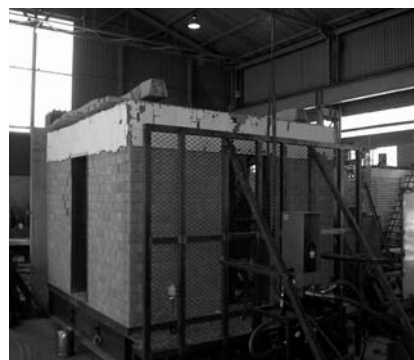
(a) before testing

(b) after testing

Figure 4 : Retrofitted test structure

The structure shown in Figure 2a was tested under series of simulated earthquake ground motions up to failure. Figure 2b shows the structure after the test. The failure was by falling of blocks in the top area and bending. The damaged top courses from the lintel level were completely removed and the mid courses were set right from the out of plumb using a soft hammer, and then top courses from the lintel level were replaced, and retrofitted with a commercially available fibre reinforced polymer mesh/ grid. The mesh was wrapped around the top courses and nailed to the wall using special nails supplied by the manufacturer and plastered. Figure 3 shows a typical method of retrofitting with fibre reinforced polymer mesh/ grid retrofitting Techniques. More details about the retrofitting procedures can be found elsewhere (Richter-GardTM, 2006). The roof load was simulated with the same RC beams and railway sleepers used in the virgin test structure. The retrofitted structure before testing is shown in Figure 4a.

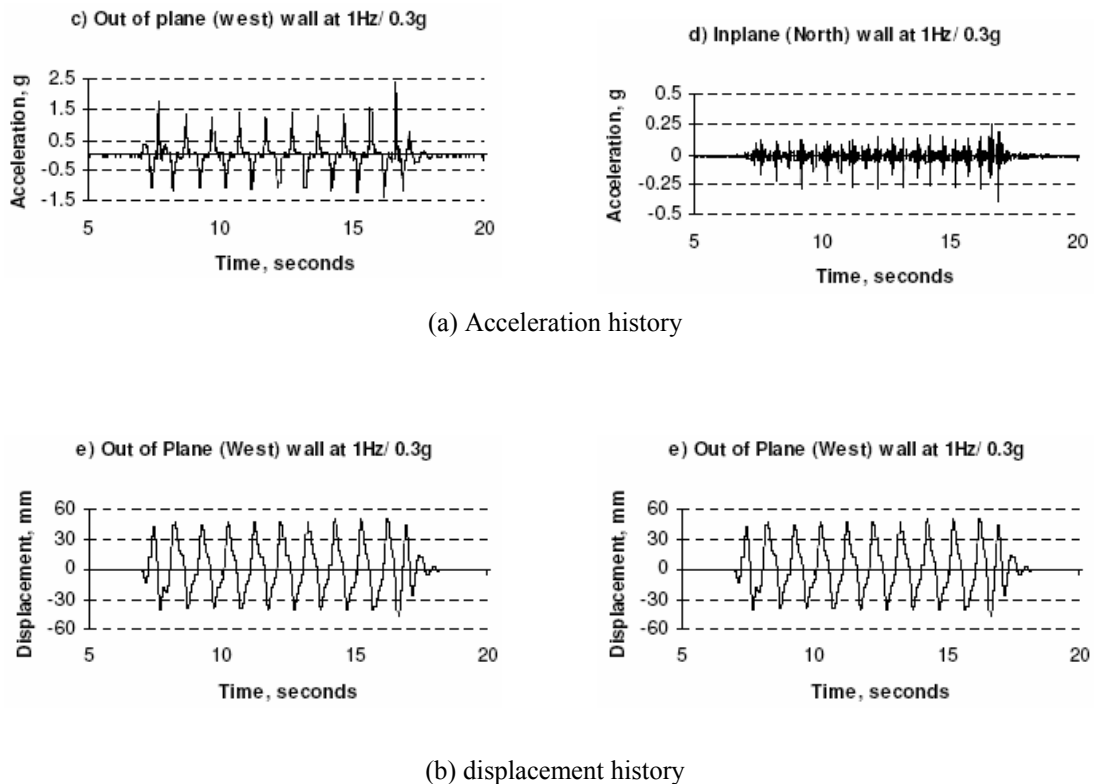
Figure 7 : Acceleration and displacement history of non-retrofitted test structure

It can be seen from the Table 1 that the tests were generally conducted in changing the table displacement with different frequency and acceleration. A trial test shows that the natural frequency of the structure is about 10 Hz. The non-retrofitted structure shown in Figure 2a was subjected to 31 test run as summarized in Table 1a. Test runs 1-7 caused no visible damage. Test run 8 produced hairline cracks on the plastered surface of the out of plane walls. Falling of plaster in some places of out of plane wall was observed after test run 18. Test run 23 caused a diagonal crack on the in plane wall. Widening of the diagonal crack was noticed for the rest of the test runs. Failure in the top courses and falling of units from the out of plane walls was occurred during test runs 30-31 and the test was concluded. Figure 2b shows the structure after the last test run. Figure 7 shows the displacement and acceleration history of in plane and out of plane wall at just one run before failure i.e. frequency, 1 Hz and acceleration, 0.3 g. The damaged structure was retrofitted (Figure 4a) and subjected to 41 test runs as summarized in Table 1b. Test runs 1-13 caused no damage. Initial failures of bond due to excessive deflection at mid span of out of plane walls were observed after test run 14. Openings in the head joint in some places of in plane and out of plane walls were observed after test run 22. The progress of above failure was seen in the subsequent test runs. Major bond failure and separation of mesh and the out of plane wall were seen after test run 41 and the test was concluded. Figure 4b shows the retrofitted test structure after the last test run. Table 2 shows the structural response including peak displacement and acceleration of the structure before and after retrofitting.
