Stability of Masonry Dome: Special Emphasis on ‘Golagumbaz’

ABSTRACT: The paper discusses some of the criteria's for the safety of masonry domes. The case study of ‘Golagumbaz’ is presented where in number of cracks in the meridional and hoop directions are found. The validation of cracks and mode of failure is described with the use of finite element axisymmetric analysis.

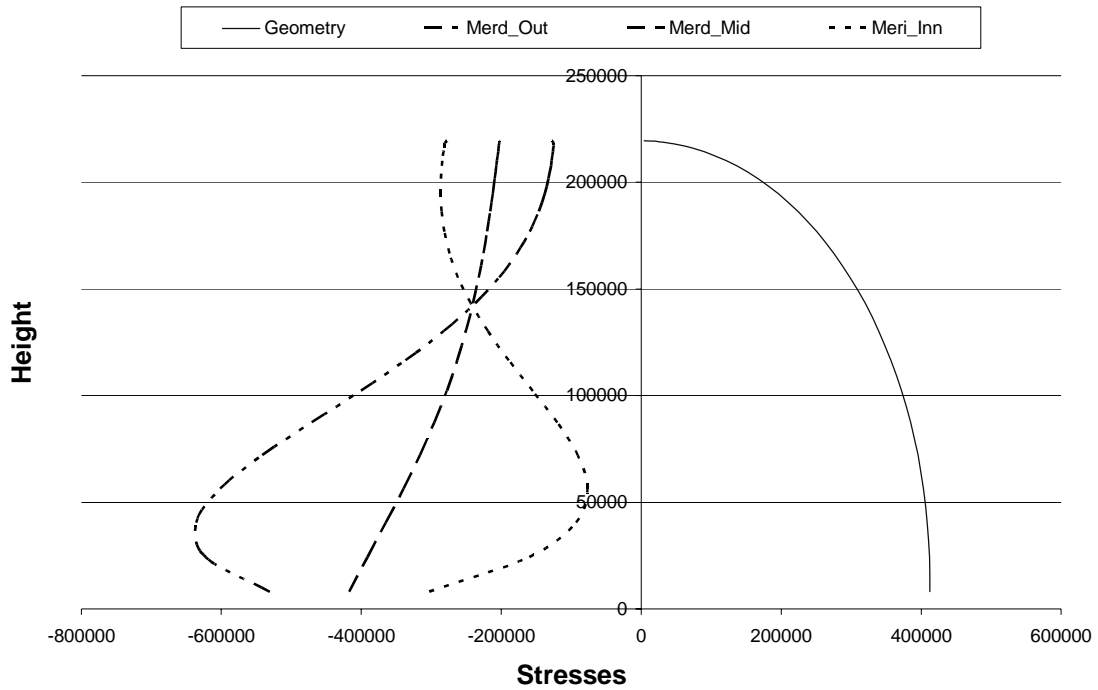
Graph 1 : Meridional stresses.

Meridional Stress: Graph 1 shows the meridional stress at outer face, middle, and inner face in KN/m^2 . The values are also tabulated and compared in Table 1 with the permissible values suggested in National Building Code of India.

Maximum compressive meridional stress of 600 KN/m^2 is observed on inner face of dome at approximately 6 meter height, and at same height on inner face the minimum compressive stress of 100 KN/m^2 is observed.

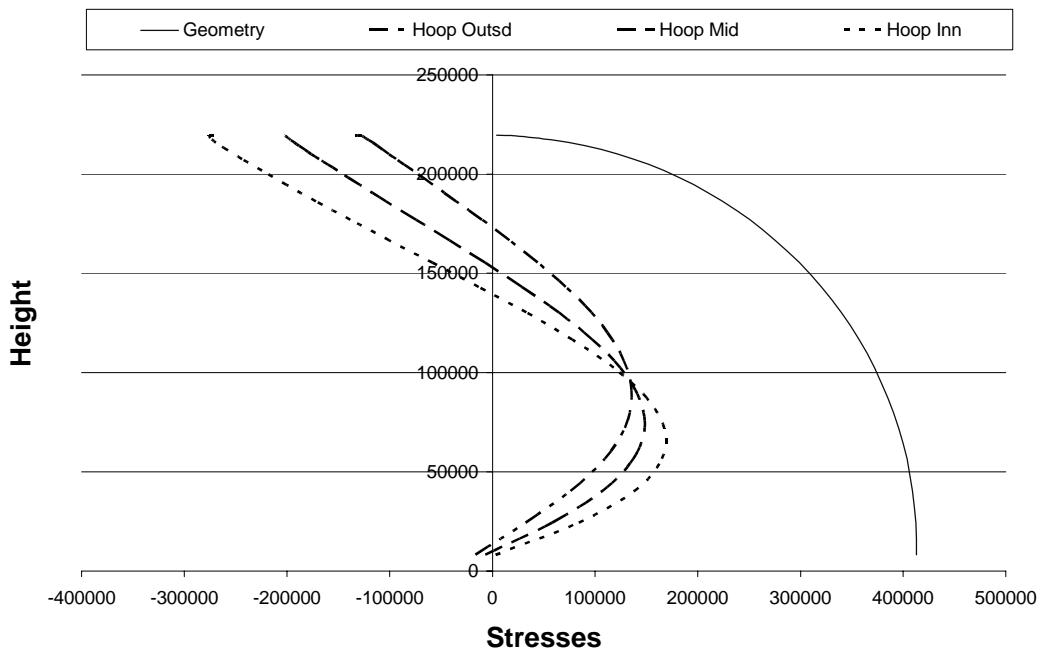
Graph 2 : Hoop stresses.

Hoop Stress: Graph 2 shows the hoop stress at outer face, middle, and inner face in KN/m^2 . The values are also tabulated and compared in Table 1 with the permissible values suggested in National Building Code of India.

Maximum hoop tension of 170 KN/m^2 is observed at about 7 meter height.

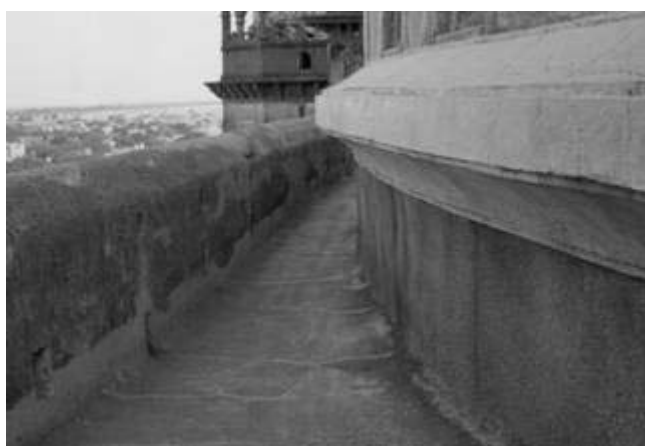
Figure 4 : Hoop cracks in radial direction all around terrace (Base of main dome).

The analysis results shows the maximum hoop tension at the 6.5 meter level where the hoop tension crack is observed in dome from inner side as shown in picture 3. The same cracks are extended to the floor and then to the supporting wall as shown in picture 4. External side of the dome is covered with the Ferro cement /reinforced concrete ^[2] and hence the cracks are not much visible from out side of dome.

In Authors opinion the tension rings or buttresses should be provided in large span Masonry domes; specifically to hemispherical domes. The structure like Gol Gumbaz, Bijapur can now also be provided with the tension rings after cracking to increase the life of structure and to avoid any accidents. The notable example in this regard is that of St. Peter Church wherein the cracks started aggregating and the chains are added afterwards and that stood the taste of time.

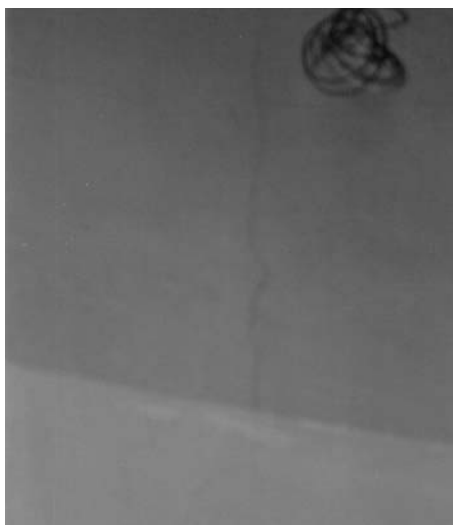
Figure 5 : Showing hoop cracks developed in dome (inner side).
