## A Method for Risk Maps in Archaeological Sites: The Case Study of the Domus Tiberii on the Palatine Hill in Rome

**ABSTRACT:** The paper presents a pilot application, on one of the most important archaeological sites in Rome, The Palatine hill, where an attempt to formulate the risk is carried out. This target is achieved by taking in exam the major possible causes of alterations which a monument can be subjected to: from the decay to the structural damage. The application is carried out on the North West side façade of the roman Domus Tiberii which was covered, in the 16<sup>th</sup> century by a system of retaining walls built up by the Farnese Family, and known as *Farnesian bastion*. In 19<sup>th</sup> century these walls partially ruined, leaving a complex situation under the point of view of historical and archaeological stratification and consequently of design choices, strategies of conservation and structural safety. The results of this preliminary screening yielded to highlight which area can be considered as the most vulnerable, requiring more detailed surveys, structural investigations and archaeological excavations. Finally a restoration and strengthening design wa

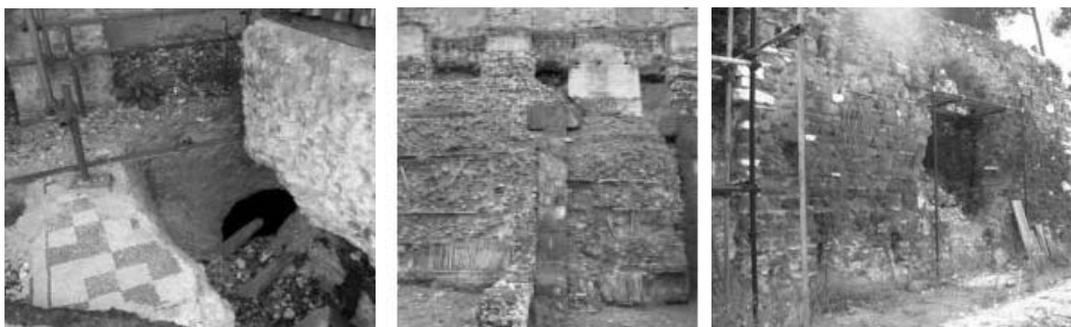
A typical situation of decay, outlining the state of abandon, is the decohesion of roman mosaics of Fig.3 (left), taken in the zone 1. Similarly Fig.3 (centre and right) illustrates the masonry and mortar erosion of external walls of zone 2 and 3.

Figure 3 : Typical examples of material decay (zone 1, zone 2, zone 3)

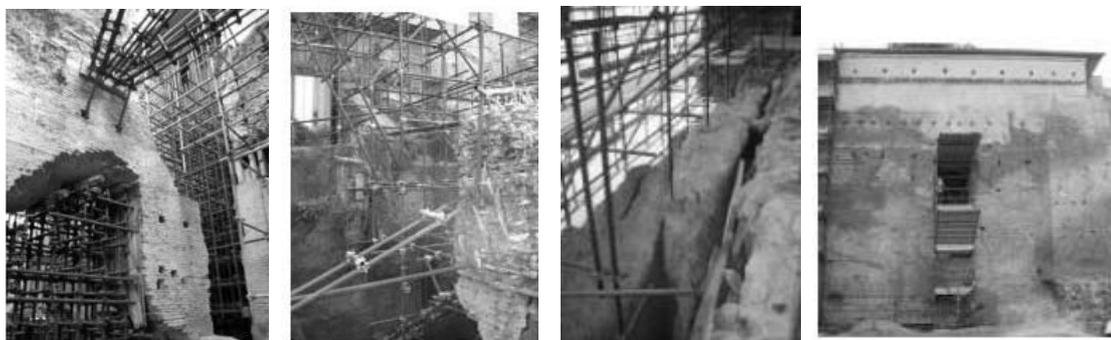
Zone 1 is featured by a system of repeated arches, getting into internal spaces, where the original concrete vaults get lost. The internal partitions are seriously cracked, requiring structural propping for avoiding further collapses. This situation jeopardizes also the external front, subjected to high thrusts weakly balanced.

The second zone, is characterised by an extensive decay of the surface, and conversely by a more contained structural damage. However the structure has lost its original configuration, featured by a system of tuff buttresses thrusting against the wall and hence contributing to the global stability. Moreover the upper part of the wall, filled of earth, debris and vegetations, represents a very high risk for the global safety.

The third zone is the one collapsed in the 19<sup>th</sup> century, when the ruined Farnesian retaining walls of 16<sup>th</sup> century, brought to light a complex situation. The hill is realised by a basement of grey tuff and red lithoid tuff on top, with an intermediate layer of sands, 2 mt thick. The tuff is deeply cracked, and vertical cracks, filled by earth, run the risk to fall down. In this case also, the roman buttresses are partially ruined, without contributing to stabilize the rest of the hill.

The zone 4 (Fig. 4 right), represents the west edge of the Farnesian Bastion, which ends with a sort of bulk buttress, known as Rivellino. This zone is featured by a system of Imperial time arches, walled up in 16<sup>th</sup> century, in order to fill up the internal vaults of earth, and hence creating the upper garden. Similarly to other situations, here the safety level is particularly low, running the risk of structural failures.

Figure 4 : Examples of structural damage of zone 1 (left), 3 (two in the middle) and 4 (right).
