Case Study on a Historical Building Structure Strengthened by CFRP

Xianglin Gu, Xiaojing Yin, Xiang Li, Weiping Zhang
Tongji University, Department of Building Engineering, Shanghai, China

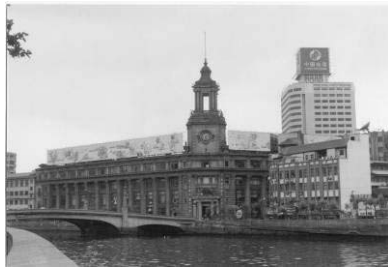
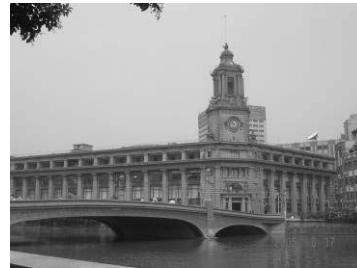
Figure 1 : Building of Shanghai post office

(a) South elevation view before strengthening

(b) South elevation view after strengthening

Shanghai post office building is located near Suzhou River in Shanghai, and takes the shape of a “U” (Figs. 1, 2). It was built in 1924 and it has been used as a post office till now. The reinforced concrete building of four storeys overground and one underground covers an area of 6400m², while the construction area is 25294m². The box foundation is a reinforced concrete structure as well as the turret in the middle of the building. Shanghai post office is protected by Shanghai municipal government for its distinguished classic British building style from 1989 and under national protection subsequently.

The situation of the building after the construction (Fig. 1b) shows that the strengthening method for this historical building in a metropolitan city proposed by the authors is effective and applicable.

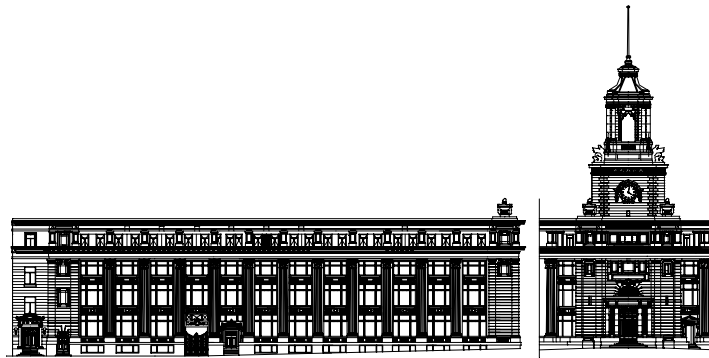
(a) South elevation of the building

All of the drawings of the building were surveyed firstly through in-situ inspection. The south elevation and the forth structural plane of the building are shown in Fig. 2. From the surveyed drawings, it can be seen that reinforced concrete slabs, beams and columns form the structural system of the building. The vertical bearing system mainly consists of reinforced concrete col-

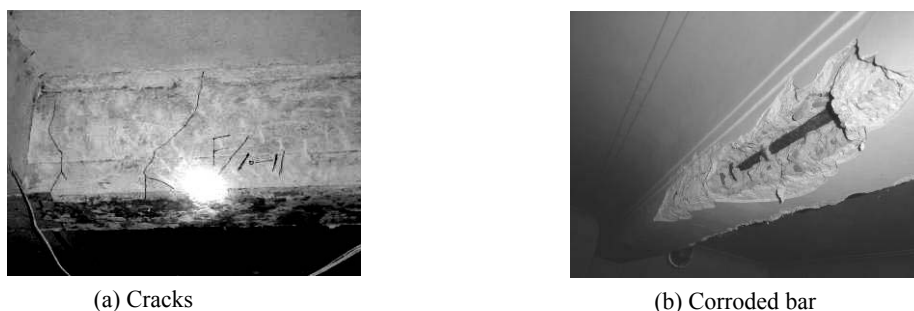
Figure 3 : Craks on a beam and corroded bar in a beam

During the inspection, cracks have been found in the area of 1-4-E-H on the floor surface of bottom storey and the upper and lower surface of the floor in the other stories. The cracking situation is especially severe in the north part of the building, where the maximum width of the crack reaches 1.5mm (Fig. 2b). Most of the cracks on the floor slab developed in the transverse direction of the building. Cracks were found on beams also (Fig. 3a).

The steel bars inside concrete corroded severely, especially in the area of 6-7-E-H of the base room. Some of the steel bars inside the stair beams in the southeast corner of the turret are corroded as well as the bars under the windows in the third storey of the turret. The situation is also severe in the skylight beams and columns, where the longitudinal cracks appear. The concrete on the surface of some parts of the members are spalling and the bars are revealed (Fig 3b).

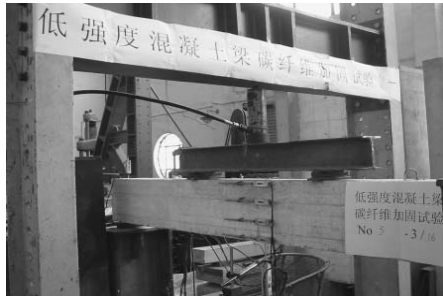
Figure 5 : Test set-up

(a) Loading system

(b) Data acquisition system

16 low-strength reinforced concrete beams were designed and constructed to study the flexural behaviour. The testing set-up and the strengthening method of the beam are shown in Fig. 5 and Fig. 6. The details and the flexural behavior of testing beams are listed in Tab. 2. 14 low-strength reinforced concrete beams were designed and constructed to study the shearing behavior of strengthened beams. The strengthened methods and dimensions of beams are shown in Fig. 7. The details and shearing capacities of the strengthened beams are listed in Tab. 3.
