## Gubbio: Bargello Palace, the Restoration of a Medieval Italian Building

Alessandro Bazzoffia

**ABSTRACT:** Umbria is a territory on which Middle Ages left many extraordinary examples, from palaces to castles, from traditions in the vernacular identity to the conscience of the meaning of the past written on the buildings' stones. At the same time, earthquakes are frequent and strong in this central part of Italy and this make the historical inheritance more vulnerable. The Bargello Palace, a XIII A.D. building in the centre of Gubbio, is a very significative example in order to understand the two directions of a restoration project and its realization.

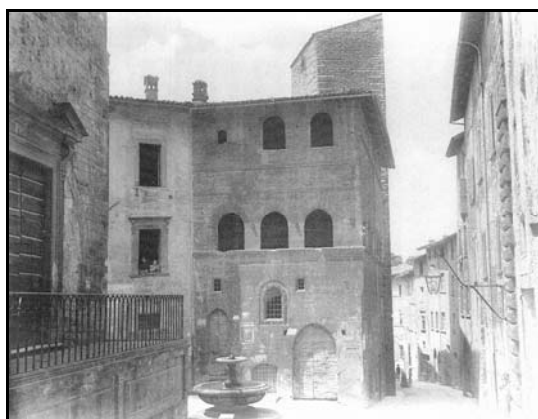
Figure 3 : Bargello Palace at the end of nineteenth-century

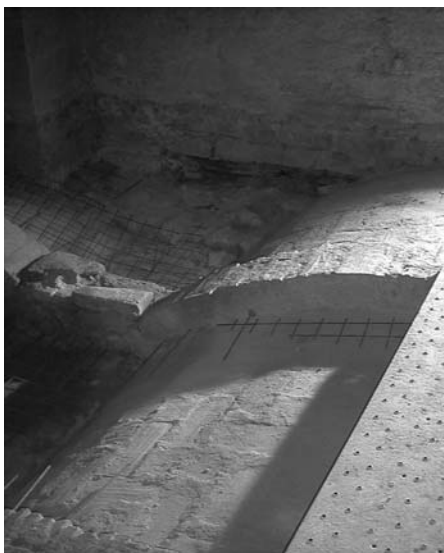
The structural reinforcing works and the extensive damage caused by the earthquake on the 26<sup>th</sup> September 1997, were mainly related to the Palace roofing, the floors and the brick vaults (Fig. 5). The wooden covering structure got decaying as years went by; not only for huge water infiltrations from the ceiling but also for the partial precarious repairs carried out in years.

Figure 5 : Brikvaults reinforcing works

Similarly the brick barrel vaults too, were placed plainly on the ground floor and were reinforced after having been removed and lightened themselves from the top; this helped to keep them in view after their sand blasting and filling with putty.

The extrados lift stage and the reinforcing with special mortars and arc-welded calendered net and anchored to the vaults would assure a better bond tie and a satisfactory structural level of stability and complete finishing with a concrete casting lightened (light cellular concrete) to arrange in the wooden floors of other storeys as well, a small space for pavement technological systems (e.that is the heating “coil” system and the electrical system backs) (Figs. 9-12).

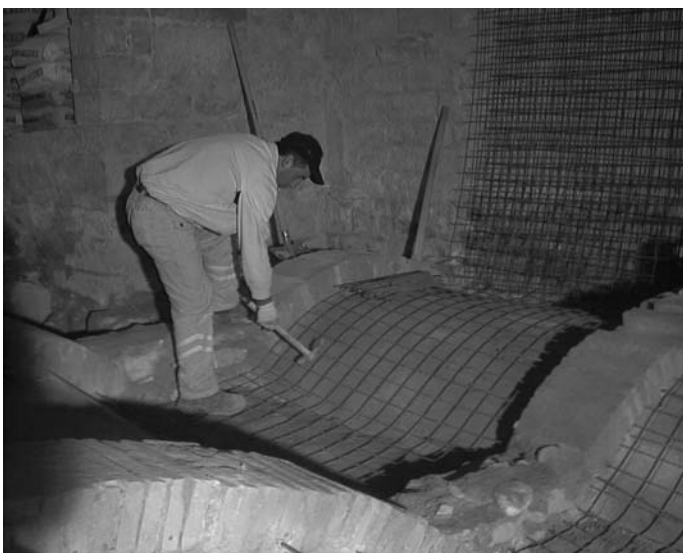
Figure 6 : Ground floor: reinforcing works

The structure needed to be dismantled in order to carry out reinforcements and consolidations with iron extrados beams on to the beams that needed restoration; this helped to let the whole inner ceiling uncovered and to change all the damaged beams (Fig. 6); moreover the string-courses were made in perimetric ferroconcrete and connectors were put inside the rough stone masonry in order to remove the thrust factors from the inside to the outside of the building.

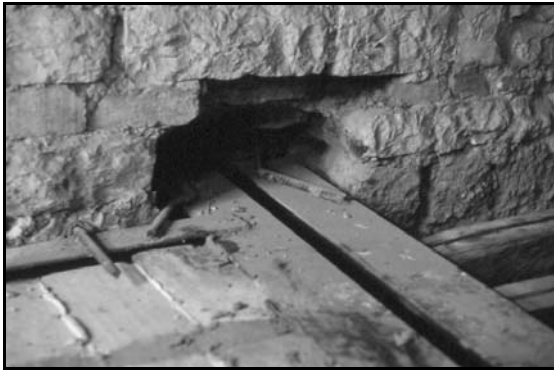
The related steel pins of the beams in the walls and the arc-welded net, partially inserted into the stone perimetric masonry (Fig. 7), would have made the whole structure perfectly connected (Fig. 8).

Figure 7 : Steel pins of the beams in the wall

Even the wooden floors' structure had to conform the existing a-seismic regulation, trough a series of special steel "T" beams, inside slots carried out on the upper part of the secondary wooden frame (original joists) of the floors in order to keep them in view, though extremely warped because of the camber in the middle of the beam.

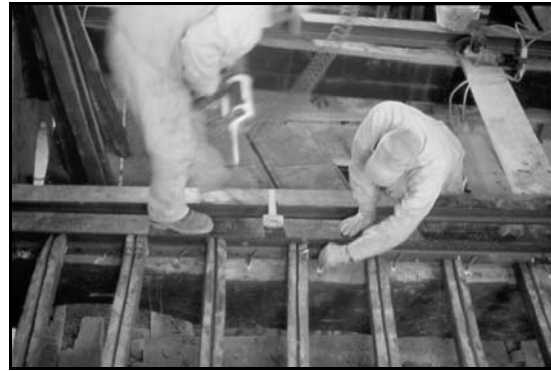
Figure 8 : Wooden floors' structure restoration

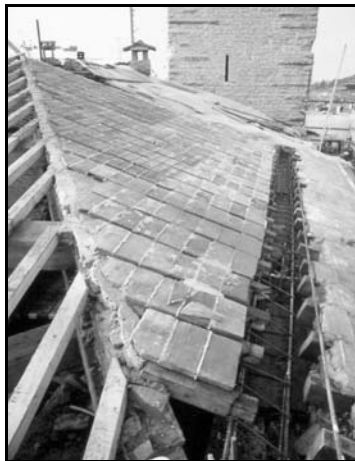
Figure 9 : Anti-seismic adjustment works

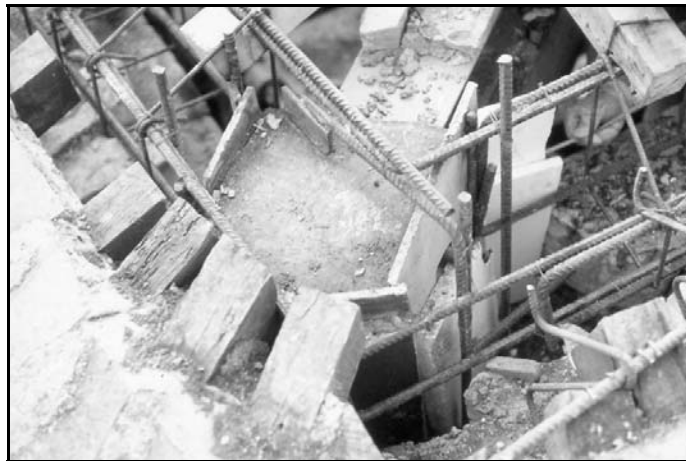
Figure 10 : The roof level

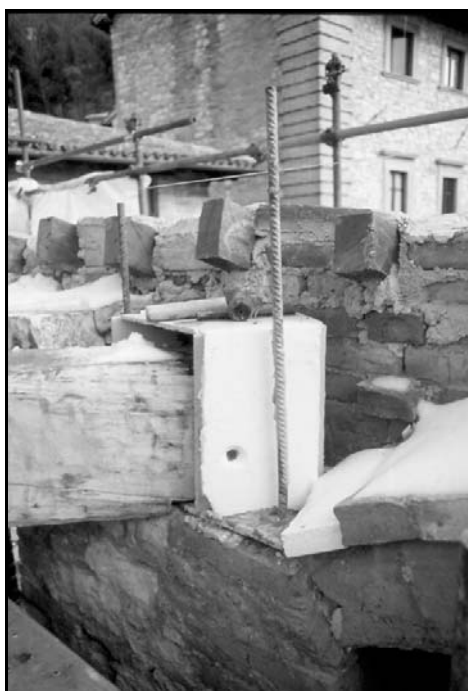
Figure 11 : Connection between roof beams and façade

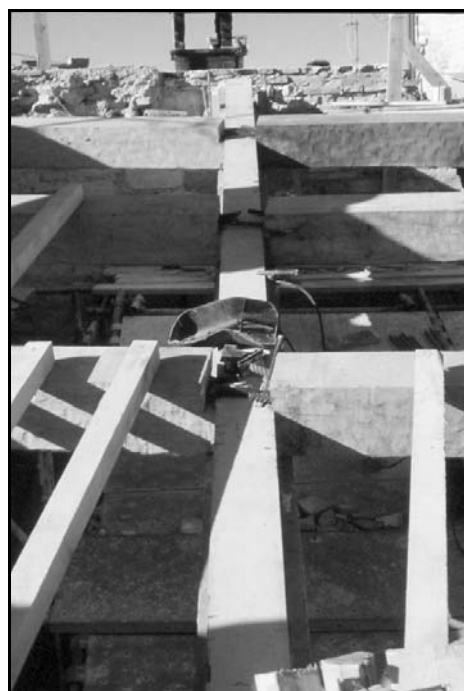
Figure 12 : Reinforcing on the extrados surface

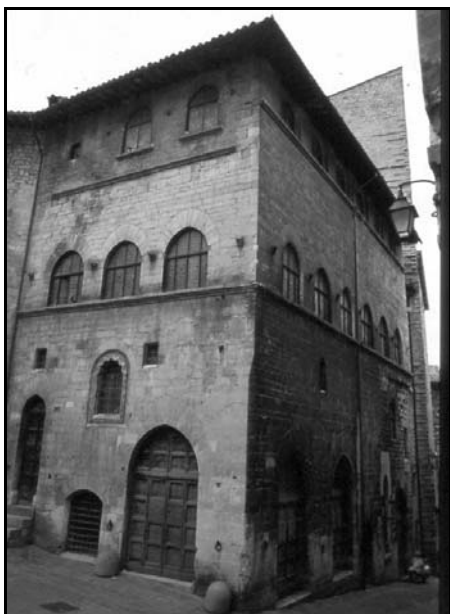
The Bargello Palace's façades needed proper and special conservative restoration works (Fig.13) because there was a lot of decayed stone material, changing colourings because of patinas, sulphations, black scales. All these phenomena begin to cause a sort of corrosion on the surface layers. In restoring the outside constructions (Fig.14), liable to be damaged by atmospheric agents we have followed these preparatory phases:

Figure 13 : Bargello Palace before the restoration

- doing no destructive preliminary tests that were necessary to get a correct choice among the most proper restoration technologies; it was also necessary to get an extensive documentation made of tests such as petrographic researches, to fix chemical features, properties and the nature of stone material which needed to be restored. Than we did a systematic chemical analysis combined to a thermal test of the materials and of the surface encrustations in order to know exactly the level of decay and the causes which produced that. As far as concerning polishing it must be said that the tests on physical-chemical-mechanical and mineralogical properties of the material

and of the black crusts which needed to be removed, were very important; it was also very important to know how to detect and set up consolidating and protection were needed. In fact it was essential to know the crystal structure of the stone we had to intervene on; the chemical nature of crystals, the cementation level, compactness, porosity, nature and pollutants coming from the air and the water that reacted on to the original crystal stone. The deposits detection was chiefly concentrated on the most protected areas from beating rain and washing away, but it was also discovered, at different heights of the building, on some areas not directly exposed to the rain;

- previous consolidation to avoid pieces of material, already detached, could be lost during the restoration phase;
- an accurate polishing to take away the surface dirtiness, caused by the atmospheric carbonious parcel and clear water soluble-salts (such as sulphates, chlorides, etc.) of the stone that were present not only on the surface;
- filling with filler and sealing slots and craquelures;
- stone reinforcement with proper consolidating material;
- final protection of the stone layers with proper products largely tested and therefore completely reliable.

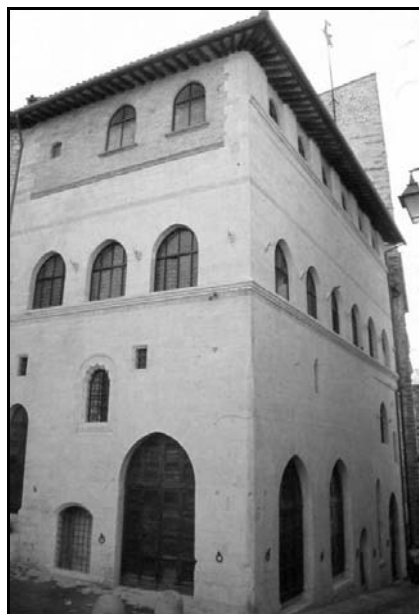
Figure 14 : Bargello Palace after the restoration

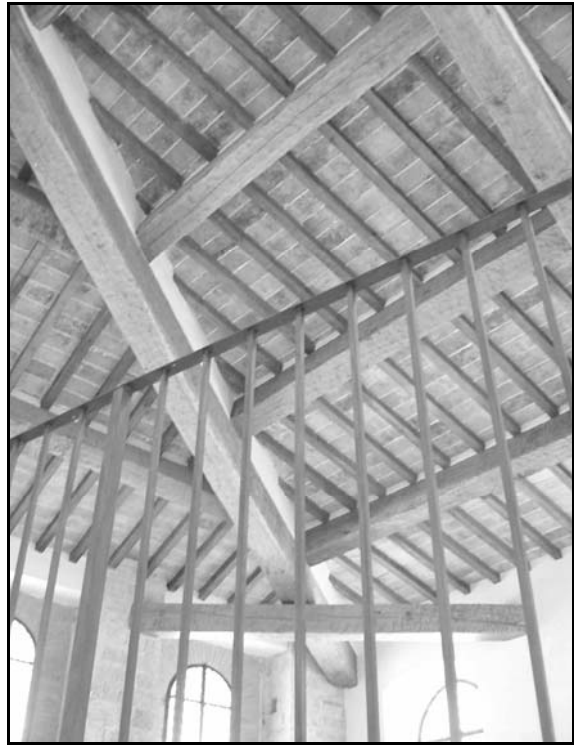
Figure 16 : the restored wooden covering structure
