## FE Modelling and Material Characterization of Tahir ile Zühre Mescidi, Konya, Turkey

**ABSTRACT:** The aim of this study was to investigate the structural behaviour of a historic monument in relation with its material characteristics. For this purpose, Tahir ile Zühre Mescidi in Konya, Turkey, a 13<sup>th</sup> century brick-masonry structure, was chosen as the case study. The basic physical and mechanical material characteristics that need to be defined in the FE modelling were determined through a series of laboratory material tests. A 3D-FE model of the superstructure was constructed using commercially available structural analysis software SAP2000. Smeared joint method was used to model mortar-brick interfaces. The model was first analyzed under dead load, wind load, and snow load. The behavior of the 8 centuries old structure under normal service conditions was simulated and performance approved by the analysis results. Secondly, a concrete coating layer was simulated over the dome and the temperature induced forces and strains at the interface were studied. The crack formation and delamination that a concrete coating might cause was simulated.

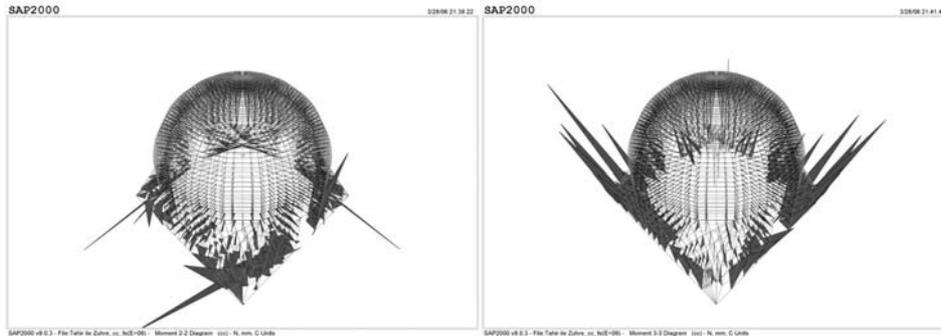
The bending moment diagram obtained for the link members between dome and concrete cover is an indication of shear developing between the two layers (Fig. 7). Shear forces between the two layers is maximum at the squinches region as an indication of the most probable location to start the delamination process. The maximum stresses developing in the cover concrete also shows the maximum tension stress zones in Fig. 8. Tensile stresses in the order of 3 MPa cannot be tolerated by the cover concrete and cracking-delamination is inevitable. Simulation of delamination by reducing the  $I$  value to semi-rigid zone ( $I=10^8 \text{ mm}^4$ ) in the critical sections results in small reduction in the stress levels, critical link members and the stress distributions remain the same; therefore, excessive damage is required to change the stress distribution.

Figure 7 : Resulting 3D moment diagrams in 1-3 and 1-2 directions, respectively (under dead load and 40°C uniform temperature load;  $I=10^9 \text{ mm}^4$ )

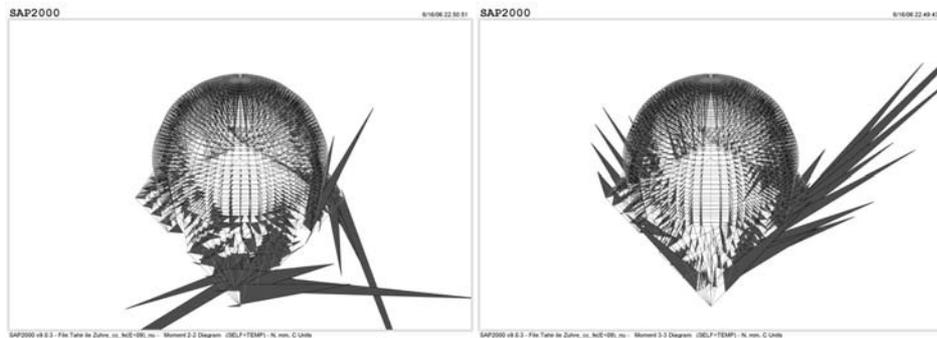
Figure 14 : Resulting 3D moment diagrams in 1-3 and 1-2 directions, respectively (under dead load and  $25^\circ\text{C}$  randomly distributed temperature load;  $I=10^9 \text{ mm}^4$ )
