# Earthquake Analysis of Historical Church of St. Sergius and Bacchus, Istanbul-Turkey

**ABSTRACT:** Conservation and preservation of the historical buildings are the common heritage of the human beings. There are a considerable number of massive historical structures in Turkey and they are mostly located in the earthquake zones throughout the country. Some of these buildings were severely damaged during the destructive recent earthquakes. Earthquake resistance analysis of such structures is a contemporary subject and has become a very important issue in the recent years. As every historical building is unique and being built by different materials and has different structural behavior it is vitally important that each structure should be examined and analyzed individually. In this research, the oldest historical structure in Istanbul, “The Church of St Sergius and Bacchus” is analyzed as a case study. This study includes a survey of the original design of the building, destructive and non-destructive material tests, soil tests and finite element analysis due to vertical and earthquake loads.

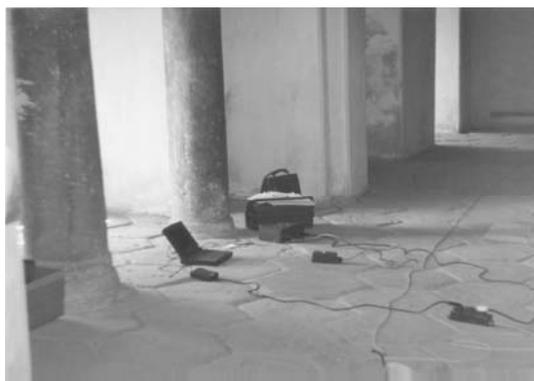
Figure 6 : Free vibration measurements of the Church of St. Sergius and Bacchus (Readings at the gallery floor).

To define the actual the structure of The Church of St. Sergius and Bacchus, a set of free vibration measurements were made. These were carried out on the gallery floor and at the dome ring. (Fig. 6). Free vibration measurements were taken by a seismometer, signal conditioner, analogue- digital converter and a laptop computer.

During the tests, the vibrations of the structure were determined with a seismometer connected to a signal controller, hence, the analog signals received from this mechanism are digitized with a digital converter loaded to the laptop and finally the data are directly recorded to the magnetic media. The modal vibrations of the structure are determined with the help of these vibration records. As a result, the three frequency values measured are 4.47 Hz, 5.15 Hz and 5.65 Hz.
