Case Study of Masonry Pillars Reinforcement in a Medieval Church

Piotr Rapp and Piotr W. Sielicki

Poznań University of Technology, Institute of Structural Engineering, 5 Piotrowo Sq. 60-965 Poznań,

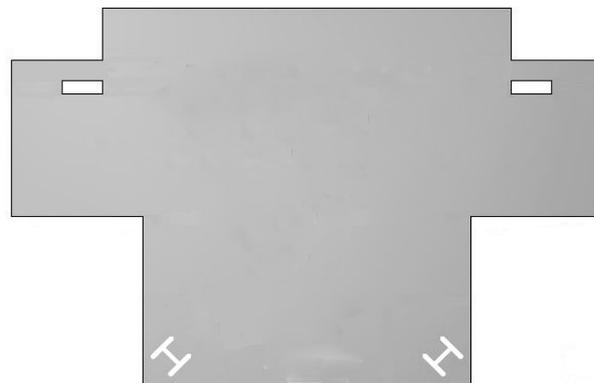
Every pillar was reinforced with four steel profiles, inserted between units and mortar. Every bricks in each of pillars was marked. The next phase involved at taking out bricks with regard to the pillars load carrying capability and with the aim of putting reinforcement section. Finally, the marked bricks were inserted in their original places. The reinforcement was made with using two HEB-100 sections and two steel flat-sheet $140 \times 50 \text{ mm}^2$ in each of the pillars, see Fig. 3. Steel elements were connected with the masonry by means of rib anchors and glue. The anchors were placed in previously drilled holes and special mortar was injected under pressure. Computational model was created with regular shape, see Fig. 4.

Figure 4 : Cross section of the pillar model with reinforcement

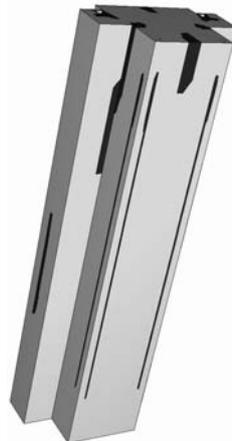
The study of the model has been carried out by comparing the numerical analysis and polish standards calculations. The results are coincident. Conclusions confirm that ultimate capability corresponds with the sudden decrease of strain energy. The third variant show, that the improvement of ultimate force increase ca. 1.8 time. Crack propagation in the third variant is presented below at Fig. 10.

Figure 10: Crack pattern in of reinforced model
