Multi-Hazard Risk Management for Heritage Buildings: Case Study Buranhpur Fort

Nirmita Mehrotra

Apeejay School of Architecture and Planning, Greater Noida

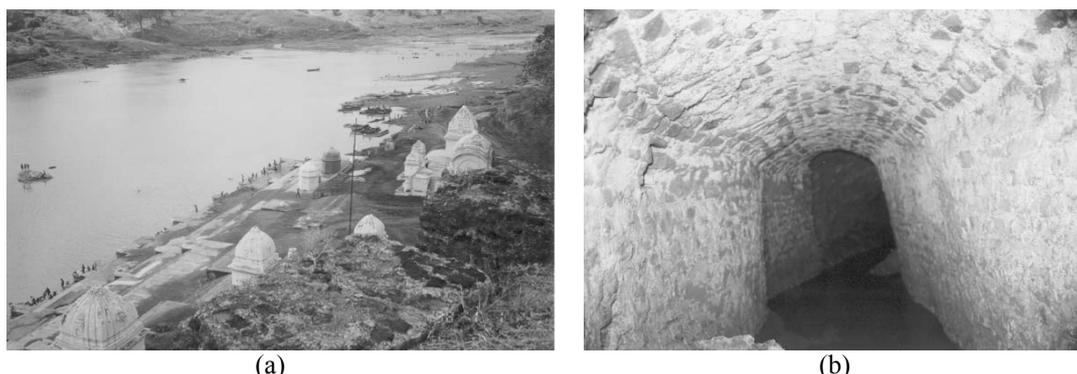
Figure 1 : (a) View of Tapti river with Raj ghat, recently renovated (b) Tunnels of Khooni Bhandara, the Persian underground water supply system water was collected from satpura hills and distributed through tunnels against gravity by making use of siphon system.

This gateway of Southern India amid Satpura Ranges on the bank of river Tapti, relish footprint of dynasties from almost 150 BC. Physical structures shows evidence of layers of settlements drowned and vanished under debris and then rehabilitated over period of time. The imperial Fort located at the river bank is a seven storied structure, whose lower floors have become inaccessible due to centuries collection of mud heaps, which also gives ideas about the instability of these floors. Town has underground water supply system based on Persian Technology, which collects water from beneath the hills and tap into well like siphons distributing it through the city.

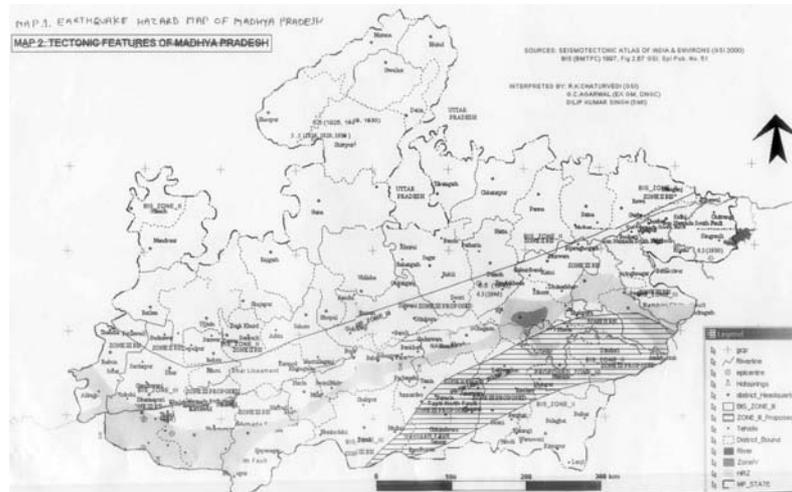
Figure 2 : Vulnerability status map of Madhya Pradesh

According to this qualification, zone III, which covers the central part of the state along Sonata - Tapti Valleys can get a maximum intensity of MM-VII. Classification as high risk depends on following factors:
