Non destructive and laboratory evaluation of strength of decayed wood members in a historic construction located in Gorgan (North of Iran)

ABSTRACT: The House of Bagheri is one of the most important buildings in Gorgan city (North of Iran) which is a tourist site and the House is a Cultural Heritage Construction. Solid wood was utilized extensively for structural members in association with other traditional materials. It has been exposed to natural environmental conditions for a long time, so some faults have developed including decay of the wooden members. The mechanical properties of decayed members have been measured in laboratory tests and the buildings have been non-destructively evaluated. Samples from the buildings were prepared which are representative of the whole structure. Flexure and compression tests were then performed on these samples. The results of NDE (nondestructive evaluation) tests on the samples were correlated with those on the buildings.

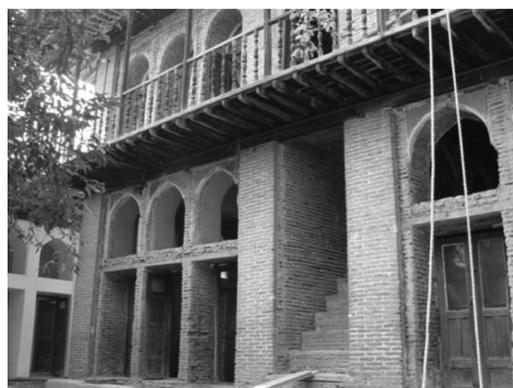
Figure 1. A view of the House of Bagheri.

The building is a collection of several main parts and yards. A small pool is located in the centre of each yard surrounded by buildings. Although there is a one-storey building in this complex, it is mainly built on two-stories with a few steps between floors (Fig. 1). The buildings have nearly the same architectural characteristics and the plan of one building is shown in Figure 2.

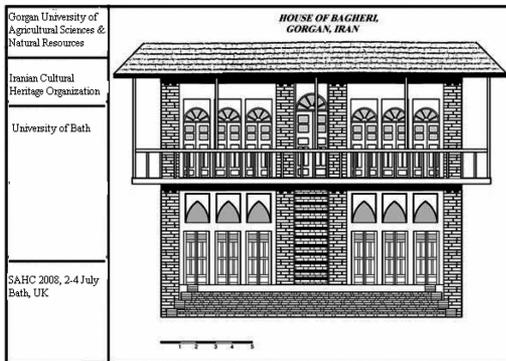
Figure 2. A plan of one building of the House of Bagheri.

This building possesses a rectangular structure and used construction materials which were essentially brick and cob in the shear walls and solid wood in the principal structural elements. Its main defects have been previously reported by Madhoushi & Eimanian (in press). Degradation caused by weathering (sunlight and rainwater splashing), decay and insect attack have led to damage and faults in the building. It is now under repair and most defective structural elements have been substituted by new members.

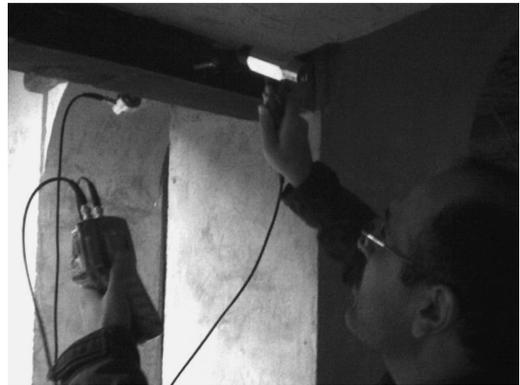
Figure 3. Measuring the transmission time of stress waves.

A nondestructive study was conducted using an IML[®] electronic hammer in order to produce stress waves in wooden members. Eight accessible structural elements were selected as representative of the whole structures (since the building is under repair, access to most of elements was not possible) and the transmission time of the stress waves were measured at three point on each sample in order to define the area of decay (Fig. 3). At each point, the instrument provides three readings.

The measured transmission time of stress waves indicates (Table 1) that 50% of samples are totally decayed and that 12.5% of samples are slightly decayed. Only about 25% of the samples can be considered as sound or nearly sound. Finally, 12.5% of samples are extensively decayed and distorted and contain fractures so that they cannot be reused. These samples are termed “unusable”.
