Strengthening of an industrial cylindrical shell damaged by a collision

ABSTRACT: This case-study concerns an old industrial reinforced concrete shell structure at the port of Antwerp. The building serves as a pilot for stowing of shipped steel and wooden products. A fork-lift hit one of the supporting columns. The impact of the collision caused the concrete to crush and the internal reinforcement to shift considerably. Some of the internal reinforcement yielded or broke. Temporary supports had to be placed to avoid collapse of the total structure. The stress situation is analyzed. A FEM model was built to gain insight into the stress distribution in the shell structure. In comparison with the undamaged situation, membrane forces, shear forces and moments did strongly increase which explains the actual damage. A solution is worked out to repair and strengthen the damaged part of the structure. The FEM-analysis demonstrates that a compression arch will arise in the top of the barrel shell to span the displaced support. This requires a tension member at the bottom side of the concrete barrel. Therefore, externally bonded reinforcement is applied to increase the tensile capacity of t

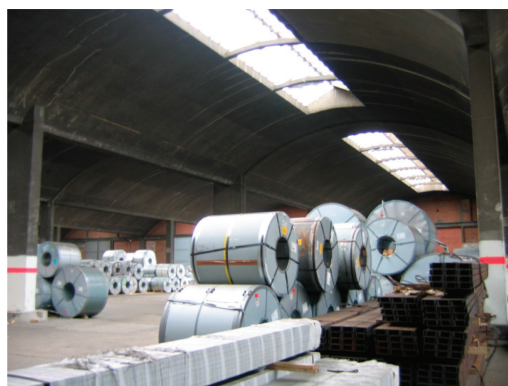
An old industrial reinforced concrete shell structure (1955) at the port of Antwerp in Belgium is used as a pilot for stowing of shipped steel and timber products, Figure 1. This shell needs a strengthening after a collision of a fork-lift with a supporting column.

Figure 1. The shell construction.

The reinforced concrete structure consists of a sequence of 25 cylindrical barrel shells, supported by reinforced concrete columns. The span of each shell is 15 m. Each shell is supported by 3 columns at both sides. The thickness of the shell decreases from 13 cm at the abutment till 8 cm at mid span. In the mid part of each shell, a longitudinal roof light is located. In

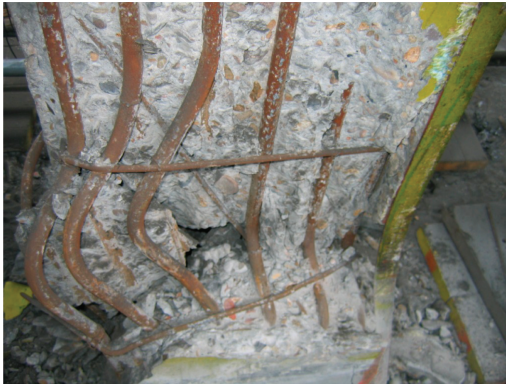
Figure 2. Damaged column, December 2004.

December 2004, a fork-lift hit one of the 6 meter high concrete columns, Figure 2. This accident was not the first one, Figure 3. In November 2007 a new accident occurred, 4.

The settlement of the column and the crack formation were studied (Figeys and Van Gemert 2006). Measurements showed a horizontal displacement of about 14 cm at the impact location of the damaged column, Figure 2. The corresponding vertical (downward) displacement of the shell support equaled approximately 8 cm. This differential settlement resulted in severe cracking of the supported shell structure. Fortunately, only the two neighboring half parts of the shell were damaged. The roof lights in the top of the shell avoid force transfer to the other half of the shell.

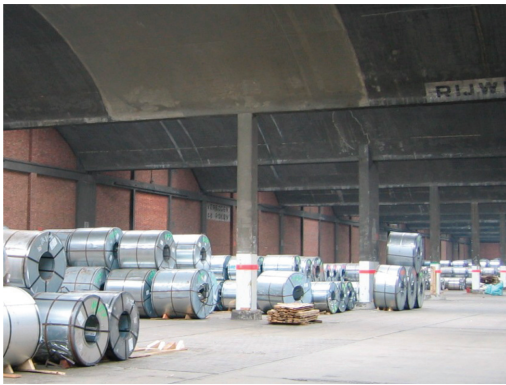
Figure 3. Damaged column in the past.

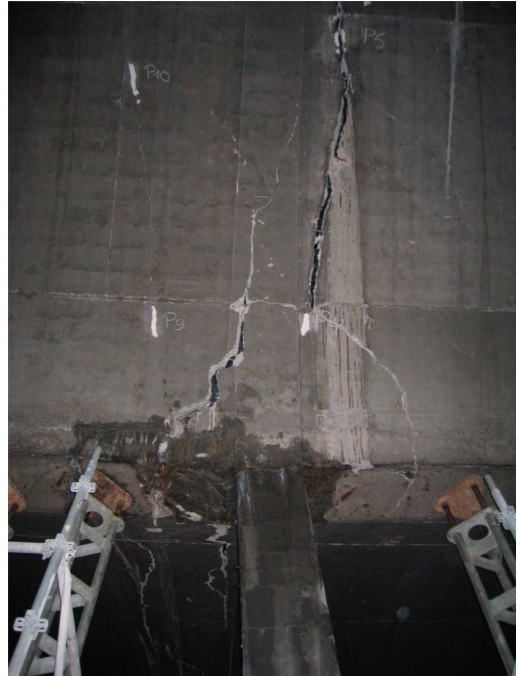
Figure 4. Recently damaged column, November 2007.

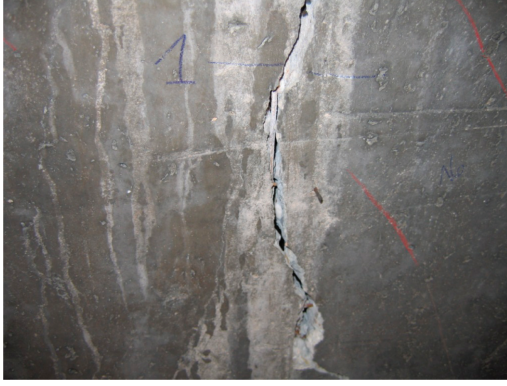
At different places, the full concrete shell cross-section is cracked. The maximum crack opening was almost 20 mm, Figures 5 and 6. The cracks start from

Figure 6. Crack above the damaged column with a maximum crack opening is 19.8 mm.

Close to the column, the mean crack opening is $\Delta l_b = 15.9$ mm. The strain in the steel bars can be estimated by this elongation. Taking the anchorage length as the original length, the strain is equal to Equation 5. The anchorage length can be calculated according to Eurocode 2, Equation 6.

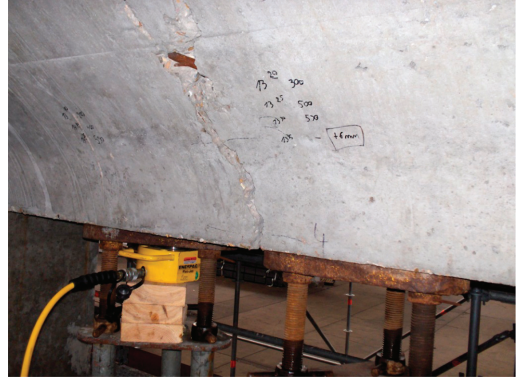
A method to repair and strengthen the damaged part of the structure was studied and executed. The FEM-analysis demonstrates that, due to the vertical settlement of the support, a compressive arch developed in the shell, that spans the displaced support. In order to restore as much as possible the initial stress-strain situation, the structure is jacked up, Figure 11.

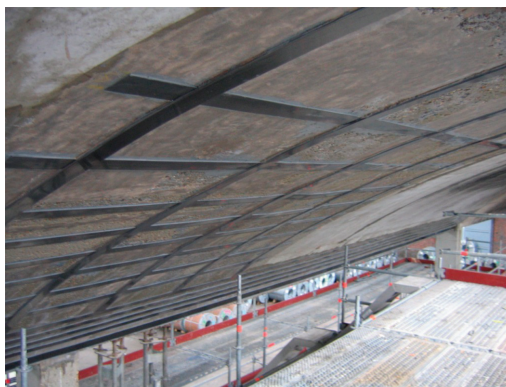
The strengthened shell construction is shown in Figure 14. After reconstruction of the damaged part of the column, Figure 15, the temporary supports were removed.

Figure 14. Strengthened shell construction.

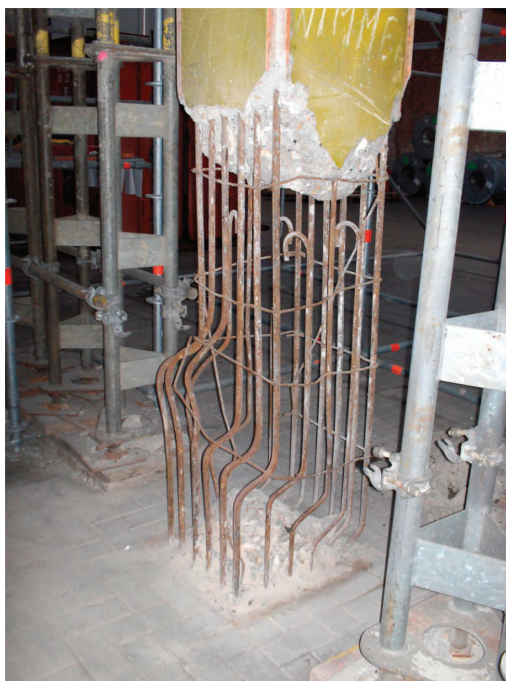
Figure 15. New reinforcement and concrete for damaged part of the column.
