Experimental results on the use of mud-based grouts to repair seismic cracks on adobe walls

ABSTRACT: This paper presents the main results obtained during an ongoing experimental test program performed to explore the possibility of repairing structural cracks on adobe walls through the injection of mud-based grouts. The structural objective was to attempt to recover the original strength of severely cracked adobe masonry elements by repairing them with mud-based grout injections. Masonry strength was first estimated with indirect tension tests of adobe sandwiches and later measured with diagonal compression tests of adobe masonry small walls. It was decided to study the use of grouts prepared with sieved soil alone or stabilized with lime, cement, and gypsum. The test results showed that grout injections based on the original soil used to build the walls are effective in restoring completely the original strength of adobe walls which had endured significant seismic damage. It seems, therefore, that a new criterion for the conservation of earthen buildings in seismic areas could be formulated, using compatible materials for the restitution of the original seismic strength of the ea

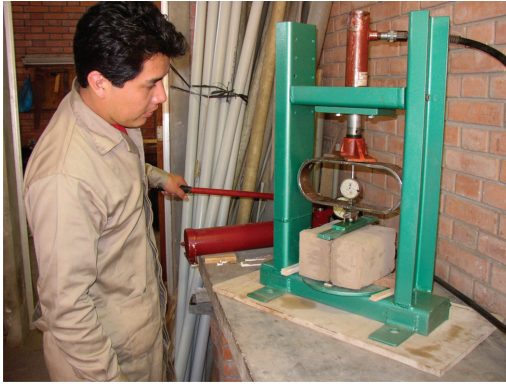
Figure 1. Device developed to perform indirect tension test on adobe sandwiches.

The indirect tension test consists of vertical compression of a “sandwich” of two adobe blocks joined by mortar, forming a vertical and centered joint (Fig. 1).

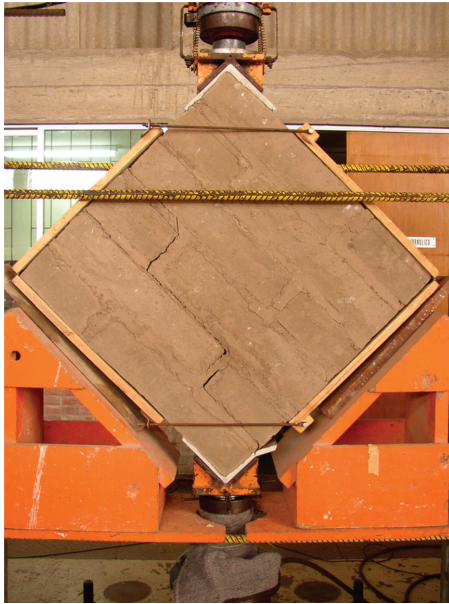
Figure 3. Diagonal compression test of adobe masonry.

In this test, a square sample of masonry is subjected to a compressive force in two opposing corners (Fig. 3). The behavior of the specimens is representative of the seismic behavior of adobe masonry (Vargas et al. 1986), but the test is elaborate and costly, so it has been used only to test the most efficient grouts. The distribution of force is similar to that which occurs in the indirect tension samples and so, the type of failure expected is a crack between the points of application of the force, generated by the dominant tension stresses.

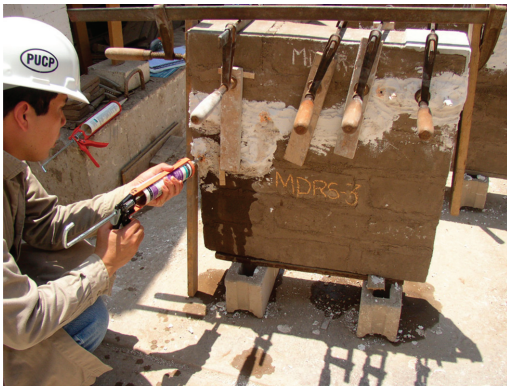
Figure 4. Repairing wall specimens through injection of mud-based grout.

After testing, the failed specimens were transported to a repair area, and were placed in their “natural” position (horizontal rows) to have gravity acting as it does in real walls. After being repaired through grout injection, and drying for 3 to 4 weeks, depending on the weather (Fig. 4), the samples were moved to the laboratory to be tested again under diagonal compression.

2. Inject water into the holes. This procedure is to prevent the fine material on the inner surface of the cracks from insulating the injected grout. It also seeks to provide better lubrication for the injection of the grout and increases the moisture in the crack walls, decreases the rate of drying and reduces the formation of micro-cracks in the filling material.
3. Immediately inject the grout from the bottom up, through the holes. Grout is injected through a hole until the material has reached the level of the next higher hole and begins to escape.
4. Remove the gypsum seal and retouch the outer surface of the injected fissure to achieve an acceptable finishing.
