Application of non-destructive techniques at the Katholikon of Dafni Monastery for mapping the mosaics substrata and grouting monitoring

ABSTRACT: The Katholikon of Dafni Monastery, one of the most important monuments of the middle-byzantine period situated near Athens, has suffered severe damages due to the 1999 earthquake. Several studies have been engaged, in order to collect all relevant data of the internal masonry structure and that of the mosaics substrata by applying non-destructive techniques, such as Ground Penetrating Radar (GPR) and Seismic techniques including tomographies. In some areas these techniques have been used both before and after grouting.

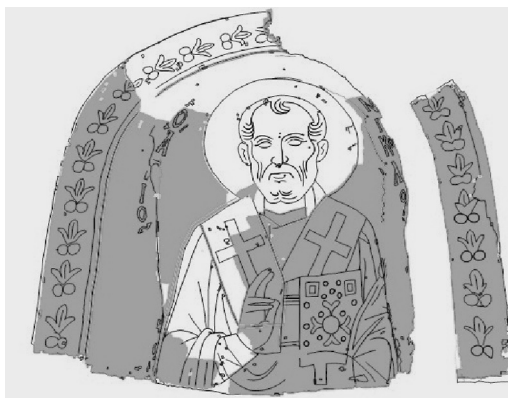
Figure 1. Manual-sonic map of “Saint-Nicolas, constructed by the mosaic’s conservators”. Damaged zones are in gray.

The objective of the current study is to correlate this radar gray-scale maps to a level of detachment or heterogeneity by comparing them to the manual-sonic maps and the pathology ones, constructed by the Conservators of the mosaics. Although, it has to be noted that this comparison has certain limitations, due mainly to the fact that GPR maps are constructed based on a multi-valued gray-scale, while the manual-sonic maps consist of two values (bad or good), deriving from subjective human-expert senses.

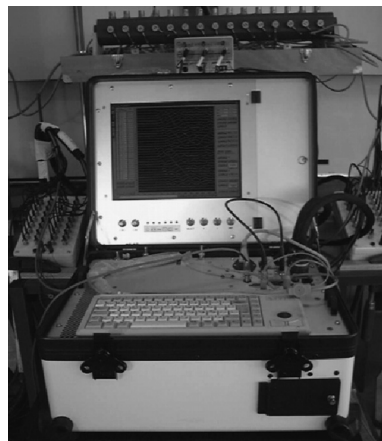
Figure 12. Seismic acquisition system.

A multi-channel acquisition system (10 bits, 1 MHz/channel) was used to collect and store the seismic signals (Fig. 12). Since the shortest source-receiver travel times amount to some ms, the sampling frequency was set at 1 MHz, in order to ensure acquiring a sufficient number of points for picking the arrival times. The source consisted of a hammer coupled with an accelerometer, while the receivers were accelerometers attached to the wall. Both the receiver and source signals were recorded for all possible source-receiver combinations. The time pickings were subsequently carried out in the laboratory. These arrival times and coordinates were then fed into the inversion process.
