Reconstruction of the Sistani House at Bam Citadel after the collapse due to the earthquake 2003

W. Jäger & C. Fuchs

Chair of Structural Design, Faculty of Architecture, Dresden University of Technology, Germany

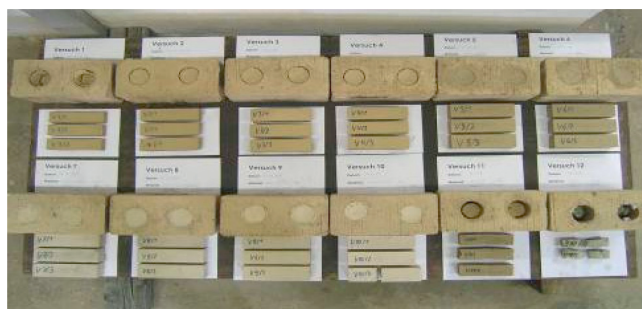
Figure 2. Test specimens for grouting material in the laboratory of the Dresden Technical University (shrinkage of the grouting material in the bore hole).

Trying to define suitable grouting materials it was important to restrict the proposal to materials that are frequently used in the Citadel of Bam, such as clay and gypsum. Further tests have been conducted with ingredients such as cement, lime or fluids added to the mixture such as potassic and sodium water glass and soda in order to reduce the demand of water (Fig. 2). Specimens were produced and tests on compression strength, bending tensile strength and splitting tensile strength were conducted.

After the completion of the test row it was decided in favour of a suspension of water, clay powder, a low ratio of lime and a very low ratio of natural wallpaper paste as plasticizing agent.

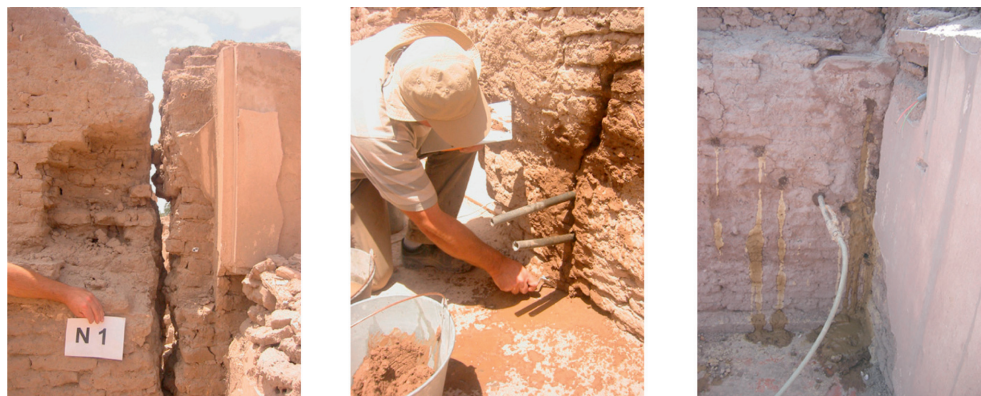
Figure 6. Grouting process in situ. On the left the cleared crack; the central figure shows the process of closing the cracks with clay leaving small holes for the subsequent injection into the cracks, figure on the right.

In July/August 2007 the first part of the preliminary tests and surveys came to an end and the actual consolidation process was put into practice. The consolidation covered all above mentioned steps of closing cracks, grouting and insertion of needles and anchors (Fig. 6).

The closing of the cracks was conducted according to the tests under laboratory conditions. As a first step they had to be cleaned. Debris and dust was removed to have a clear open gap with no loose parts.

In a second step locally available clay was mixed with water in order to create a paste-like consistency with which the cracks were superficially closed. A plastic pipe with the diameter of the neck of the injection pump was inserted into the crack in regular intervals of about 25 cm in order to create openings for the following injection of the grouting suspension.

The grouting suspension was composed as described above. In order to prevent the suspension to dry up too quickly the grouting was only carried out at early morning and late afternoon because of the very high temperature at the building site. It was done according to the rules for grouting of historic stone masonry and with a pressure no higher than 2 bar.

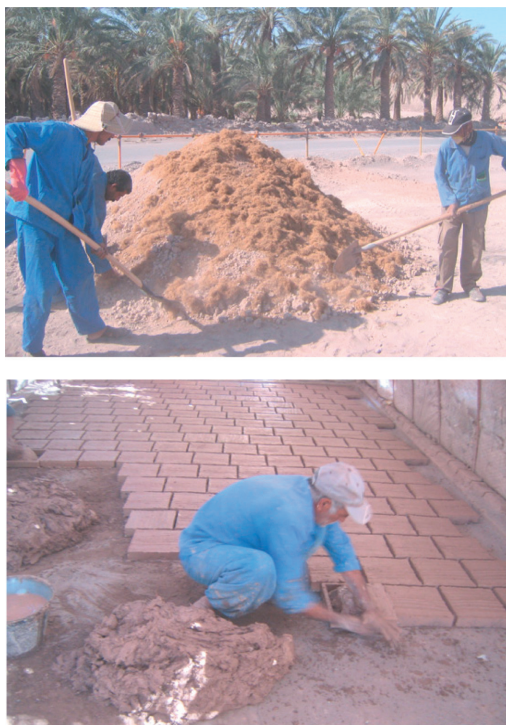
Figure 7. Production of palm fibre reinforced adobes in Bam.

In order to prepare the subsequent works of reconstruction it was necessary to start a large scale production of palm fibre reinforced adobes proposed by the earlier test series. Geological tests executed by the Iranian Cultural Heritage, Handicrafts and Tourism Organization (ICHHTO) have determined a suitable quarry for clay in a small city about 25 km south of Bam. Further tests conducted by the Dresden University of Technology have shown that the content of salts does not exceed the recommended quota. It was thus decided to bring the soil from there to the adobe production site close to the Citadel of Bam. The palm fibres were easily available but had to be processed in order separate the fibres from each other and to cut them into an appropriate length of about 4 cm. This processing was done by a cutting machine that was bought just for this process. Experience showed that it was very important to look after a good distribution of the fibres in the compound. The mixing of soil, sand and fibres was carried out in a dry state (Fig. 7, below). In a second step, water was added and the compound was left for three days to achieve an ideal malleable texture of the material. On the third day the compound was mixed another time and the adobes were produced with wooden moulds. The fresh adobes are not to be exposed to direct sunlight for one week to prevent them from cracking; the further drying process takes about three weeks. In order to improve the regularity of the masonry on the building site, it was decided to produce, apart from the traditional square shaped $25 \times 25 \times 4$ sized adobes, also a half size (Fig. 7).

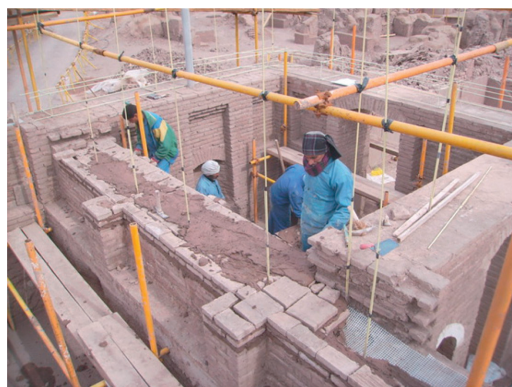
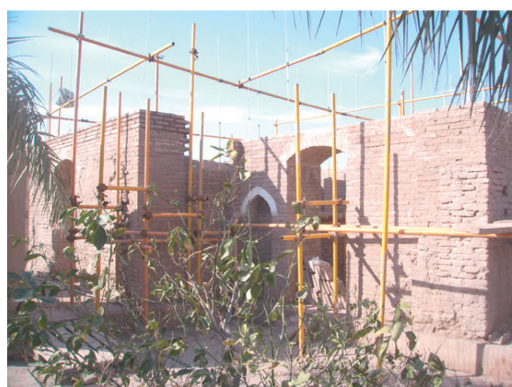
Figure 8. View of the building site of the Sistani House. January 2008.

The vertical anchors reach up to the highest parts of the walls (Fig. 8, below).
