Unexplained blasting vulnerabilities in a historic town

ABSTRACT: Historic residential and commercial structures in an early twentieth century town in the south-eastern United States that is adjacent to a quarry have regularly and repeatedly been damaged, despite the diligent keeping of blasting levels below peak particle acceleration levels previously thought to be safe. This paper explores the possibility of the damage mechanism being blasting-induced partial, repetitive liquefaction and the investigation methodology that led to this conclusion. The detonation of high explosives has been used in research to induce liquefaction at designated field sites and in laboratories, but the possibility of this occurring as an unintentional side-effect of commercial blasting has not been explored. This paper evaluates data from an actual community to assess the likelihood that the recorded damage is being caused by the quarrying in the southeastern United States. Although the results are not definitive they are strongly indicative that induced liquefaction is endangering this historic town.

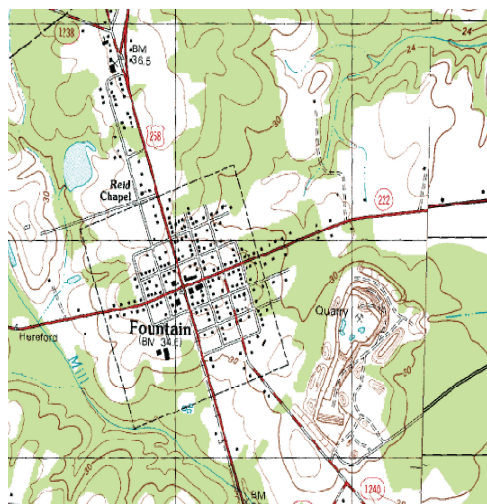
Figure 1. Aerial view of Fountain, NC, USA and quarry.

In 1904 the town of Fountain, North Carolina in the United States was founded. Approximately 50 years later a granite quarry opened adjacent to the town, thereby providing a major source of employment (fig. 1). Another 50 years brought the expansion of the quarry's blasting line closer to the community, a community that was increasingly less dependent upon quarry economics for its livelihood. As such, tolerance for quarry-induced noise, vibration, and potential damage decreased.

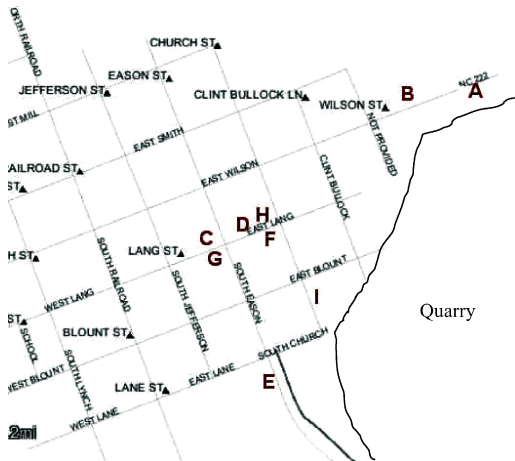
Figure 2. Map of Fountain, NC showing the location of the ten most damaged structures of the 26 inspected.

In Spring 2004, residents commissioned an independent inspection of 26 properties, for interior and exterior architectural and structural damage. Additionally, a road damage survey was executed at that time, which was then updated in the Spring of 2006. The locations of structures experiencing the most severe damage are illustrated on the accompanying map (fig. 2).

Structures located extremely close to the quarry were most damaged. Of the two closest (E and B on fig. 2, respectively), figure 4 shows extreme rotation of a foundation pier of a home that was generally in poor repair, but figure 5 shows an apparently well-constructed and maintained church extension built in the 1960s; adjacent to Figure 5, daylight was visible through the separation of two load-bearing walls.

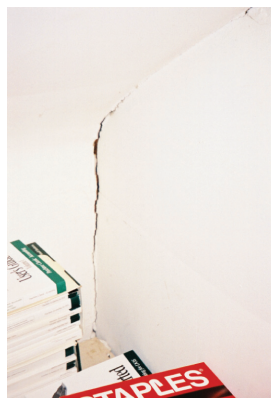
(a) Cracked plaster wall

Figure 3. Typical damage throughout the community.

Typical damage included [1] plaster wall and ceiling cracks with especially pronounced openings and large horizontal travel (fig. 3a); [2] separation and rotation of the architectural features (fig. 3b); and [3] cracking of the masonry – mostly architectural, although some structural (fig. 3c). Such damage amongst the ten properties shown in Figure 2 is summarized in Table 1.

The damage appeared extremely widespread and repetitive, irrespective of recent decoration or renovation, as well as regular maintenance, and a generally high level of property upkeep. During oral inquiry, residents attested to the newness of much of the damage. In the case of one home, all internal damage recorded had occurred within only two years, since the house had been jacked to correct existing deformations and subsequently painted. In that structure, relatively minute damage was found in the masonry foundation and skirt, with respect to the rest of the structure, which may have been attributable to the extremely soft, sandy, lime-based mortar, which has a high capacity for deformation without cracking and can also undergo a certain amount of self-annealing when cracked. Building displacement had caused extensive cracking in the structure's interior plaster walls, especially evident in upstairs bedrooms; where one crack near the fireplace measured approximately 1.22 m long with a width of 1.25–1.5 mm. Extensively cracked wall plaster included large areas of horizontal travel (fig. 3a).

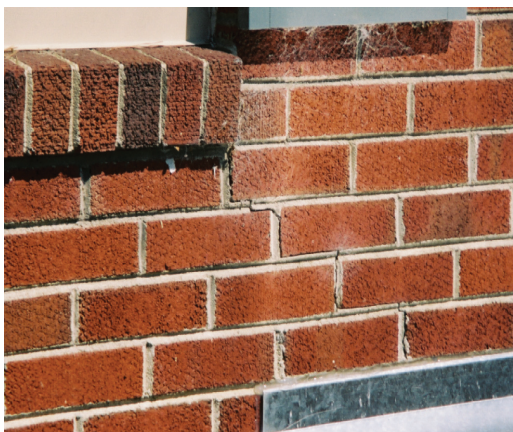
(c) Cracked masonry

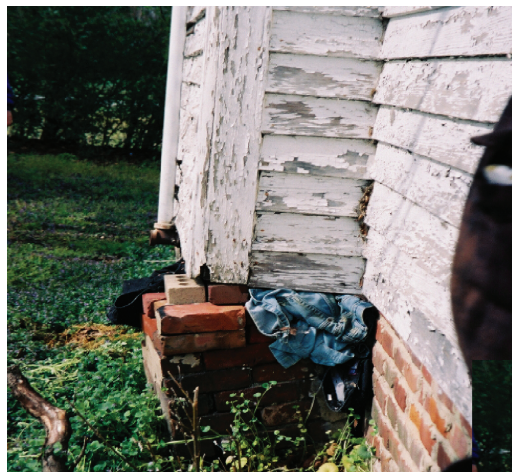
Figure 4. Rotation of pier foundation, where gap has been filled with a large amount of detritus.

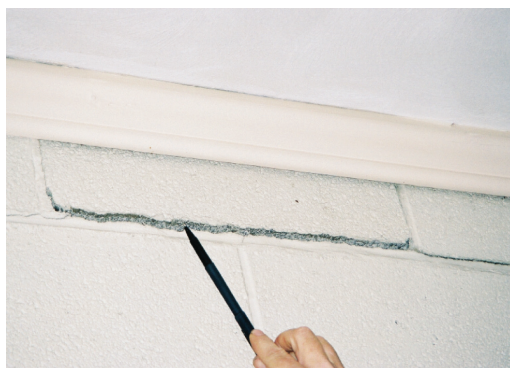
Figure 5. Major cracking in concrete masonry unit wall.

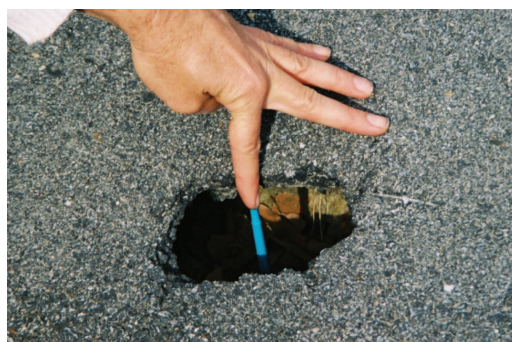
Figure 6. Typical pot hole.

The community was plagued by ground level depressions. In the roads, these manifested themselves as potholes. In the lawns, they resembled large rodent burrows (100–200 mm deep and 200–400 mm in diameter), generally large enough to trap a foot. Nearly all properties and streets near the quarry were pocked with

these indentions (fig. 6). A survey of the potholes was conducted by one of the residents in 2004 and repeated by that individual in 2006 (fig. 7). During the initial investigation in a mere five by five block area, over 109 potholes or potholes clusters were recorded. Note that much of the damage reported in 2004 was repaired by the town, prior to the 2006 survey (fig. 7).

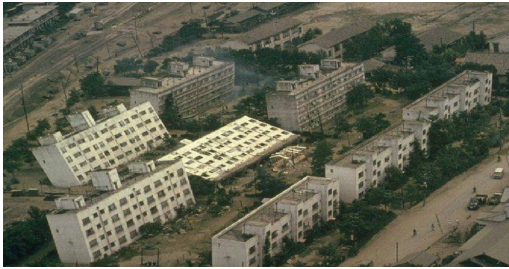
Figure 9. Overturned building from liquefaction generated collapse, Nigita, Alaska, 1964 (www.ce.washington.edu).

Liquefaction is a reduction in strength of a saturated soil, due to increased pore water pressure, volumetric compression and densification, caused by vibration or rapid loading. During this action, loose sands have a tendency to densify. Depending on the rate of loading, there may be insufficient time to allow pore water to escape, resulting in the pore water pressure (PWP) increasing and pushing the soil particles apart, thereby reducing the soil’s strength. Under extreme conditions the PWP can increase sufficiently to liquefy the soil (Seed and Idriss, 1971), possible results of which are shown in figure 9.

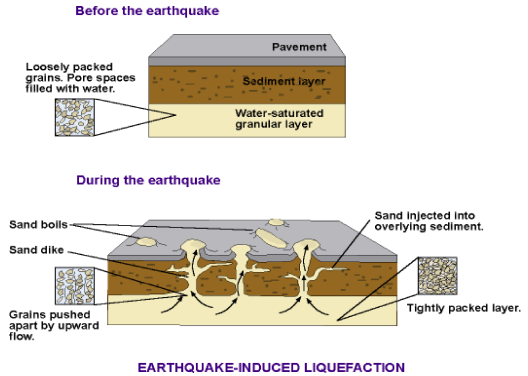
Figure 10. Sand boil description (<http://wapi.isu.edu>).

In addition to destabilizing structures, liquefaction can cause sand boils (sand blows), which occur, when pore water pressure steadily increases in a sand layer underneath a hardened surface (figs 10 and 11). During liquefaction, the pore water pressure increases, eventually reaching a magnitude sufficient to break through the solid surface and appear much like a bubble in boiling water.

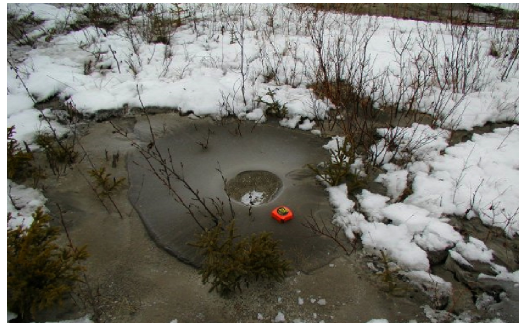
Figure 11. Documented sand boil in Mentasta Lodge, Alaska (courtesy of Shannon and Wilson).
