Vulnerability and seismic improvement starting from experimental investigation

Cristiano Algeri

C-SPIN, Engineering Design Development Centre, Bergamo, Italy

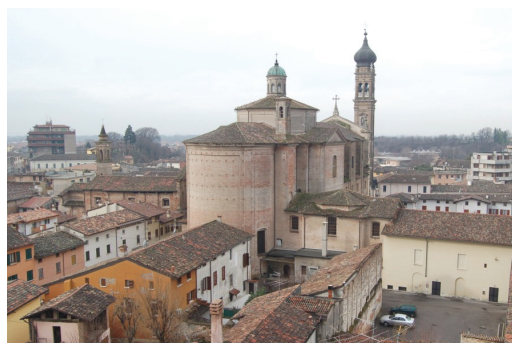
Figure 1. Panoramic view of St. Giovanni Battista church.

This paper reports the structural analysis of St. Giovanni Battista church (Figs 1 and 2) located in Carpenedolo (Brescia – Italy). After the earthquake which struck Brescia district in November 2004, this church was analyzed in its entirety, in order to identify appropriate strengthening interventions. Religious buildings generally present a pronounced seismic vulnerability related to their significant dimensions and masses, reduced horizontal connections, tall masonry elements lacking orthogonal stabilizing walls, and presence of vaults and arches that can increase their thrust following the seismic event. Damage in such churches have often been detected after low/moderate intensity earthquakes (Lagomarsino 1999) indicating for this structural typology an actual safety problem. The analysis of the Church was conducted with respect to (Casarin & Modena 2006) its constructive history and structural evolution, post earthquake damage manifested and current condition. Subsequently an on-site investigation campaign was erected. Finally, the seismic assessment of relevant parts of the structure, involving different modelling strategies, was carried out. Global linear elastic numerical models, calibrated based on the results of the experimental phase, were used.

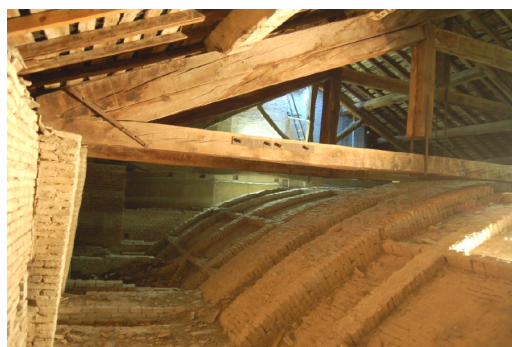
Figure 2. Wooden trusses and extrados nave barrel vault.

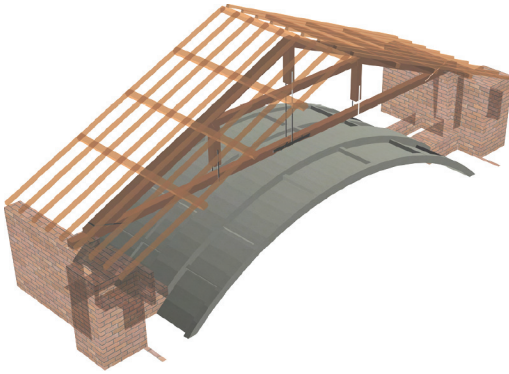
Figure 3. “Palladiano” scheme truss.

The western part was built between 1693 and 1713, whereas the eastern part was built after 1761. The facing east apse, following the tradition, has a simple round arch vault morphology without any opening. An elliptic dome is sustained above the extrados of a big octagonal structure, at the cross between the nave and the transept. A top lantern crowns the edge of the dome. The wooden roof is a double pitched one characterized by a truss structure. In particular, the pre-existing truss structure is a simple truss, whereas the following intervention presents a “Palladiano” design (Fig. 3).

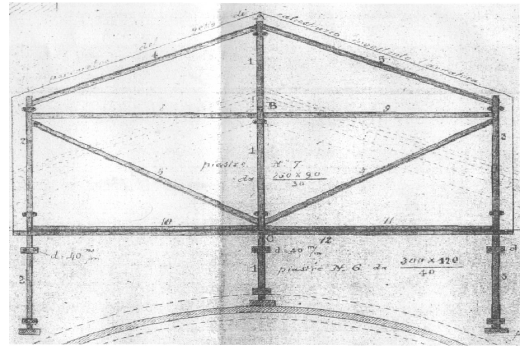
Figure 4. Drawing concrete tympanum Ing. Mazzocchi (1908).

is another tympanum made of concrete and added later, during the strengthening interventions of 1908. This element, which has a thickness of 300 mm, functions as a counter-weight.

In 1902, the restoration of the façade caused static problems especially on the decorated pediment and on the pitched roof. Both the pediment and the roof had slanted towards the below square. In 1908 the engineer Luigi Mazzocchi created a steel truss structure covered by concrete, firmly fixed to existent tympanum and supported by three steel beam to lower vault (Fig. 4).

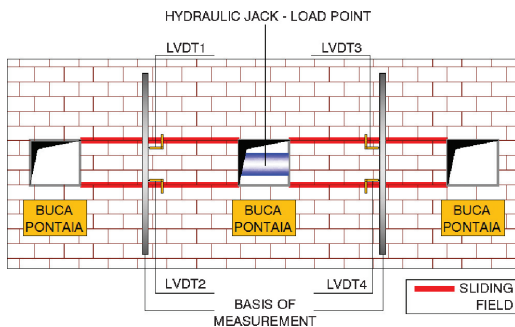
Figure 5. Sliding Shear Test (SST) scheme.

Shear failure is characterized by joint failure, as a function of the bond strength linked to the frictional resistance at the brick-mortar interface and the compressive stress normal to the bed joints. The criterion is known as Coulomb type failure criterion:

The SST is made using a hydraulic jack positioned in a pre-existing hole (200x200 mm) of the investigated masonry able to create a force parallel to mortar bed joints. After having chosen the test area, the positions of the measurement points are identified as shown in figure 5, using an appropriate contrast base linked with a piece of undisturbed masonry out of the sliding phenomena.

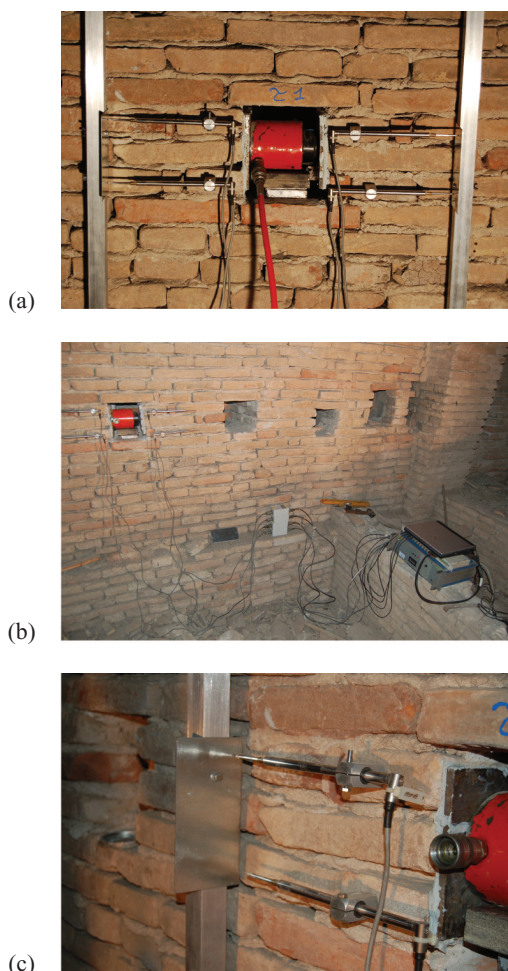
Figure 6. Sliding Shear Test (SST) set-up. Hole dimension 200×200 mm, distance between holes 600 mm, distance between upper and lower instruments 150 mm.

The test was carried out using a hydraulic jack positioned, in this specific case, into a “buca pontaiia” (i.e. a pre-existing hole). In this way, a pseudo-isolated piece of masonry was tested, as this part was between other two “buche pontaiie” and so it was free of moving. When masonry is subjected to tensile loads, along the parallel direction of bed joints, the brick and the head joints are subjected to compressive stresses, while the bed joint is subjected to shear stresses. The displacements – associated with the force applied by the jack on the piece of masonry – allow the calculation of the shear strength of that piece of masonry and of the mortar stiffness, knowing the flow surface of the mortar. Figures 6a-6c show some moments of the test.

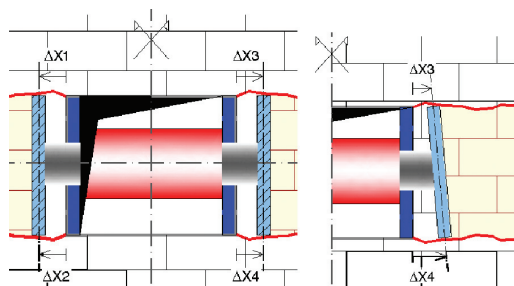
Figure 7. Homogenous and non-homogenous sliding.

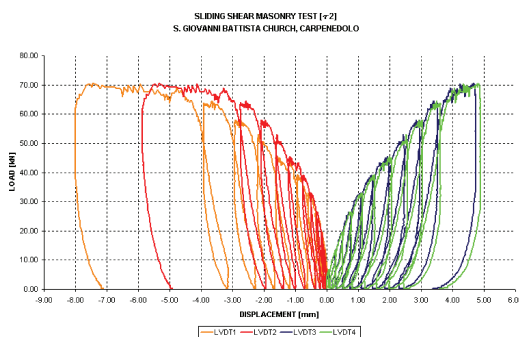
Figure 8. Load-displacement graph of Sliding Shear Test.

The mechanical behaviour of URM, for each basis of measurement, is thus characterized by (Fig. 8):

- a first elastic phase, until the 50% of the maximum load, identified by an high gradient (stiffness) calculated as the ratio between load and displacement;
- a second phase, with a smaller stiffness and characterized by the presence of no longer negligible inelastic phenomena. These indicate a cracking in action;
- a third and last phase characterized by a plastic behaviour with significant deformations till the break for sliding shear of the mortar joints.

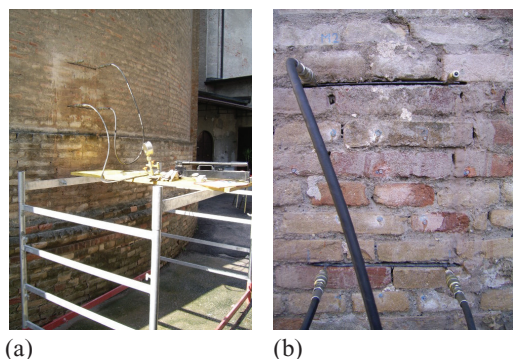
Figure 9. Flat jack tests.

This kind of test methods concern the measurement of in-situ compressive stress and the deformation properties in existing masonry by use of thin, flat jack devices that are installed in saw cut mortar joints in the masonry wall (Figs. 9a–9b). These test methods provide an in situ minor destructive technique (MDT) determining masonry stress distribution under service load by using one flatjack and the deformability characteristics of the masonry by using two parallel flatjacks.

The masonry investigated in the lower part of the church – in the apse external side – shows a compressive stress of about 0.75–1.15 MPa and an average deformability modulus of 4800 MPa.

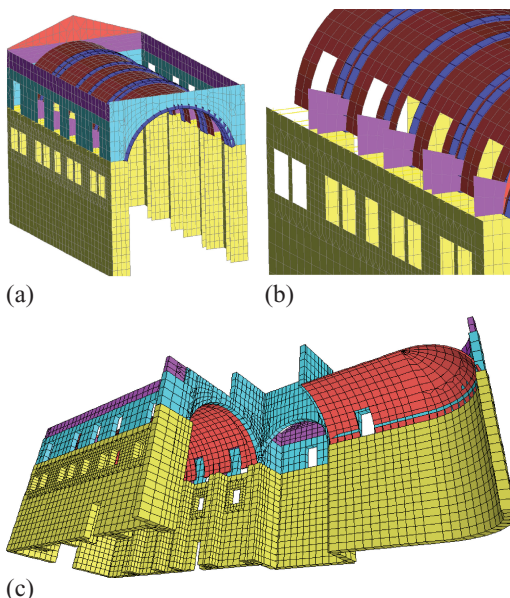
Figure 10. FE model views.

The perimeter walls were modelled using “plate” elements, split in different groups depending on the different identified thicknesses. Then buttresses were introduced – always using “plate” elements – in the nave, orthogonally to its walls. The tympanum on the top of the façade was modelled, considering that at the beginning of 1900 a new tympanum made of concrete was added against the original one, like an element stiffer than the lower masonry (see section 2.1). Vault ribs, identified during the geometrical survey in correspondence of the buttress, were modelled as “plate” elements with appropriate thickness (Figs 10a–10c). The wooden trusses were introduced in the model as “beam” elements. Finally, the structure was restrained at the base by, in first approximation, rigid connections (no degrees of freedom). Consequently a dynamic analysis with spectral response has been conducted in agreement with the Italian Code.

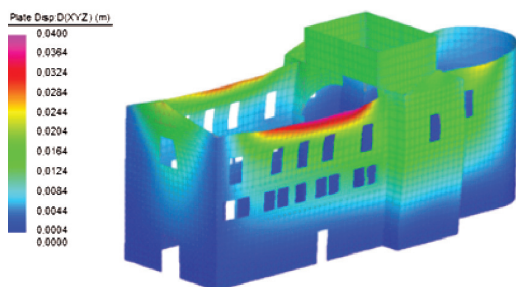
Figure 11. Displacement envelope under transversal seismic force and dead load – configuration BEFORE strengthening.

Figures 11–14 show the displacements obtained by numerical analysis under horizontal loads. Results are presented using the same chromatic scale (displacement range 0.00–40.00 mm). From the results of the global modal analysis, it is possible to conclude that an intervention aimed to link all the walls including also the wooden truss can be efficient against earthquake.

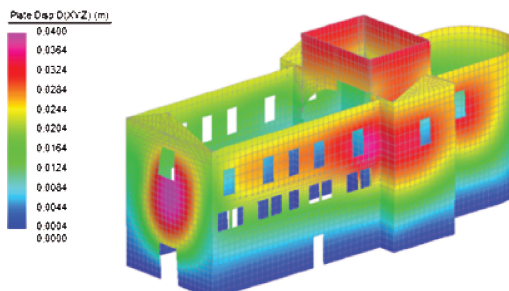
Figure 13. Displacement envelope under longitudinal seismic force and dead load – configuration BEFORE strengthening.

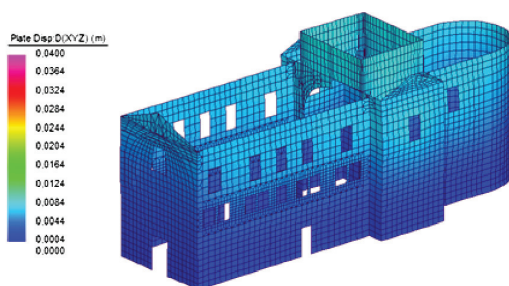
Figure 12. Displacement envelope under transversal seismic force and dead load – configuration AFTER strengthening.

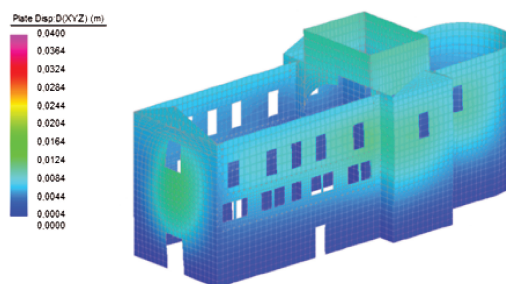
Figure 14. Displacement envelope under longitudinal seismic force and dead load – configuration AFTER strengthening.
