## The effects of temperature on historical stone masonry structures

C. Blasi & E. Coisson

*University of Parma, Italy*

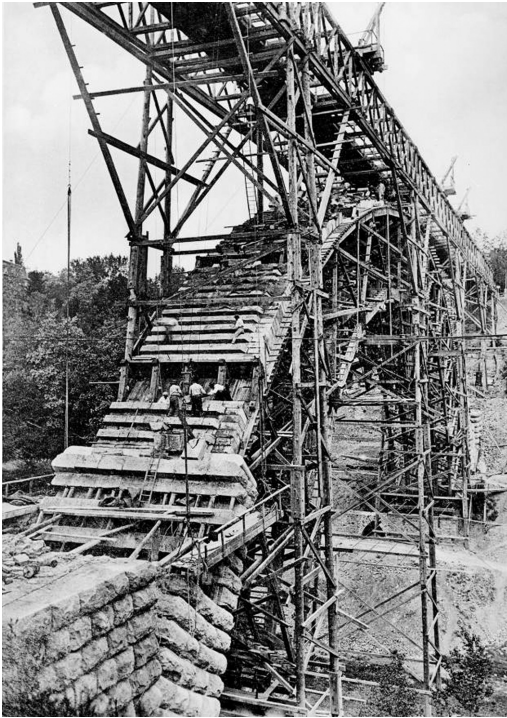
The Pont Gran Duc Adolphe, designed by Paul Séjourné and built between 1900 and 1903, with its 84.65 m of span, is one of the largest arch stone bridges in the world. It is a milestone in the art of construction and the pictures of the construction phases are particularly impressive (Fig. 1).

Figure 1. The construction phases of the Adolphe bridge in Luxembourg.

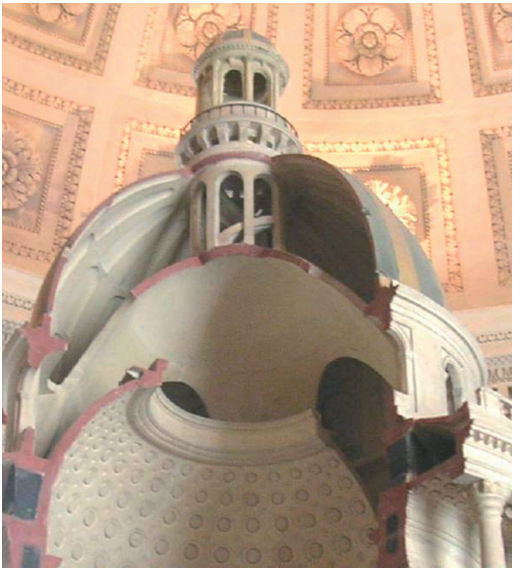
The French Panthéon, designed by Soufflot and completed by Rondelet at the end of the XVIII century, has three superimposed domes (Fig. 3): an inner one, hemispherical and with a central hole, has only a scenographic purpose, an intermediate one, with a catenary section, sustains the lantern, and an outer one for protection. They are all made of stone masonry reinforced with the widespread use of iron clamps.

Figure 3. The model of the three domes of the Panthéon made by Rondelet.

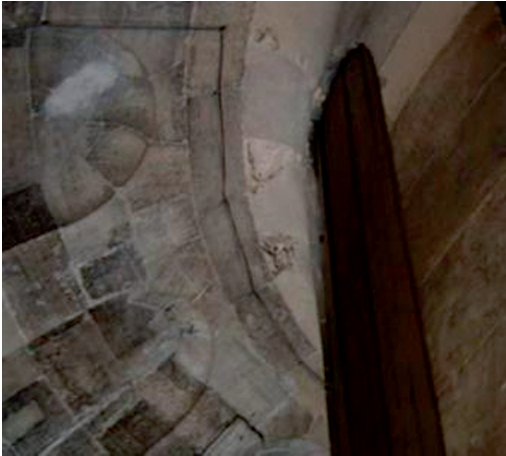
The area that shows more frequently fractures and detachment of stone fragments is the one at the intersection between the intermediate and the outer dome, where the lantern begins (Fig. 4).

Figure 4. The cracks at the connection between the intermediate and the outer domes.

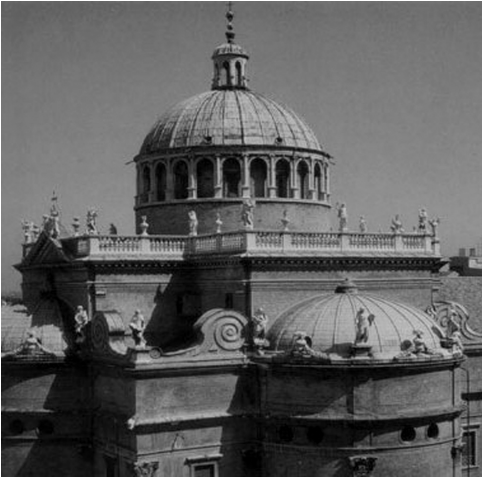
An interesting local effect due to thermal variations appeared on the stone balustrade built at the end of the XVII century on the crowning of the roof of the Renaissance church of Santa Maria della Steccata in Parma (Fig. 7).

Figure 7. The church of Santa Maria della Steccata in Parma (Italy) with its balustrade crowning the roof.

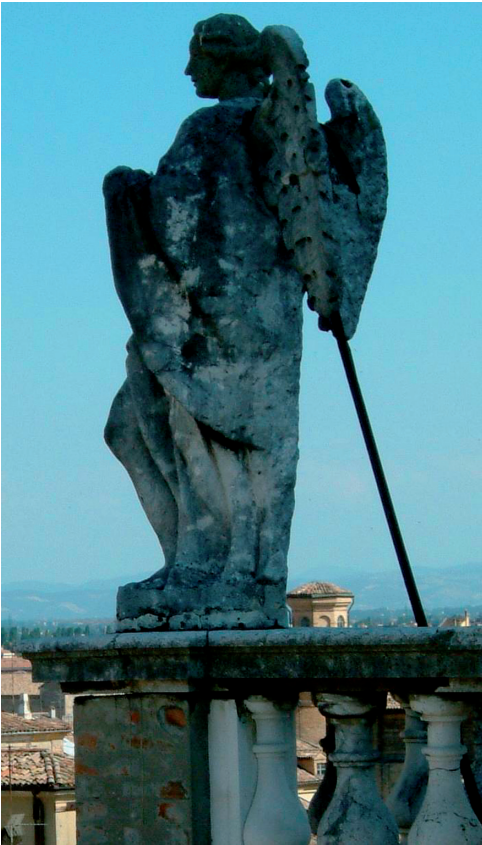
The stones of the upper part of the balustrade showed, indeed, quite surprising upliftings in their central parts, while the lateral pillars on the corners of the balustrade were cracked (Fig. 8).

Figure 8. One of the statues over the balustrade: notice the iron bar on the back and the gap created between the pillar and the statue base.

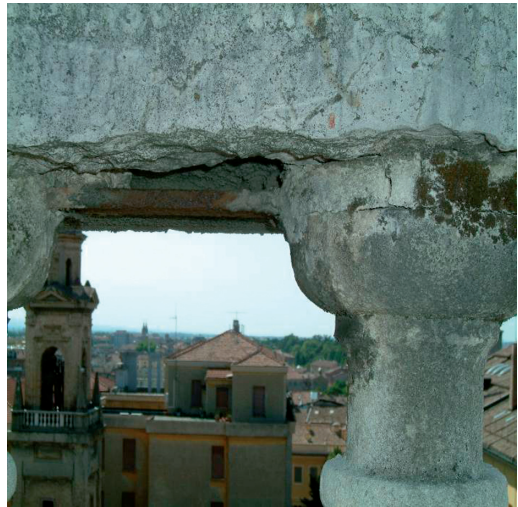
Figure 9. The iron bar inserted after the WWII to connect the balustrade and the thick layer of resin inserted after the 1983 earthquake.

A very simple thermal analysis, following an attentive in situ inspection, demonstrated that the phenomena were linked to the different thermal strains between the surface stones and a metal bar inserted after the Second World War to retrofit and better connect the structure, hit and damaged by a bomb (Fig. 9).

The restoration intervention, still ongoing, foresees the removal of the metal bar and the creation of joints between the stones, so that the thermal strains will be free, and will not provoke stresses, cracks and disorders on the surrounding elements. Moreover, it is planned to insert connection bars for the statues that hinder the dangerous out of plane movement but allows the in plane movements (Alfieri & Fioretti, 2007).
