Vulnerability screening by visual inspection of churches of North-East Anatolia

ABSTRACT: The aim of this study is to detect historical churches in north-eastern region of Anatolia and to perform a visual inspection regarding their structural conditions. A group of churches, which are located in the north-eastern region of Anatolia, are investigated in a field trip. Due to the important historical works of art and architecture, the north-eastern part of Anatolia offer a priceless treasure with the traces of Byzantine, Roman, and Pontus Empires. Reflecting the architectural features of the century, an important number of churches were built in different centuries. Some of these churches still serve for different purposes, while some other are severely destroyed. Today, none of these churches are used for worshipping. On the other hand, these churches are among the most important means to reveal the cultural heritage. It is very important to protect these buildings to provide the link between the past and the upcoming generations. Any process related to the protection of a structure starts with a detailed diagnosis. But when an important number of structures are in question, it migh

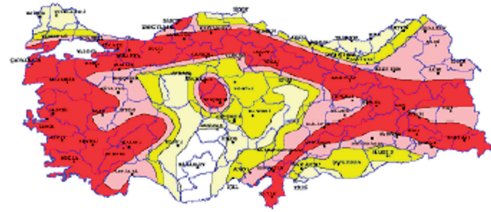
Figure 1. Seismicity of Turkey (General Directorate of Disaster Affairs, Earthquake Research Department).

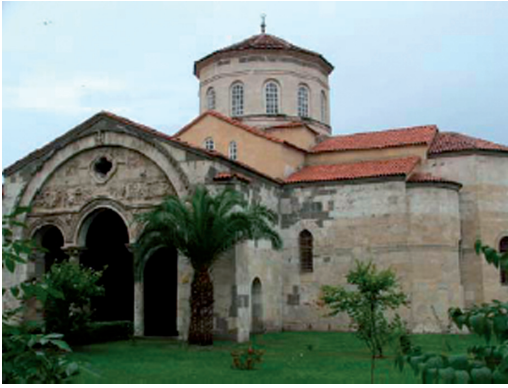
Figure 4. Outer view of the Trabzon Hagia Sophia.

The building is a good representative of the late Byzantine churches. It has a cross shaped layout covered with a central dome at the top. The 12-cornered dome and its drum are supported by means of four marble columns, arches and pendentives. The abscissas are circular at the side naves and pentagonal in the central nave. The narthex, which hosts a chapel, serves as the entrance. Different types of vaults were used as the means to cover the top of the structure around the main dome. This ends up with different heights along the structure, all covered with roof tiles.

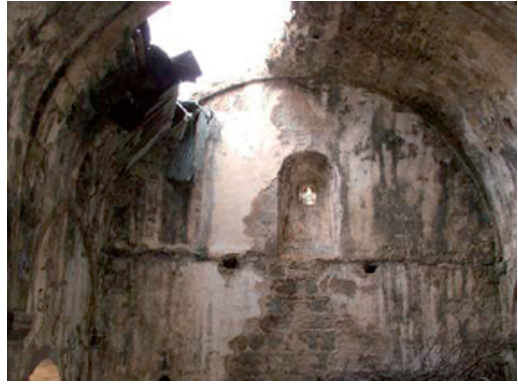
Figure 6. Gumushane Mother Maria Church.

The church, which is located in the Kurtun Province-Yaylali Village is a work of 19th century. It is rectangular in plan and has one nave and one abscissa. Constructed of cut-stones, the structure is covered by a steep triangular roof at the top. Surrounded by marble architraves, the entrance of the church is on the southern side unlike the other churches. There are no frescoes or any other ornaments in the church.

On the eastern part of the church a cistern, which is connected to the building with an arched passage takes

place. Meanwhile, on the southern part, there seems a partially damaged fountain located about 5 m away from the church.

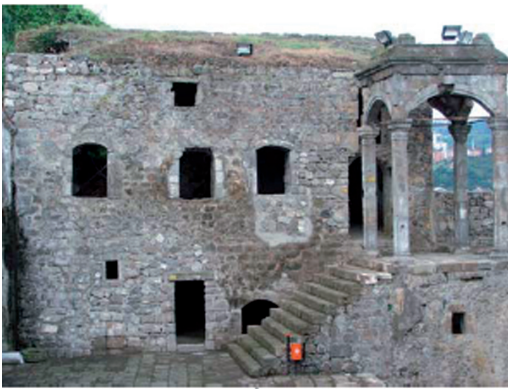
Figure 5. Trabzon Girls Monastery

The Monastery was built in the 14th century (1349–1390) under the reign of Alexsios III. Several additions were made to the building in the 18th and 19th centuries. When it was first constructed, it was composed of the Rock Church with sacred water inside, and a chapel at its entrance and some small chambers. There are epigraphs and the portraits of Alexsios III, his wife Theodora and his mother Irene in the Rock Church.

In the 19th century (1893–1906), a church on behalf of Konstantions, the bishop of the monastery, his sepulcher, student rooms and guest rooms were built. Located on the hillside of Boztepe, the Monastery is surrounded by fortification walls. The frescoes inside the Rock Church and on the outer walls of the entrance part are severely damaged. The sons of Alexsios, Anrokinos and Manuel are buried here. The monastery has been abandoned since 1923.

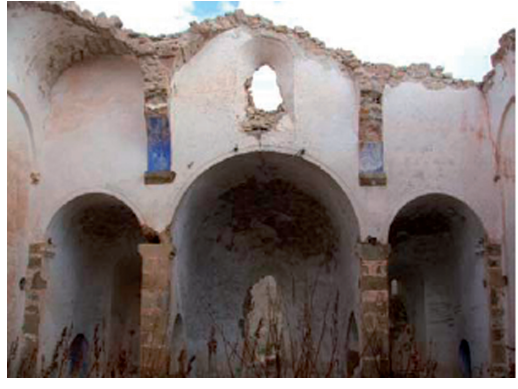
Figure 7. Gumushane Sariun Church.

The Sariun Church, which was constructed in the 19th century, is located in Yaglidere Village, Krom Valley, Sariun District. The building is rectangular in plan with three naves and three abscissas. Constructed on a scenery hill, the top cover of the church was demolished years ago. The only means of ornament of the church is seen to be the motif of a cross on the entrance door. There are no frescoes or any other ornaments within the building.

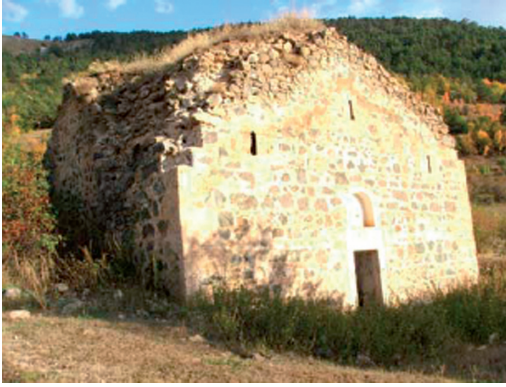
Figure 8. Gumushane Harmancik Church.

The building is located in the Torul Province, Harmancik Village, Mesehor District. It is an Armenian church, which is believed to have been built in the second half of 19th century. The building is

constructed of regular cut stones on the western wall, and rough stones on the rest. It has a rectangular layout in plan. The arched entrance has a tympanum at the top, and is on the west. Nine windows are arranged around the building. The roof, which is supposed to be a barrel vault, is severely damaged. Just as the church itself, the chapel, which is 100 m away at the south, is also demolished.

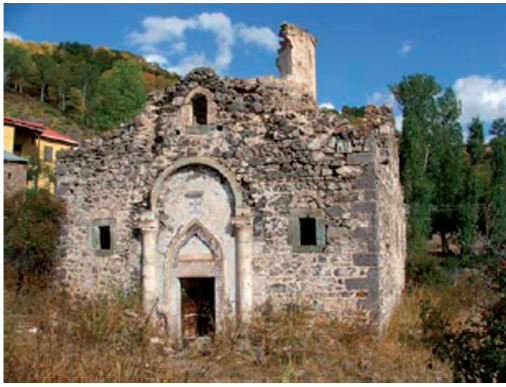
Figure 9. Gumushane Ugurlutas Church.

The building is in the Torul Province, Ugurtas Village. The construction date is not known. The building is rectangular in plan and has three naves and three abscissas. There are 14 windows around the building. The top cover consists of a barrel vault and a hexagonal dome, which is partially demolished. There take place 6 columns and arches in between, to support the roof. The columns are connected to each other by means of tension ties underneath the arches. The entrance door is original.

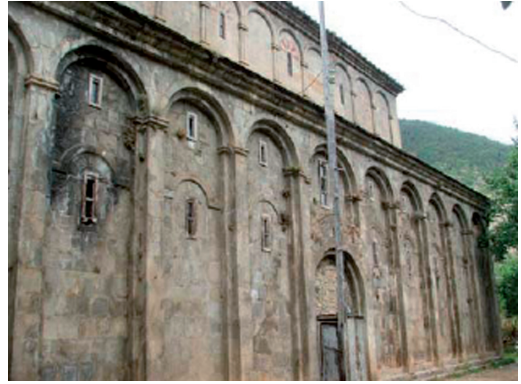
Figure 10. Artvin Yusufeli Church.

The church, which is also known as Barhal Church is located in Altiparmak Village within the borders of Yusufeli Province. The literature depicts that the building is a work of late 9th and early 10th century and was dedicated to Saint John the Baptist during the period of King David Magistros. After 16th century, it was repaired on behalf of Haci Serif Efendi and was converted into a mosque. The church is constructed of regularly cut stones in a basilical plan layout with about 28×19 m dimensions. The building has three naves. The facades, all of which are constructed of grey coloured cut stones, are given a harmonious rhythm by means of identical arches on the southern and northern facades and slightly widening arches from the sides to the middle on the western and eastern facades.

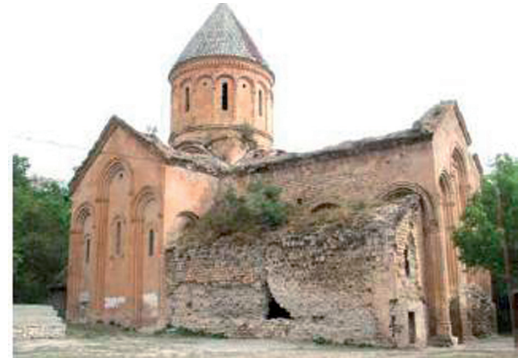
Figure 11. Artvin Ishan Church.

The monastery is composed of a church and a chapel, both of which are constructed of regularly cut stone. The church is an important reflection of the art of the age both with architectural features and with frescoes at the inner surface of the dome. Outside, the dome is seen to be a cone which sits on a deep drum. The column capitals have carved ornaments. The entrance of the church is surrounded by means of geometrical relieves.
