Safeguarding safety and significance – Saving an historic village in Bath

ABSTRACT: Twenty-one hectares of unstable mines threaten the future of the village of Combe Down. This is an integral part of the World Heritage Site of Bath. Economists used the technique of contingent valuation to value the continued existences of the village. Government funding was provided to stabilise the mines to save the village.

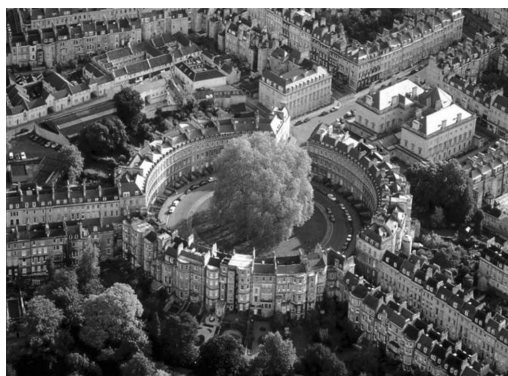
Figure 1. The Circus, Bath – Bath Stone Georgian architecture.

The historic buildings of Bath are almost all built of Bath stone which is an oolitic limestone of yellowy cream stone which in polite buildings is worked as ashlar fronted facades (see Fig. 1).

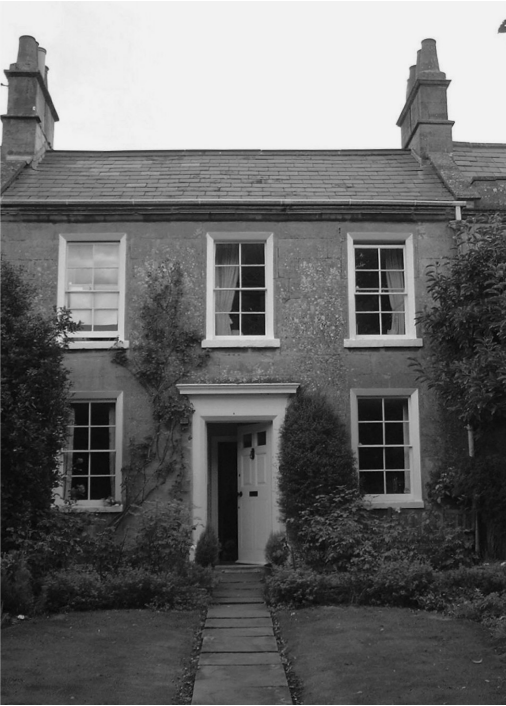
Figure 3. A typical example of workers housing which were built to a high standard in Combe Down. (Webb, O: 2007).

When Allen began his operation, Combe Down was open land with only scattered agricultural buildings and few inhabitants. The area became developed with the paraphernalia of mining such as quarries, the railway, cranes, stone yards etc. Ralph Allen built houses for his workers, both on Combe Down and at the bottom of the hill. The houses were built of Bath stone and were early workers housing of high standard with ashlar facades (Fig. 3).

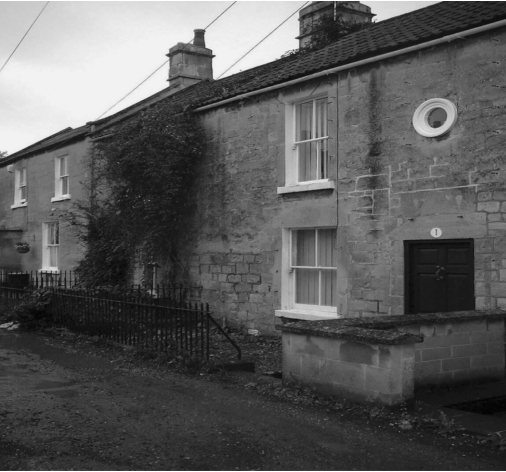
Figure 4. Quarryman's Cottage built during the 18th century in Combe Down. (Webb, O: 2007).

During the eighteenth century further quarryman's cottages were built, mainly small vernacular buildings of rubble stone (see Fig. 4). A village grew up in Combe Down and chapels and pubs were established. The village is built of Bath stone with little drungs (stonelined paths) and detached gardens, which combine to create a pleasant and attractive environment.

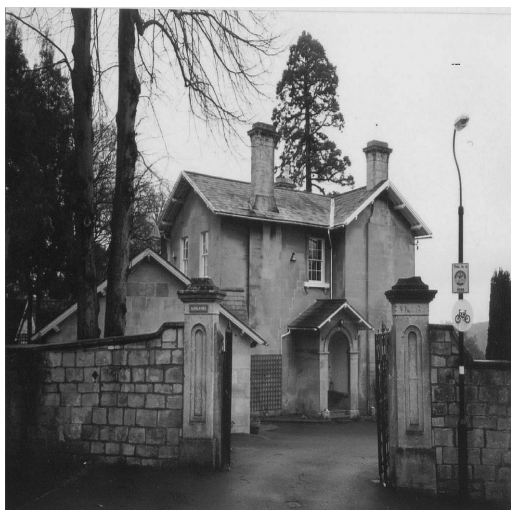
Figure 5. Example of a 19th century Villa in Combe Down. (Webb, O: 2007).

During the nineteenth century, the area became popular with the middle classes, especially because of its clean fresh air and wonderful views to the south. Villas were built in the village and these are often large detached buildings, of ashlar stone (Fig. 5). The village today is densely inhabited with schools and churches, and shops as well as dwellings.

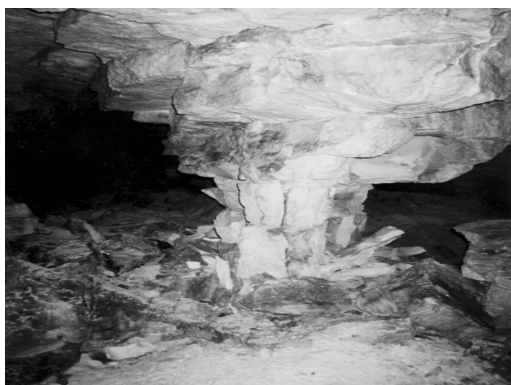
Figure 6. The mine roof has become fractured as the stone pillars have been robbed of stone.

was found in nearby Wiltshire. This stone was used in Bath and the Combe Down Stone mines were gradually abandoned. Since then the condition of the mines has deteriorated. Pillars were robbed (see Fig. 6) and the roof has become fractured.

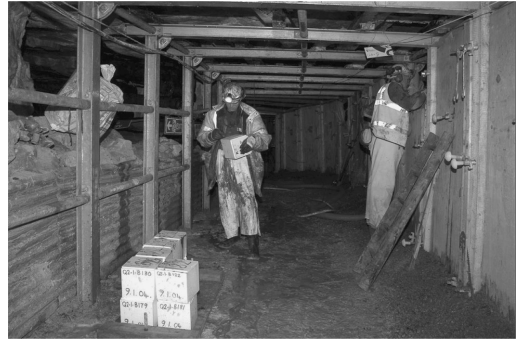
Figure 8. Protective roadways (Hydrock:2004).

Because the mines are unsafe, engineers are not able to carry out surveys or design stabilisation areas until protective roadways have been built (see Fig. 9). These underground roadways are built by miners from steel and provide a protective 'cage' for engineers to survey the mine extent and mine condition and develop engineering design. The roadways are also used to support the shuttering to contain the foam concrete which is poured in lifts and allowed to set.

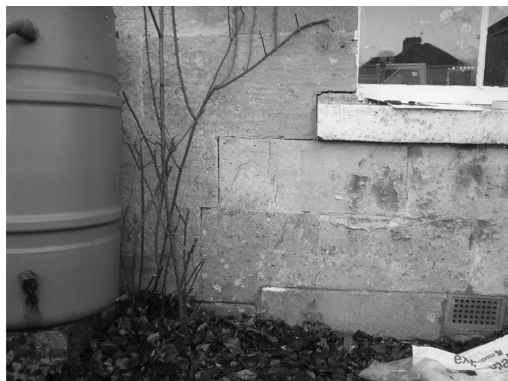
Figure 9. Noticeable fractures appear on a number of the houses in the Combe Down Stone Mines Area. Here a crack can be seen to the left hand side of the window. (McCabe:2007).

In carrying out plaster repairs to several properties the construction of the older houses has been revealed. The external walls are constructed of two skins. There is an outer leaf constructed of ashlar stone blocks and an inner leaf constructed of rubble. There are no ties or bonding between the two skins. This may have been

the cause of accentuated cracking internally with little evidence of movement externally.
