## Structural faults in earthen archaeological sites in central Asia: Analysis and repair methods

E. Fodde

*BRE Centre for Innovative Construction Materials, Department of Architecture and  
Civil Engineering, University of Bath, UK*

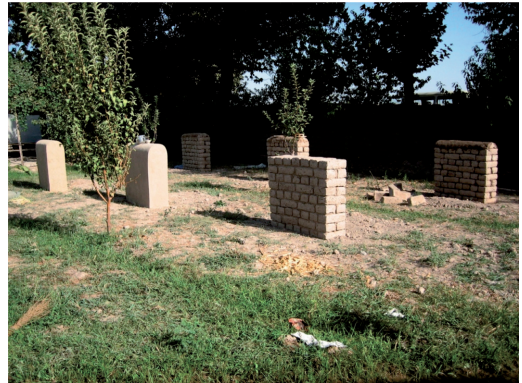
Figure 3. Ajina Tepa, Tajikistan, 2006. Test walls construction in the project house yard. This was an essential tool for the selection of best performing repair materials.

Another important conservation method was the structural consolidation of leaning walls by building massive buttresses. Some walls were so endangered that it was necessary to build such support to avoid collapse of parts of the historic fabric. This was done after extensive experimental analysis (Fig. 3).

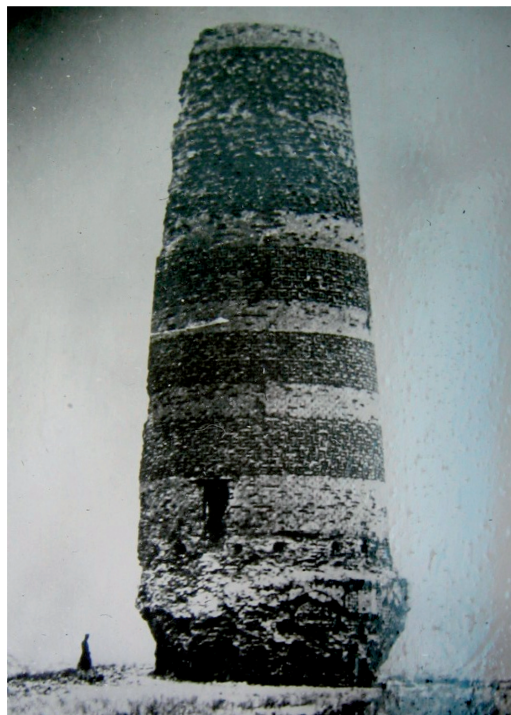
Figure 4. Minaret of Burana (10th–11th century AD), Kyrgyzstan, 1927. Archival picture showing coving effect at the base of this fired brick structure.

Burana Tower (10th–11th century AD) provides a clear view of the approach to architectural heritage conservation in central Asia before the collapse of the Soviet Union (Goriatcheva 1980, Genito 2002). It was heavily consolidated by adding a fired brick skin and an octagonal base (Figs 4–5). This treatment is characterised by hydraulic cement mortar that is too strong for the brick, with the result that moisture evaporation does not occur over the whole masonry, but takes place through the external face of the brick. The exposed faces then tend to flake off, either through the freeze-thaw cycles or the crystallization of salts, resulting in a masonry where the mortar face stands proud (Fig. 6). Humidity patches were noticed in the lower masonry and this seems to be due to water leaking through the parapet. The question to be answered was whether it would be feasible to remove all new bricks that were laid with cementitious mortar without damaging the historic fabric underneath. Being the cementitious pointing mortar too strong, it was advised to leave it into place to erode and fall out rather than attempt to rake it out, otherwise extensive damage may be caused to the brick. Another question is related to the structural stability of the tower. Both archival records and the documentation carried out during the project show a lean and it was suggested that constant monitoring be carried out regularly.

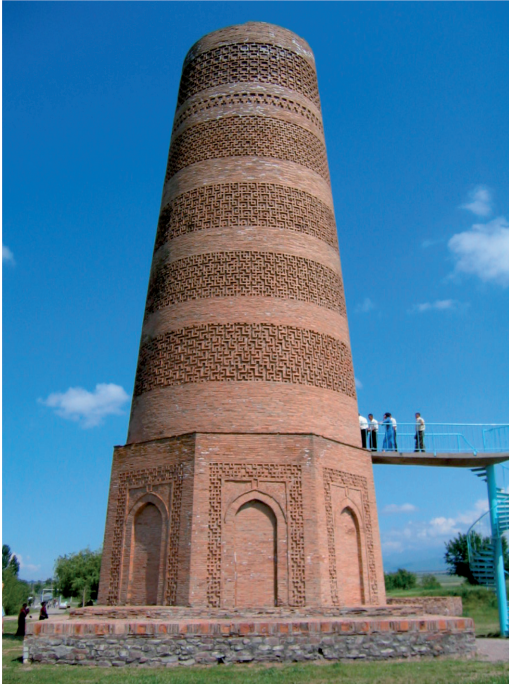
Figure 5. Minaret of Burana, Kyrgyzstan, 2006. Picture showing conservation work as carried out by Soviet conservators: heavy reconstruction of wall base and facing with fired brick. The main criticism to this kind of intervention is that reconstruction was undertaken without documentary evidence.

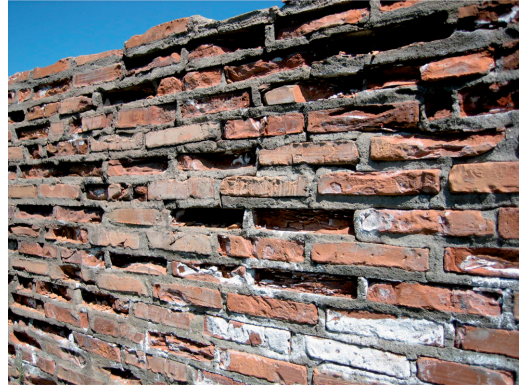
Figure 6. Mausoleum II, Burana, Kyrgyzstan, 2006. In the Soviet period reconstruction was often carried out with fired brick bedded with cement mortar. This caused two major decay patterns, both due to water infiltration and lack of breathability of the mortar: erosion of brick face and bulging of reconstructed parts.

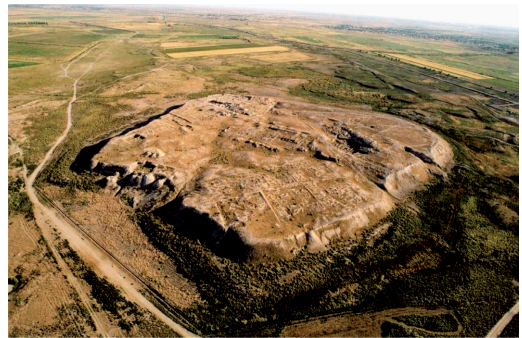
Figure 7. Otrar Tobe, Kazakhstan, 2003. Bird eye view of the elevated citadel or *shahristan*. The area around the citadel, *rabat*, was predominantly residential. Picture kindly provided by Renato Sala.

Otrar Tobe (Fig. 7) is considered to be the most important of a system of six medieval towns located in the

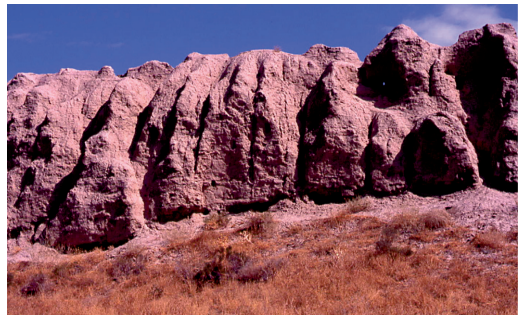
Figure 9. Sauran, city wall (14th–15th century AD), Kazakhstan, 2002. Deep preferential channels on mud brick walls are visible in the city wall of this medieval city. Picture showing coving effect at the bottom due to combined action of rising damp, soluble salts, and wind erosion.

Another form of rheological decay is that caused by precipitation and the formation of typical erosional patterns (Fig. 9). These can be uniformly distributed, but it is often common to observe water collecting along erosional channels that tend to deepen until more serious structural faults happen.

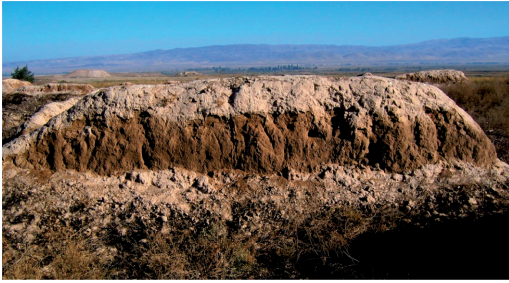
Figure 10. Karakhanid Palace, Krasnaya Rechka, 2004. The phenomenon known as ‘petrification’, represented in the upper part of this earthen wall, consists in the natural creation of a protective hard crust of clay. This can be directly inspected in several earthen structures in Central Asia, but a scientific study of the phenomenon is still at an early stage.

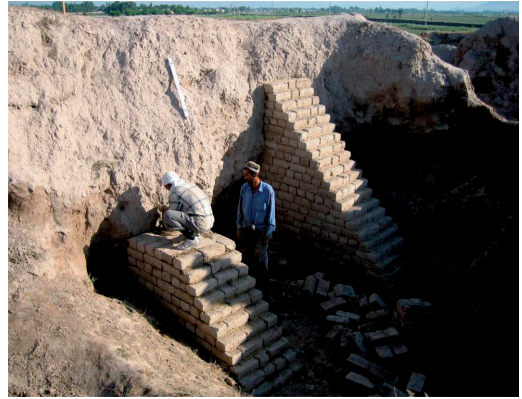
Figure 11. Ajina Tepa, Tajikistan, 2007. Mud brick buttress construction to support a leaning wall. In order to have reversible interventions the buttress was built without inserting any bricks into the historic fabric, but by making sure that the connection was well packed with dry soil.

Buttressing may be considered as a temporary or permanent device for those walls that are leaning or close to collapse. In the context of earthen sites conservation they are extremely useful especially for implementing urgent consolidation measures. Mud brick buttresses tend to be bulky and cumbersome and their employment should be considered after proper assessment. It is important to prepare the area where the buttress is going to be built so that to avoid water collection at the wall base after construction is completed. In this sense ground drainage should be insured before construction. Buttress dimension should be proportional to the size of the wall to support. Length of wall is also important in the dimensioning and it may be necessary to construct more than one buttress, as in the example on Figure 11: in the site of Ajina Tepa (Tajikistan) the structural consolidation of leaning walls was carried out with the help of earthen buttresses by employing local materials and techniques. Special attention should be paid to the connection between the buttress and the historic wall. It is advised not to excavate niches to form a key, nor to use mud mortar if possible. Dry packing should be employed instead so that to make the intervention reversible. Maintenance should be ensured so that to divert water away from the foundation. If water is allowed to pond near the buttress, the ground may reach the plastic limit and make the buttress settle because of its own load.

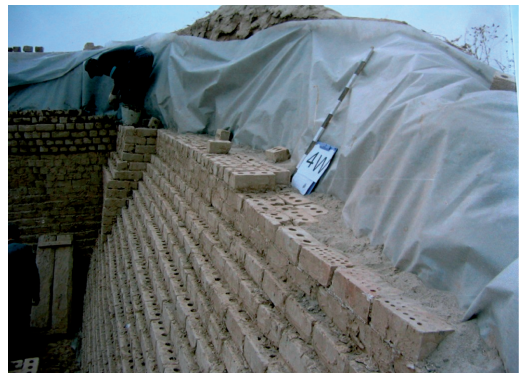
Figure 12. Buddhist temple II (XI century AD), Krasnaya Rechka, Kyrgyzstan, 2003. Shelter coat construction. From left to right: new mud bricks, sand infill, geofabric, and historic earthen wall. Picture: Jumamadel Imankulov.

The encapsulation of decayed walls with shelter coats is often necessary for the following reasons: ideal against vandalism and for repairing walls that are heavily thinned by erosion (Fig. 12).

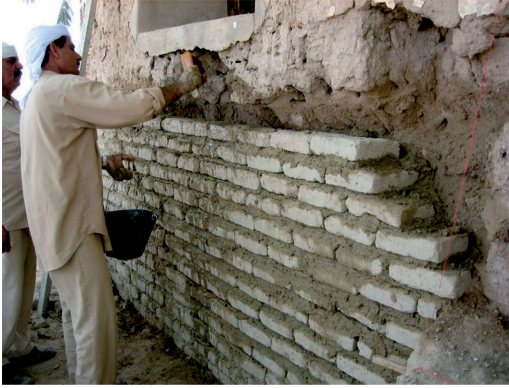
Figure 13. Mosque of Al Jahili, Al Ain, UAE, 2007. Structural consolidation of coving by inserting mud brick masonry.

When the combined action of salt crystallization and wind-blown sand is so high that walls are heavily eroded at the bottom and show severe coving effect, these can be repaired with a traditional system that is widespread from vernacular Pakistan (where the method is called mud *pushta*) to other building cultures such as that of Sardinia (Fodde 2007d) and the UAE (Fig. 13).

Such reinforcement, made of mud brick set in a stepped pattern with mud mortar, is applied along the perimeter of the decayed wall. This procedure foresees a preliminary brushing-off of all loose earth of the ground surface. A sheet of geotextile should be inserted before laying the first brick course.

Construction is carried out so that the last course ends just in the upper area of deterioration. The intervention is then mud plastered and it has the advantage of being clearly legible as a new. Firmer connection of the new masonry to the historic fabric can be achieved by inserting a grid of wooden pins.
