Strengthening design of Ganxi's Former Residence

ABSTRACT: Some key questions in strengthening of a modern architecture called Ganxi's Former Residence are roundly discussed, including foundation reinforcement, brick wall reinforcement, seismic reinforcement, wood floor and wood roof truss reinforcement. The original foundation was strengthened by adding new reinforced concrete strip foundation, which expanded the bottom area and increased bearing capacity and rigidity of the foundation. The wall were strengthened by one-side or two-sides composite mortar laminate reinforced by mesh reinforcement, which increased compressive bearing capacity and seismic bearing capacity of the wall. By setting up the steel plate constructional columns and steel plate ring beams, which improved the seismic behavior but not occupied the useable area. These methods can be referenced for strengthening design of modern half-timbered architectures.

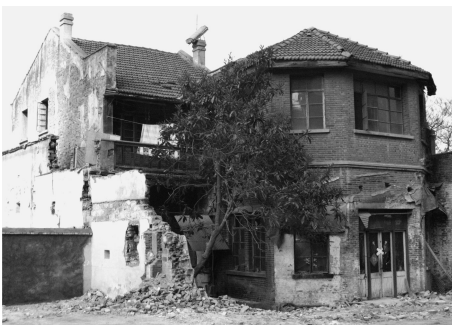
Figure 1. Elevation of the building.

The main strengthening and renovation project of Ganxi's Former Residence is one half-timbered building. Built in the 1920s and 1930s, it is now on the priority protection lists of cultural heritage defined by Nanjing City Government. This building has two stories, with east-west length 17.75 m, south-north length 10.15 m, construction area 320 m², 10.57 m in height. The floor and roof are wooden. The structure is mainly bear by longitudinal-cross masonry walls, with outer wall thickness 380 mm and inner wall thickness 260 mm. The wall is made of solid soil bricks, and constructed by soil mortar. The roof structure is space wood truss. The foundation is made of large footing bricks. Despite years of exposure to sunshine and rain, the construct is not seriously damaged, yet it

severely weathered. For later safe use, it needs to be strengthened and renovated. (Fig. 1, Fig. 2)

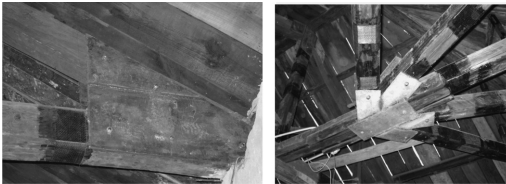
Figure 14. Construction of strengthening joints of the wood roof truss.

ending joint is connected in tooth profile, its ultimate state is determined by shear parallel to wood grain, so it is the weak link. In addition, the axial force of top chord at the end is the biggest, thus the shear force translated to the ending joint is much more bigger. Therefore, the ending joint must be strengthened (Fig. 12). Strengthening for the middle joint is presented in Figure 13. Figure 14 is the field construction photos.
