## Structural strengthening of the Dobrzyca Palace, Poland

**ABSTRACT:** In the presented paper authors show the idea of strengthening the construction of historical Palace in Dobrzyca (Poland). The complex consists of the English style park, the Palace, the Pantheon and the Monopter. There were necessary restoration works and, in the first order, protection and constructional stabilization, because of the bad technical state of the Palace construction. The Authors elaborated complex programme and schedule of strengthening the construction of the Palace which guarantee its stabilization through equilibration of internal tensions in structural elements. As a consequence of it some difficulties occurred in arrangement the appropriate rigid constructional system. Steel braces were applied in those areas. Additional bracing of building structure, in the level of ceiling above the ground floor, was obtained by initially compressed band jointed with steel braces and reinforced concrete ring beam in the level of the wall cap. As a result of carried out strengthening spatial stiffness of building considerably raised, protecting it from repeated constructional damage.

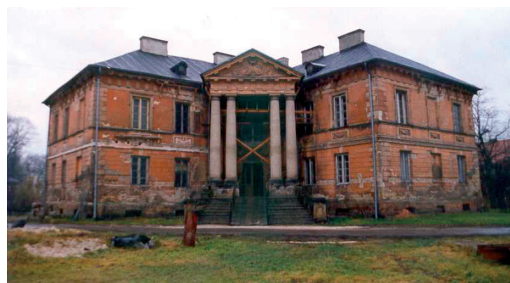
Technical state of the Palace building construction is diversified (Figure 1). Spatial stiffness of construction is reduced, that was caused by inappropriate building works on different stages of building's development and lost of primary strength features of applied materials. As a result of these, many cracks and rifts in

Figure 1. General view of the Palace in Dobrzyca before executing strengthening and renovation works.

walls and lintels can be observed as well as construction separation, plaster detachment, considerable biotic damages of wooden elements and general constructional degradation of building. The walls near landing of main staircase as well as walls of the first floor and wall coping belong to the most destroyed zones.

Temporary repair works were executed in the Palace in earlier years, but there was not realized complex solution of strengthening and building's stabilization. The Authors of this paper elaborated complex programme and schedule of strengthening coherent to conservatory and constructional regards which satisfied general solution of building stabilization. This programme have got positive opinion and it received admission to realization. It was assumed, because of antique interior decoration of the Palace, that in

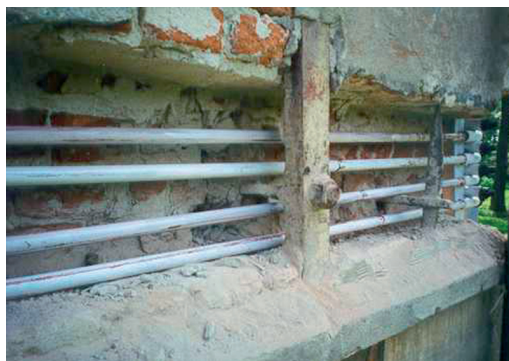
Figure 4. General view of initially prestressed band.

On a level of ceiling over the first floor it appeared that the best constructional and economical solution was to realize strengthening of building's bearing system by means of reinforced concrete ring beams. At selection of ring beams section, it was taken under consideration that their task is not only to stiffen the building, but also to transfer of tensile forces which are caused by non-uniform settlement or loading and strut forces from roof. As a result of application of reinforced concrete ring beams in wall coping more uniform stress distribution in strengthening masonry was obtained. Realization of ring beams was carried out in traditional way and based on the insertion suitably strengthened elements in longitudinal and transverse bearing walls (in the place of

biotic damaged wall plates) which fasten circularity arrangement of walls in closed and rigid spatial contour. That ring beam co-operates with walls by means of friction and adhesiveness what effectively increase stability and spatial stiffness of construction on lower roof's level. Additional advantage of executed reinforced concrete ring beam was using of it to reproduce damaged roof cornices. In ring beam angle bars supporting reproduced brick cornice of roof were anchored (suitable constructional detail is presented in Figure 5), in the place of damaged and ruined wooden elements for cornices. Additionally, during strengthening of roof construction built-in reinforced concrete ring beam for anchoring floor's beams by means of angle sheets and strut anchors was used. Such as in case of ceiling strengthening above ground floor many routine protecting and impregnating works were executed.

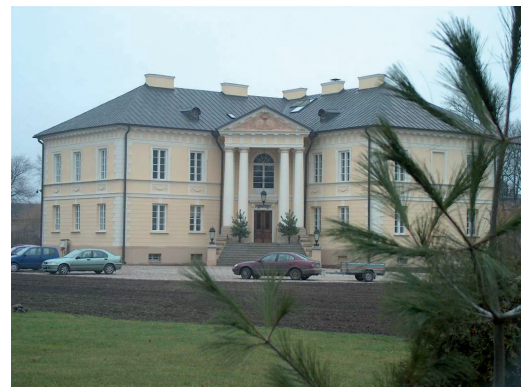
Figure 6. General view of the Palace in Dobrzyca after executing strengthening and renovation works.

reconstruction and repair). Protecting works described above are in the majority executed. Strengthening and repairing works are executing now in the limits of ceiling over first floor and rafter framing. Destabilized chimneys were totally re-erect. The fragments of roof framings are exchanged and repaired surfaces are covered by copper sheets. It should be noticed that presented above realization complex constructional protection of building will permit the stabilization of its bearing arrangements and will allow making further conservatory works. In results of executed strengthenings up to the present, spatial stiffness of the building was considerably raised, protecting it from renewed constructional damages. Possibility of reconstruction and preservation of historical interior decoration of the Palace as well as its façades was obtained in this way.
